**ISLAND PONDS MITIGATION MONITORING  
AND REPORTING  
YEAR 1- 2006**

Philip Williams & Associates, Ltd.  
H.T. Harvey & Associates  
University of San Francisco  
Santa Clara Valley Water District  
U.S. Fish and Wildlife Service - Don Edwards National Wildlife Refuge

January 2007

PWA REF. # 1864

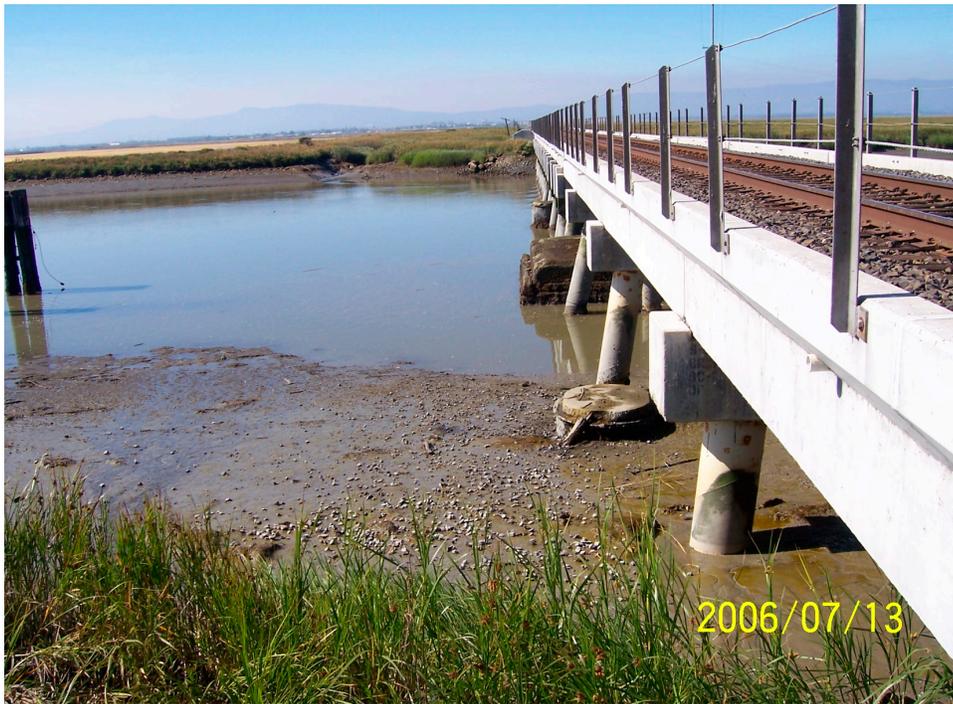
Although scour was documented at the bridge piers in November 2006, it is unclear whether this scour was induced by the Island Ponds Restoration or whether the scour occurred prior to the breaching. Since there are no pre-breach baseline photographs or measurements of conditions at the base of the piers, we suggest continued annual monitoring to see if the scour continues to advance over time.

East Side of Bridge Looking South – July 13<sup>th</sup>, 2006

Limited scour was observed at the base of the railroad bridge piers. However, it is unknown whether this scour occurred pre-breach or post-breach, as there are no photographs or measurements to verify the pre-breach conditions of the piers. It would have been useful to have pre-breach baseline information to better explain and track this phenomenon. We recommend continued annual monitoring to see if the scour continues to advance over time, using the 2006 data as baseline.

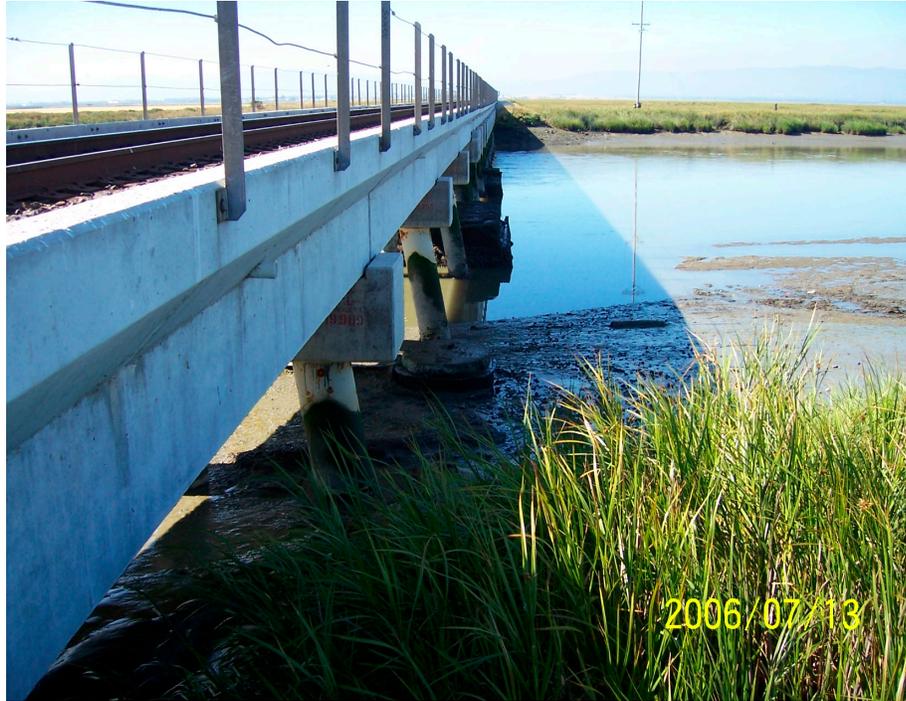
West Side of Bridge Looking South – July 13<sup>th</sup>, 2006

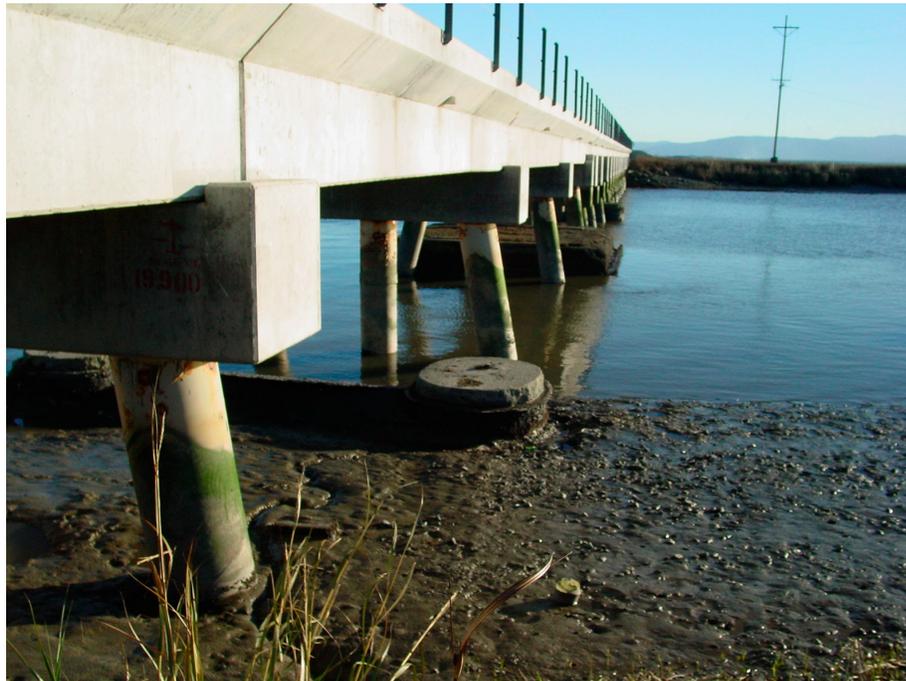
West Side of Bridge Looking South – November 29<sup>th</sup>, 2006

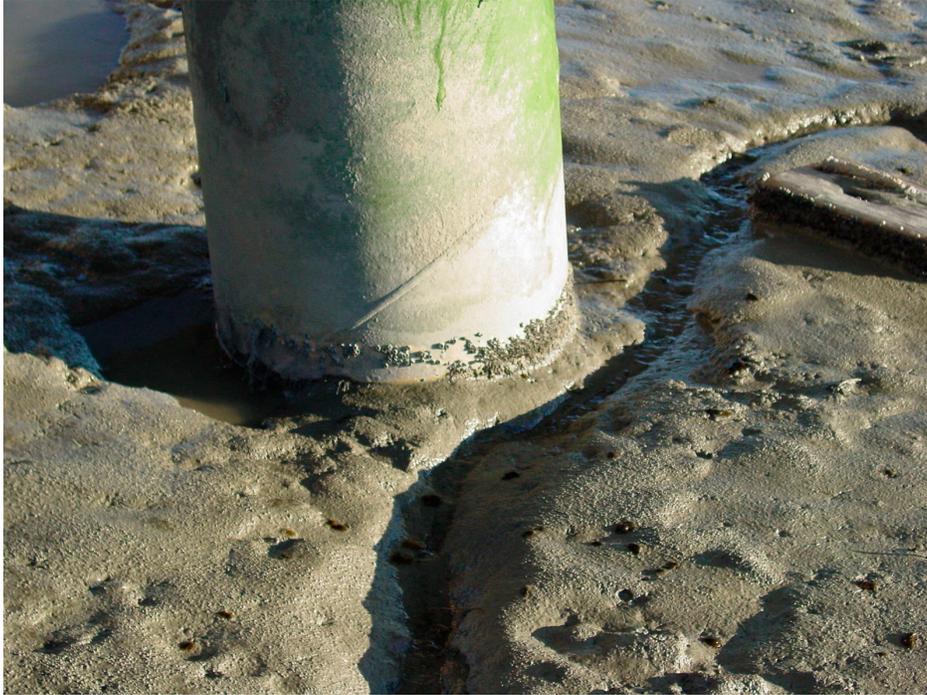
Close-up of West Side Pier on North Bank Looking West

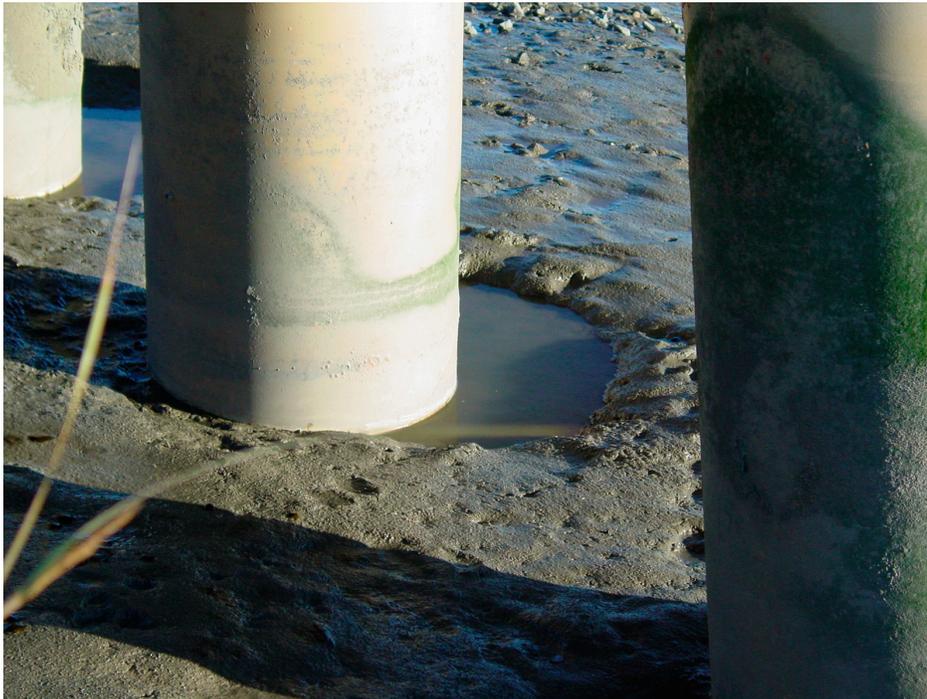
Close-up of Central Pier on North Bank Looking East

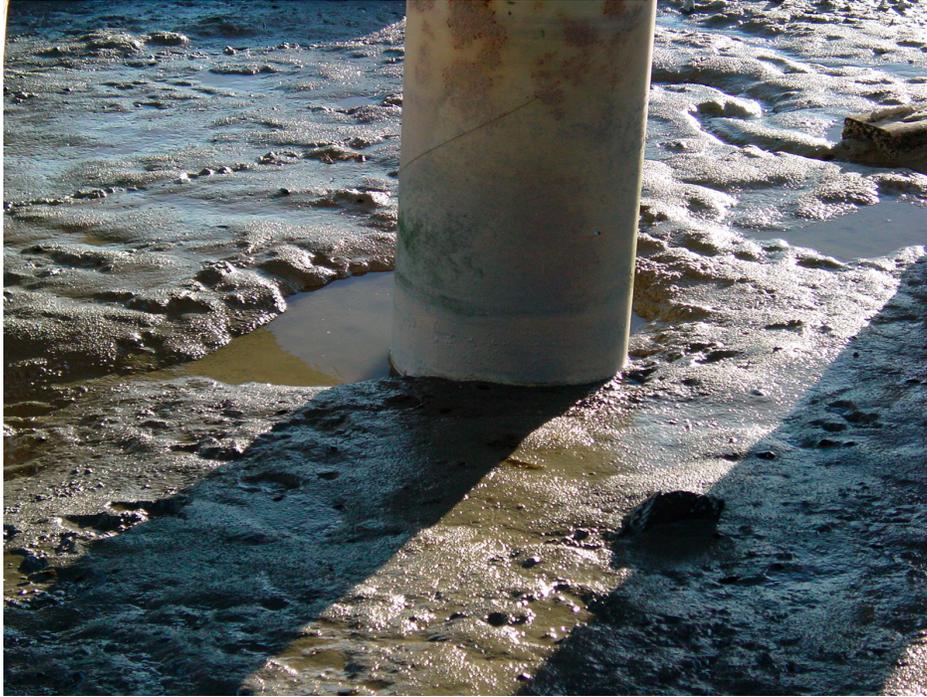
Close-up of Central Pier on North Bank Looking West

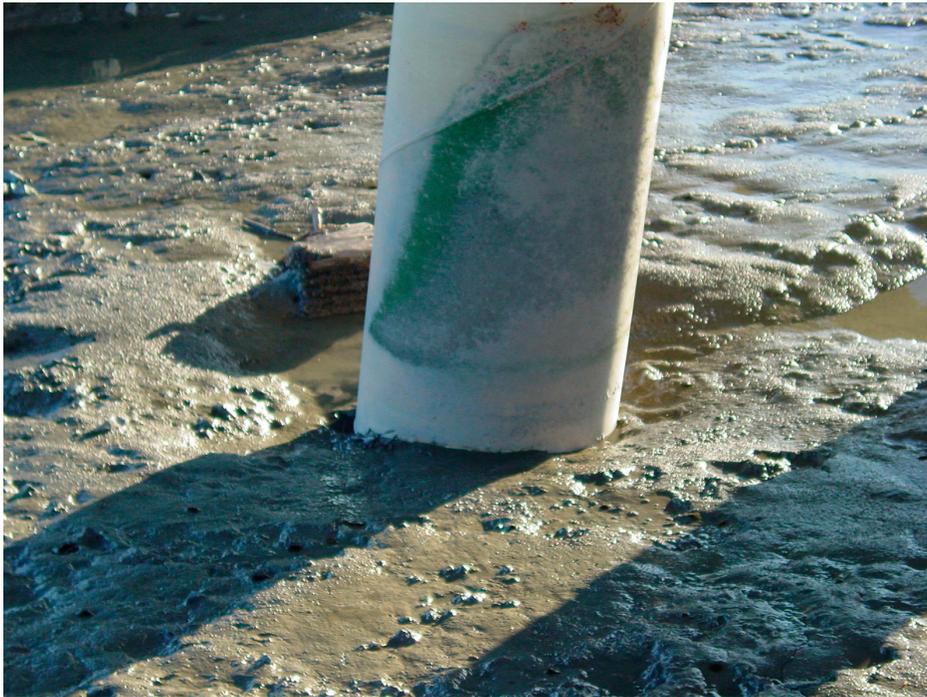
Close-up of East Side Pier on North Bank Looking West

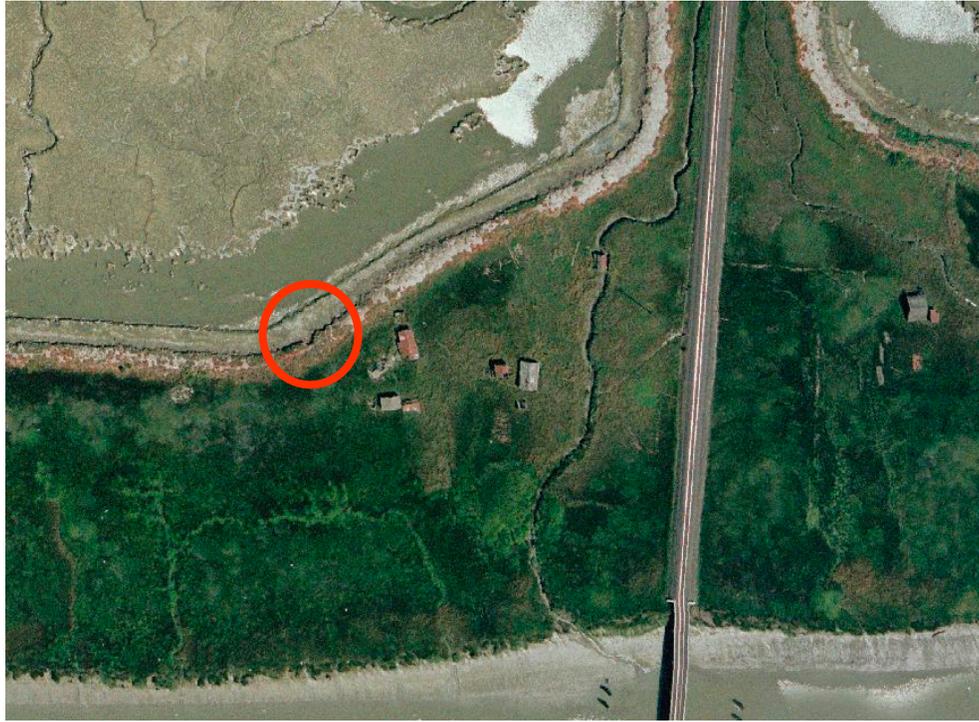
While inspecting the Pond A20 and A21 levees adjacent to the Town of Drawbridge, one particular area of erosion was found. The eroded levee is located near the southeast corner of Pond A21, approximately 100 feet from two existing Drawbridge structures and approximately 70 feet from the remnants of a previously collapsed structure. The erosion is occurring on the pond side of the levee with a large portion of the levee being affected. This erosion however is not a direct result from the breaching activities, as this same erosion scar is visible on the 2005 aerial photos. Based on measurements using ArcView GIS, there is no difference in the size of this scour pre-breach versus post-breach. Therefore, it appears that this erosion is not rapidly advancing. A photograph of the eroded levee and an aerial photograph of the general area are included in Appendix B. These photographs and the 2006 measurement of the scour will serve as the baseline information for this particular monitoring effort.

Aerial view of the railroad and the Town of Drawbridge.  
The red circle in the southeast corner of Pond A21 depicts the area of concern.

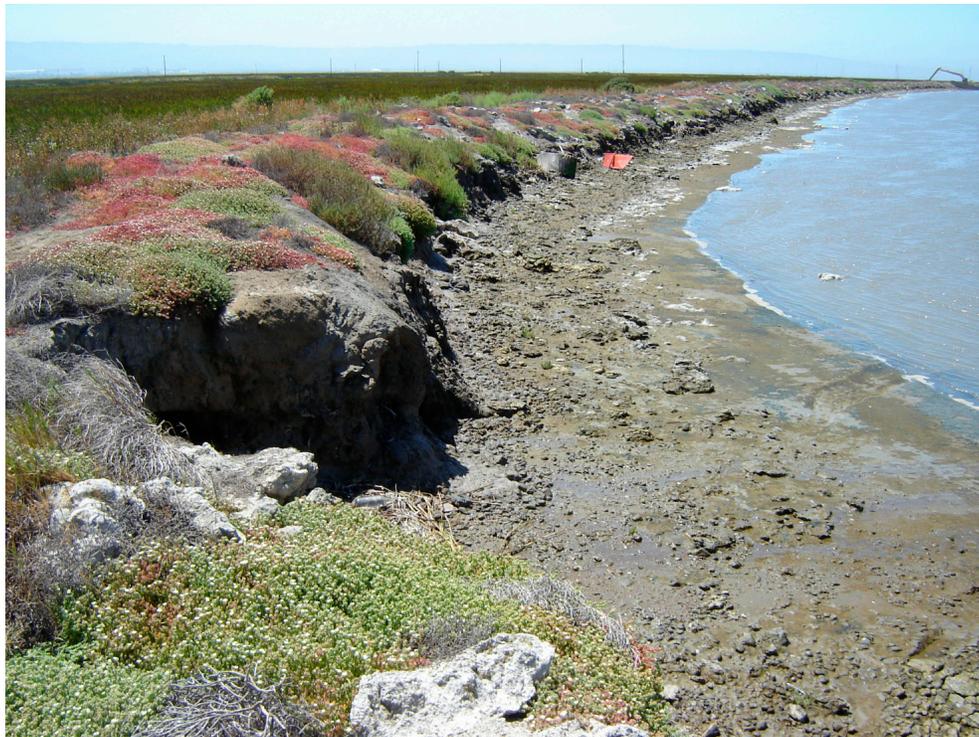
Close up of eroded levee in the southeast corner of Pond A21

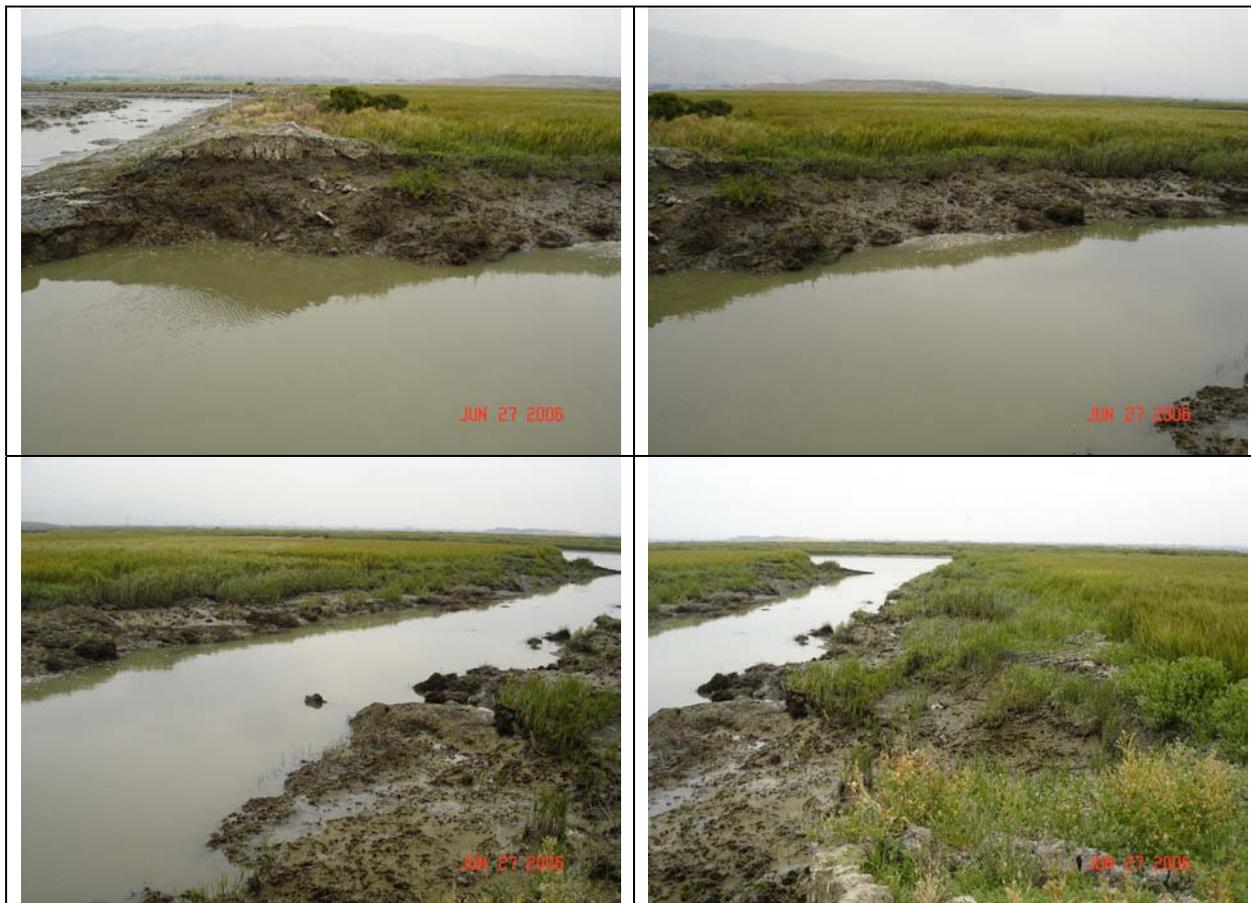
Pond A20 panoramic photos taken from the old levee on June 27, 2006. Notice much of the sidecast material has eroded or slumped into the breach channel.
