Levee Assessment

Submitted to:
California State Coastal Conservancy
U.S. Fish & Wildlife Service
California Department of Fish and Game

Prepared by:
Geomatrix Consultants

October 2006

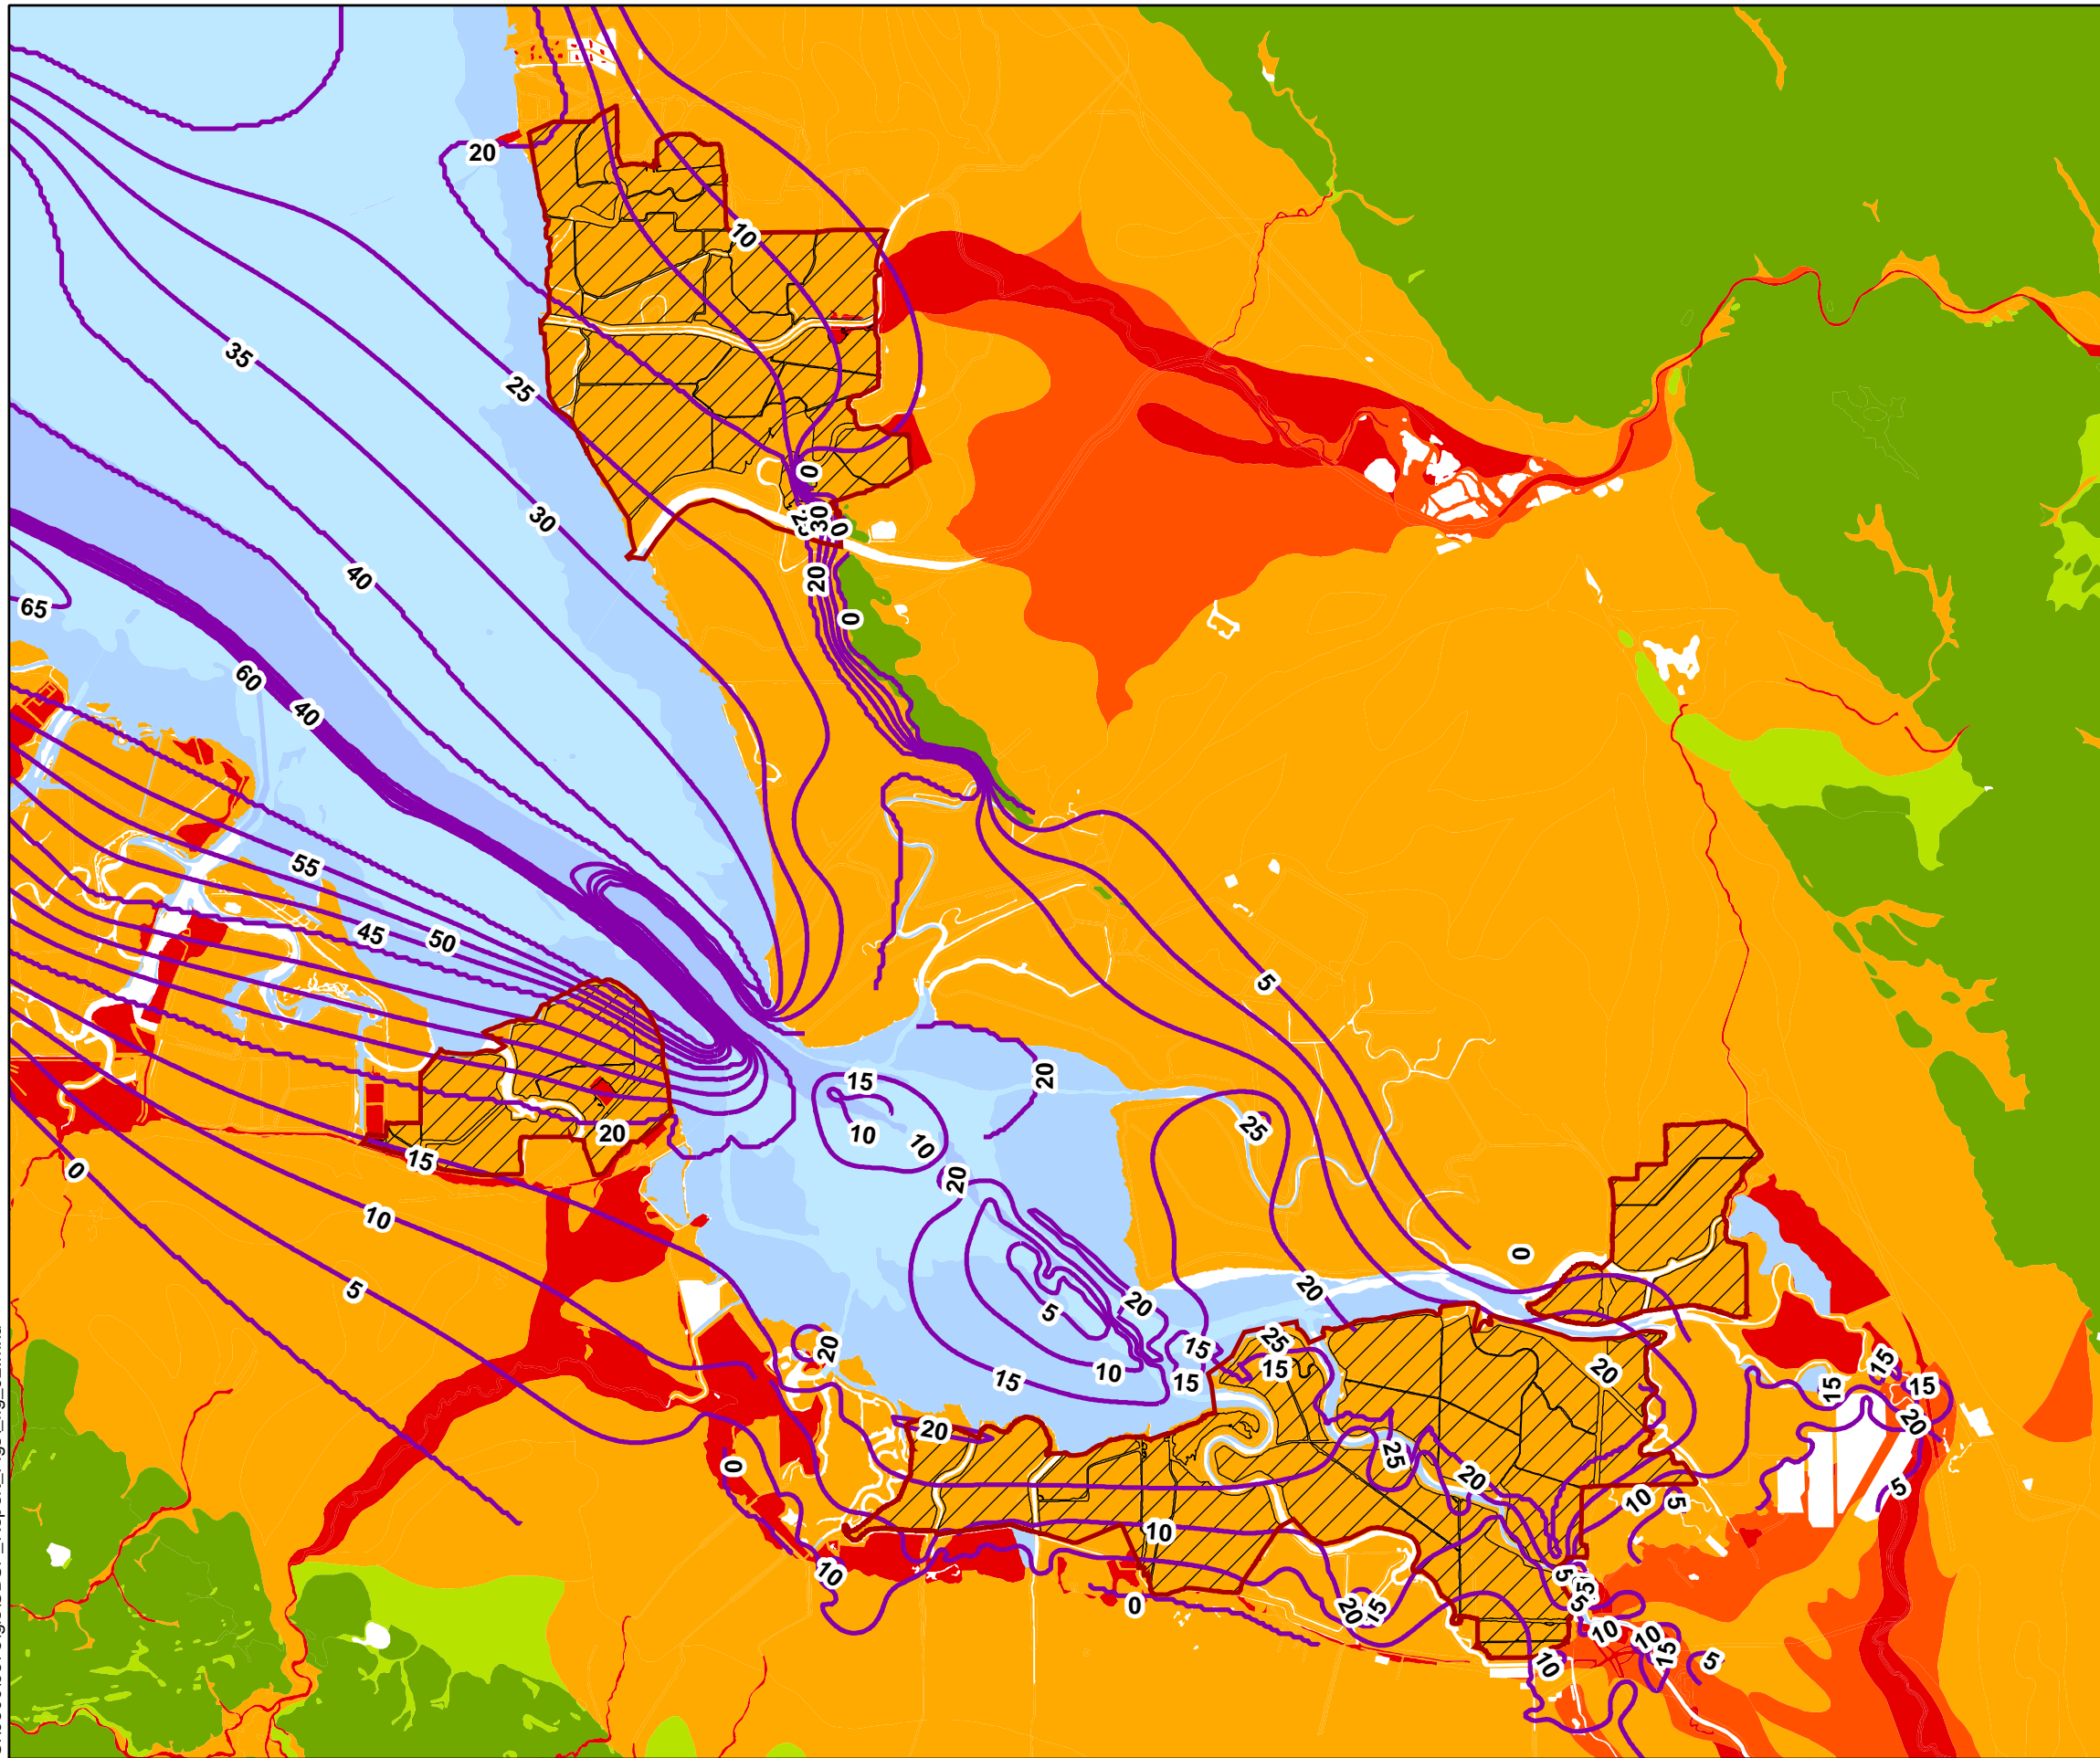
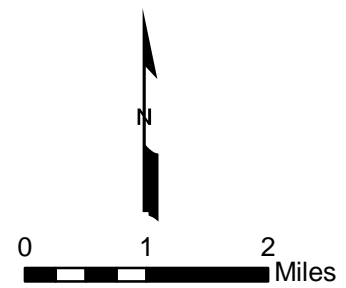
BAY MUD THICKNESS AND BORINGS
Levee Assessment
South Bay Salt Ponds Restoration Project
San Francisco Bay Area, California

Figure 2 summarizes subsurface conditions in terms of liquefaction potential and Bay Mud thickness for the project area.

Liquefaction evaluations were beyond the scope of this study. However, saturated loose granular soils exist within, and below, sediments of the San Francisco Bay throughout the SBSP Restoration Project area. These soils are potentially liquefiable. The amount of liquefaction is expected to vary within a given pond complex based on density, depth, and thickness of potentially liquefiable soil layers. A liquefaction susceptibility map for the SBSP Restoration Project area (Knudsen and others, 2006) based on soil type, soil thickness and depth to groundwater is presented in Figure 2.

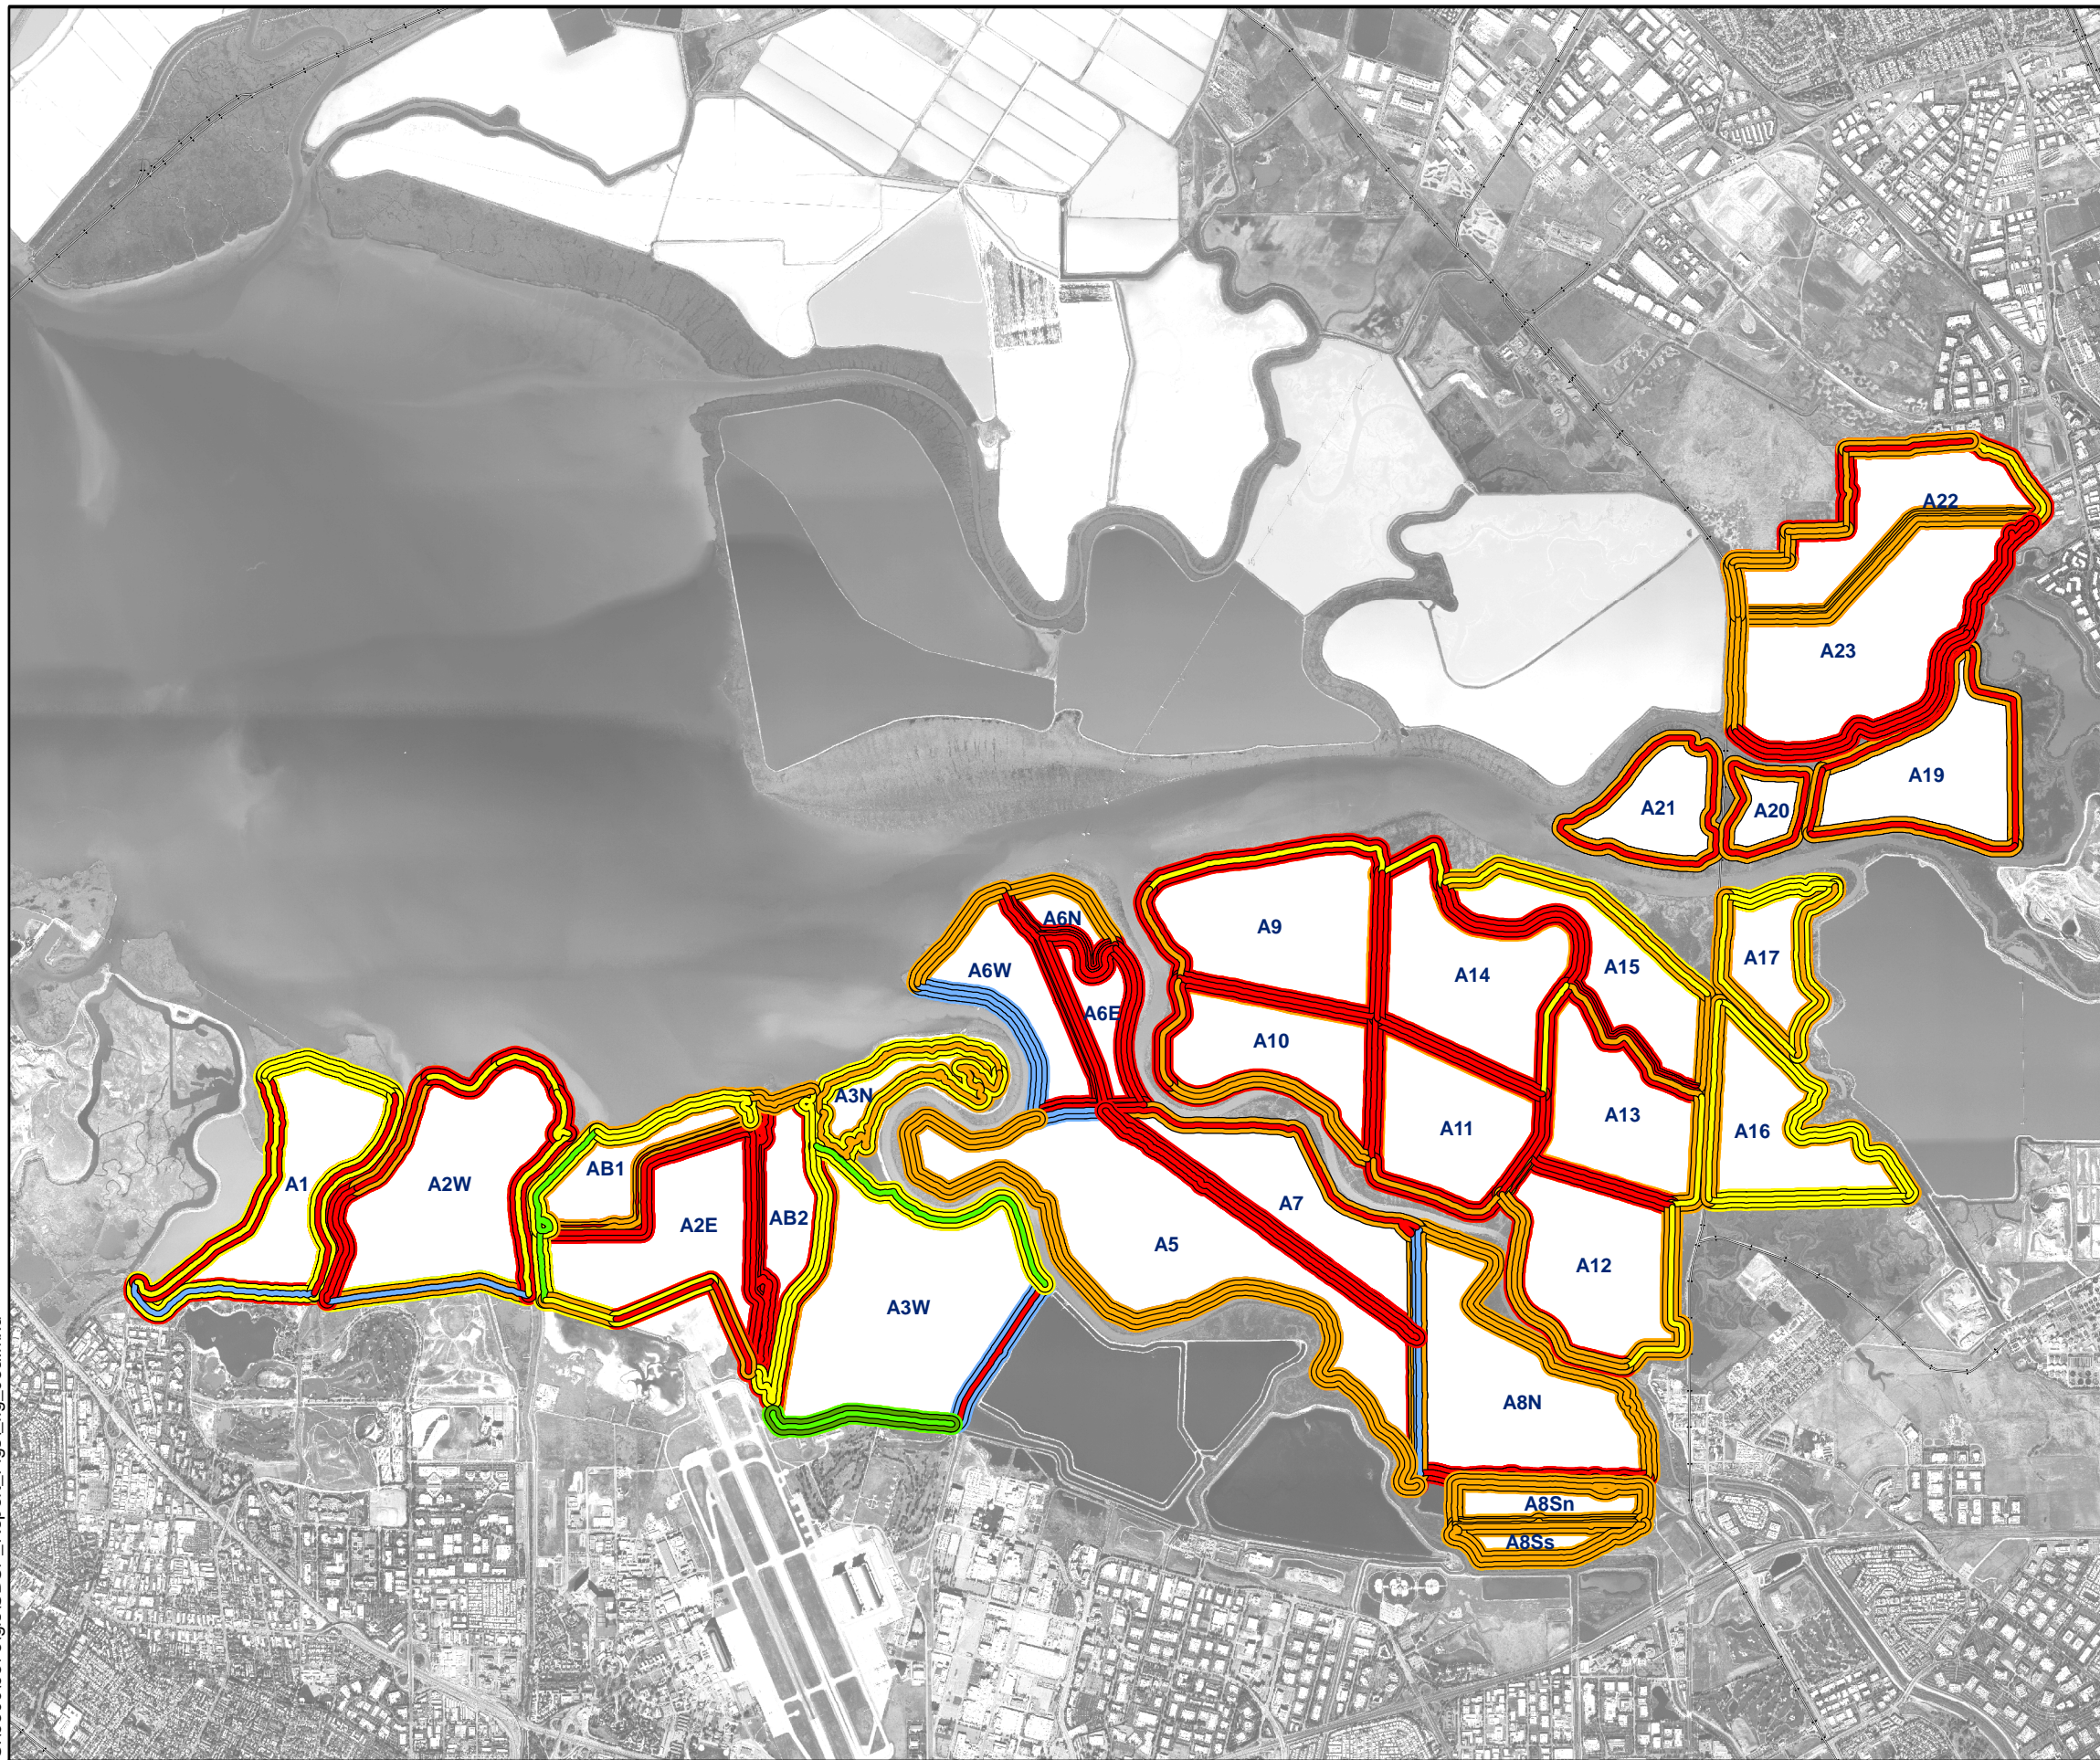
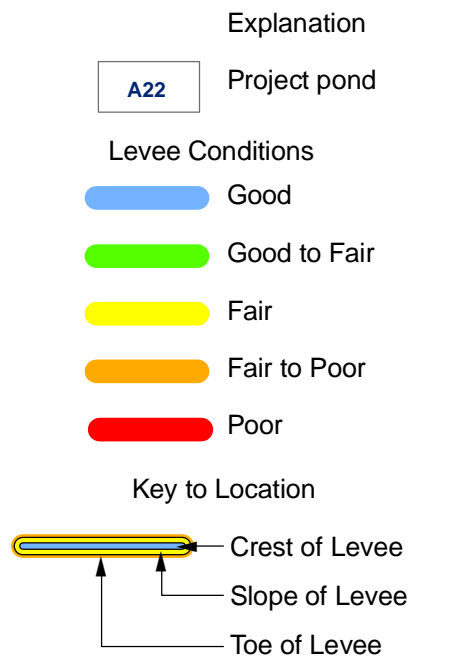
LEVEE ALIGNMENT CONDITION
ALVISO
Levee Assessment
South Bay Salt Ponds Restoration Project
San Francisco Bay Area, California

Figures 3a, 3e, and 3r are a series of maps for each respective pond complex (Alviso (a), Eden Landing (e), Ravenswood (r)) showing summarized levee alignment conditions for the crest, slope and toe. These figures include data compiled from multiple sources. Where overlapping data exists, that from the most recent source is presented. Levee conditions in Figures 3a, 3e, and 3r are labeled and color coded good (blue), fair (yellow) and poor (red).
