**ISLAND PONDS MITIGATION
MONITORING AND REPORTING
YEAR 4 - 2009**

January 2010

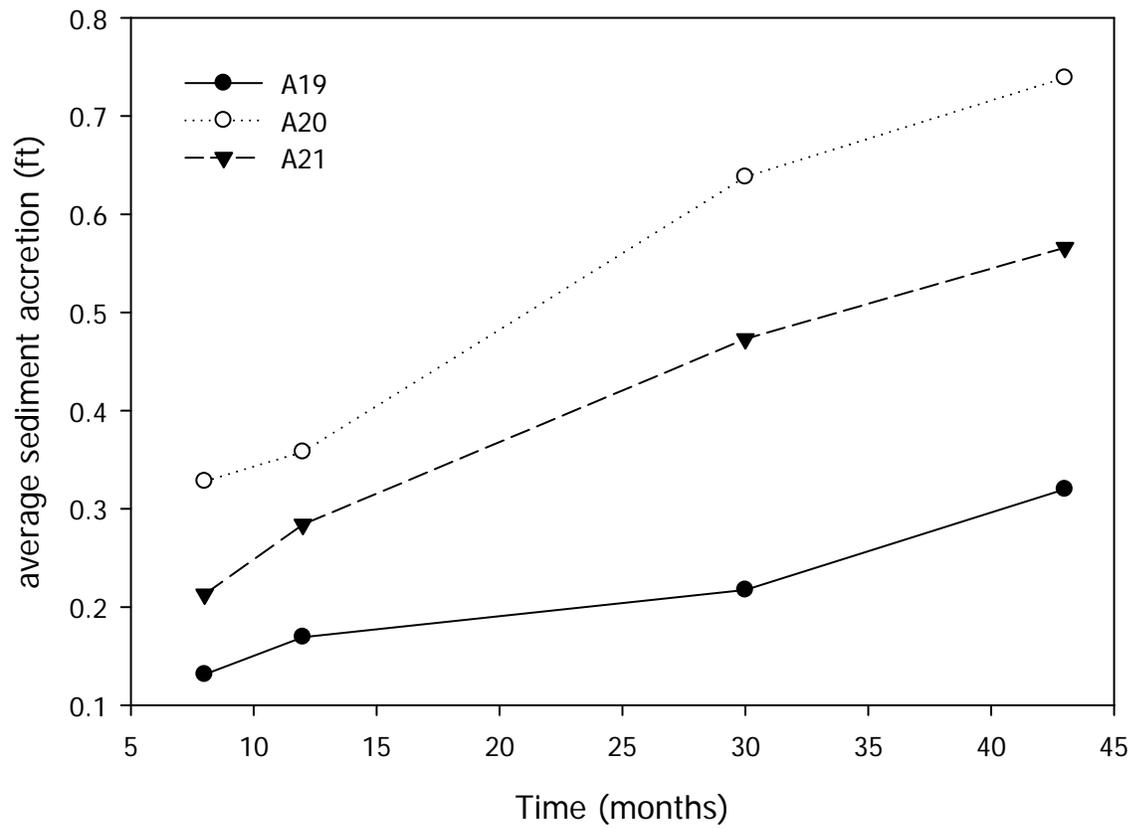
All three Ponds have accumulated substantial sediment in the 43 months since they were breached (Figures 2 and 3). Pond A19 had the lowest accretion rates of the three Ponds (Figure 4). After the first year following the levee breaches, Pond A19 accumulated an average of 0.17 feet (52 mm). Accretion rates slowed between 12 and 30 months to 0.05 ft (15 mm) but increased again between months 30 and 43 to an average of 0.09 ft (29 mm). Erosion has occurred around one pin, A1912, which was positioned in a location near a breach where the gypsum layer is cracking and eroding. Two of the fifteen pins in Pond A19 accumulated more than 0.2 ft of sediment (the annual projected accretion rate) since the 30 month post-breach measurements; the depth changes around the other pins ranged from 0 to 0.11 ft. A small reduction in sediment of 0.01 ft was documented around one pin, A1908. The three sediment pins located farthest from the breaches had the lowest deposition rates; however, there was no statistically significant trend between distance from the nearest breach and deposition.

Figure 3. Sediment accretion averaged across all pins increased over time at Ponds A19, A20, and A21 (error bars not shown).

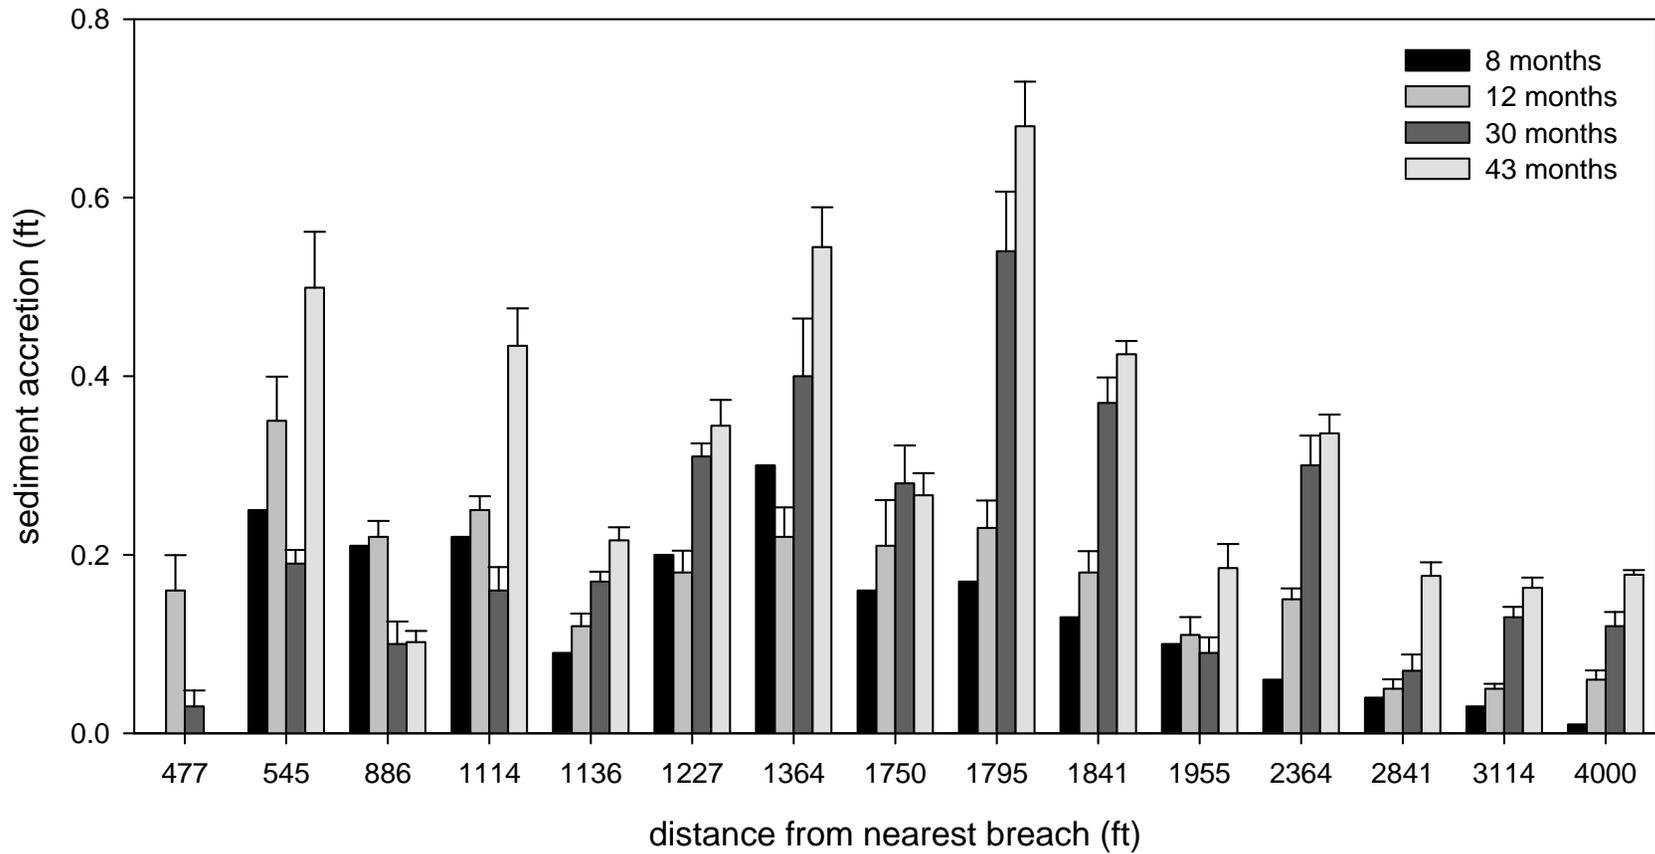
Figure 4. Average sediment deposition over time at each pin location in Pond A19 (error bars represent ± 1 standard error; 8 month data represent average of 3 measurements; all other data represent the average of 8 measurements).

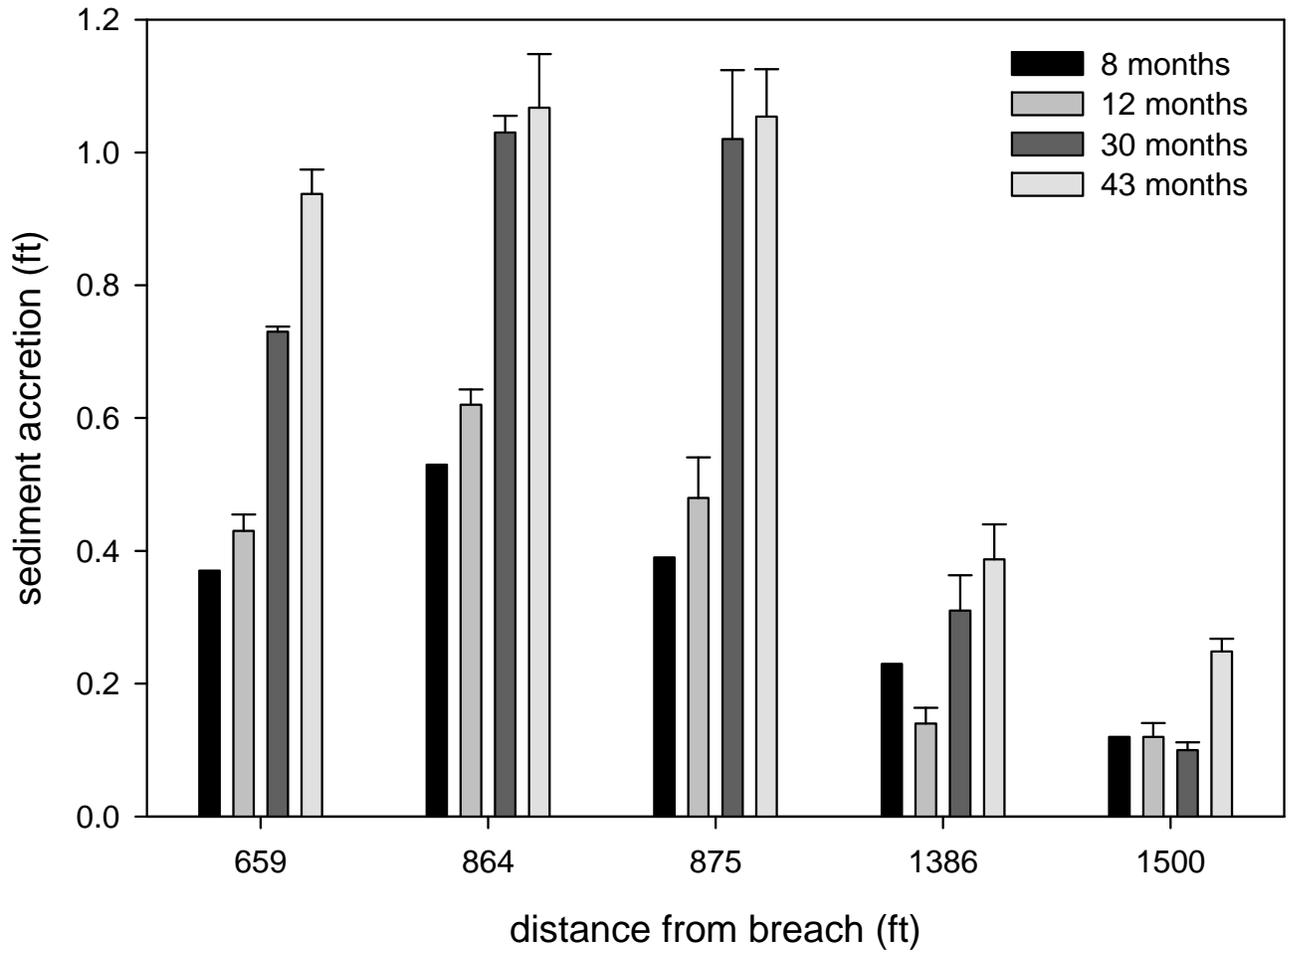
Figure 5. Average sediment deposition over time at each pin location in Pond A20 (error bars represent ± 1 standard error; 8 month data represent average of 3 measurements; all other data represent the average of 8 measurements).

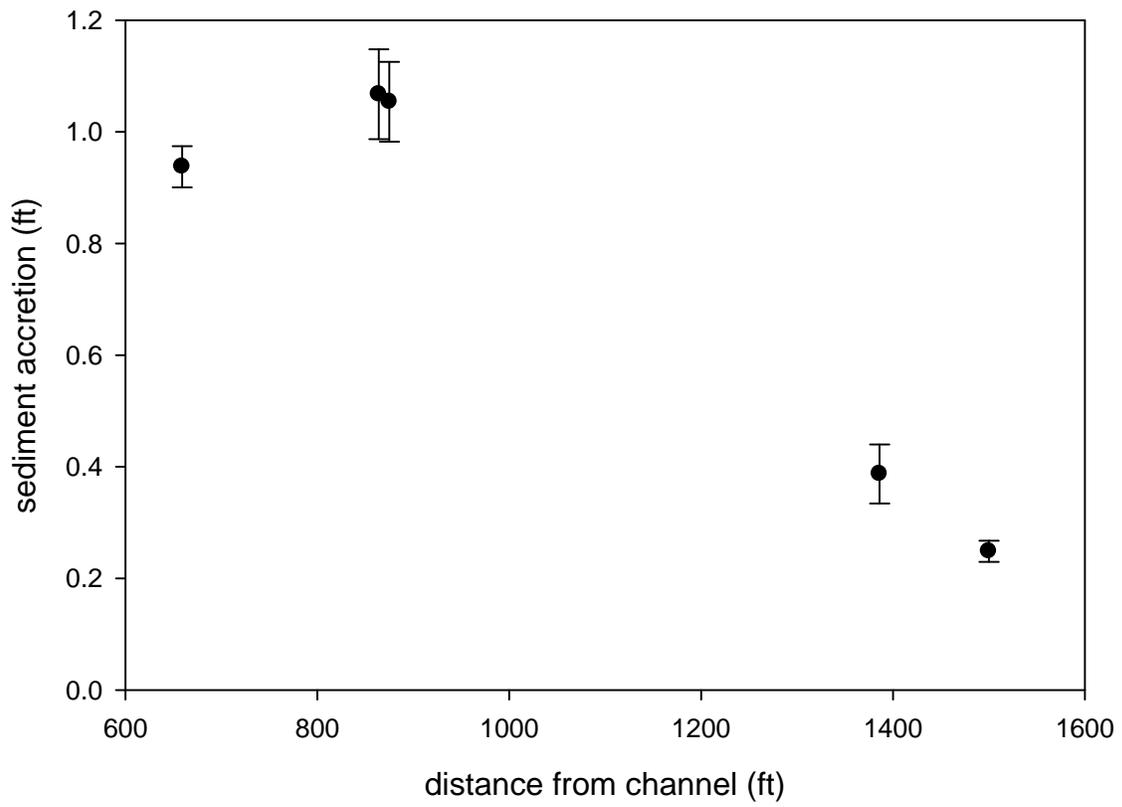
Figure 6. At Pond A20, sediment deposition 43 months post-breach decreased with increasing distance from the breach (error bars represent ± 1 standard error).

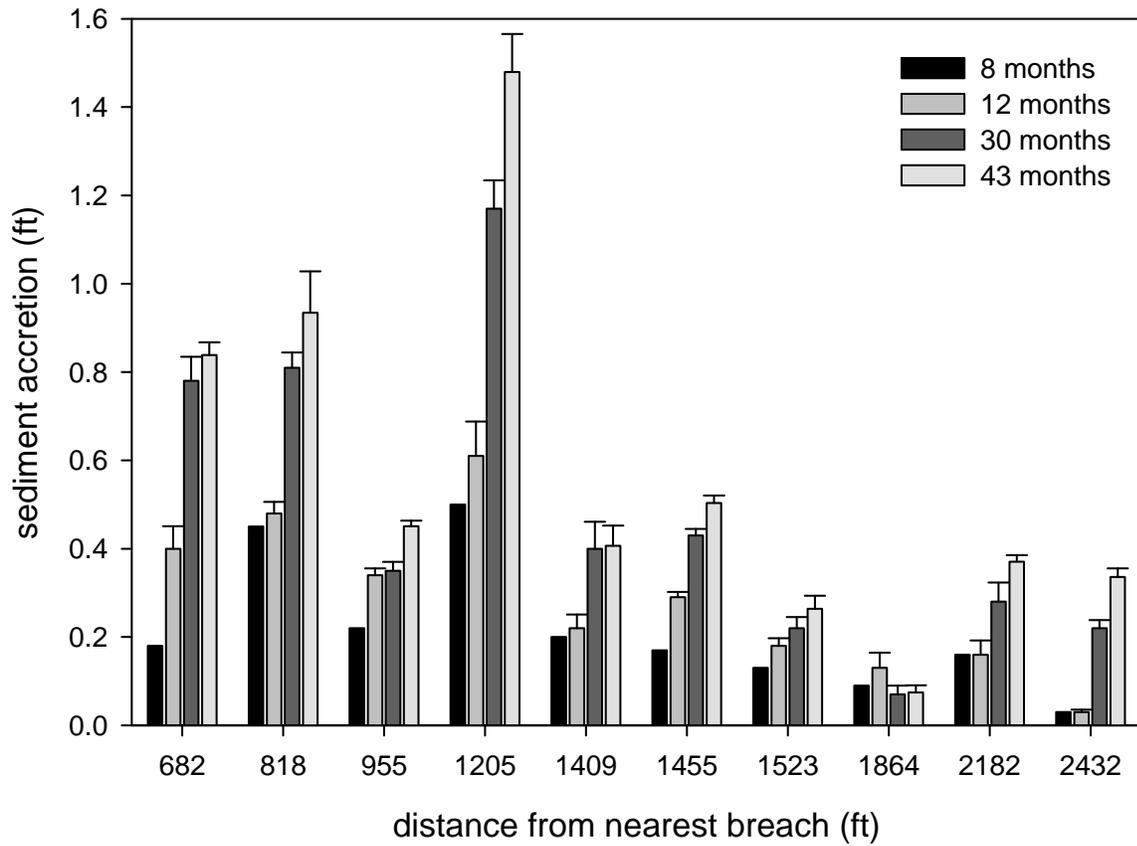
Figure 7. Average sediment deposition over time at each pin location in Pond A21 (error bars represent ± 1 standard error; 8 month data represent average of 3 measurements; all other data represent the average of 8 measurements).

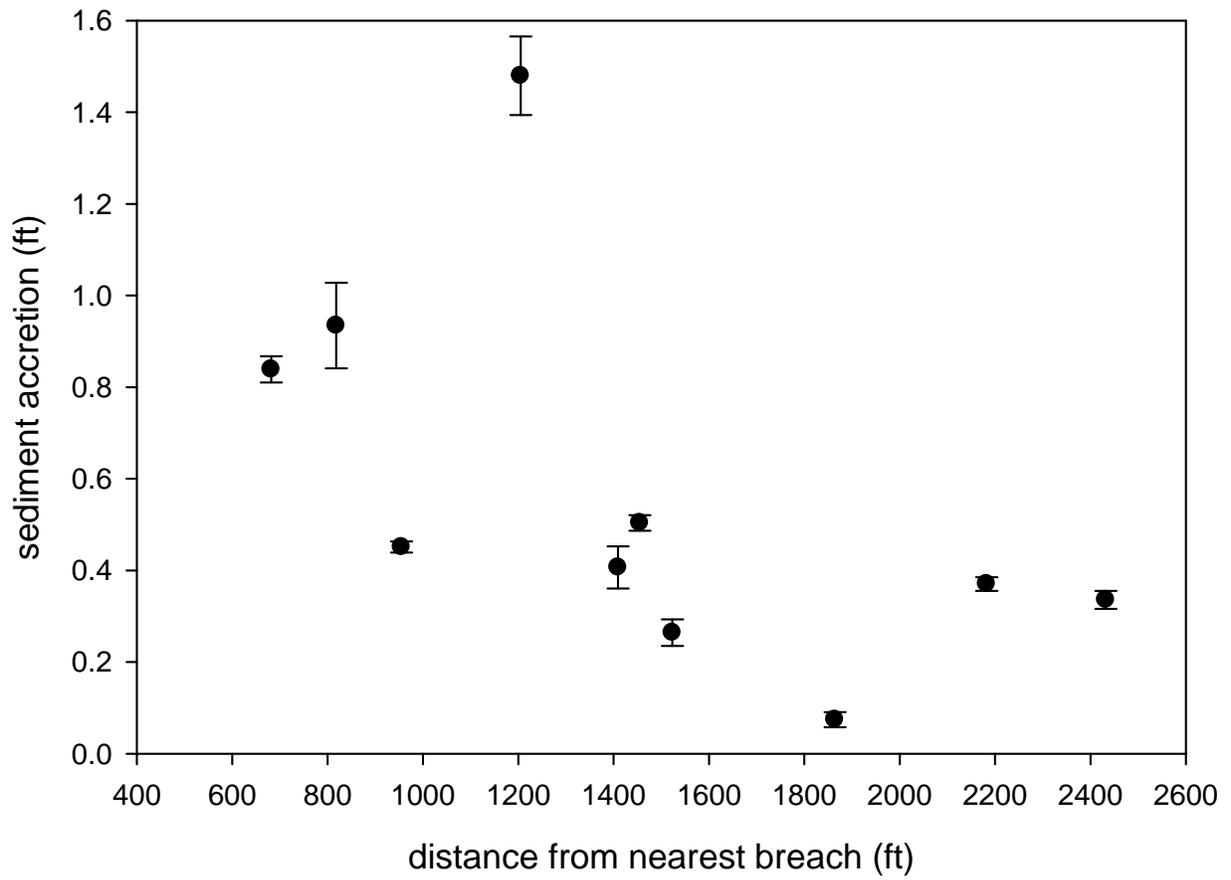
Figure 8. Excluding pin A2110 (point with the largest sediment accretion), sediment depth decreased with increasing channel distance at Pond A21.

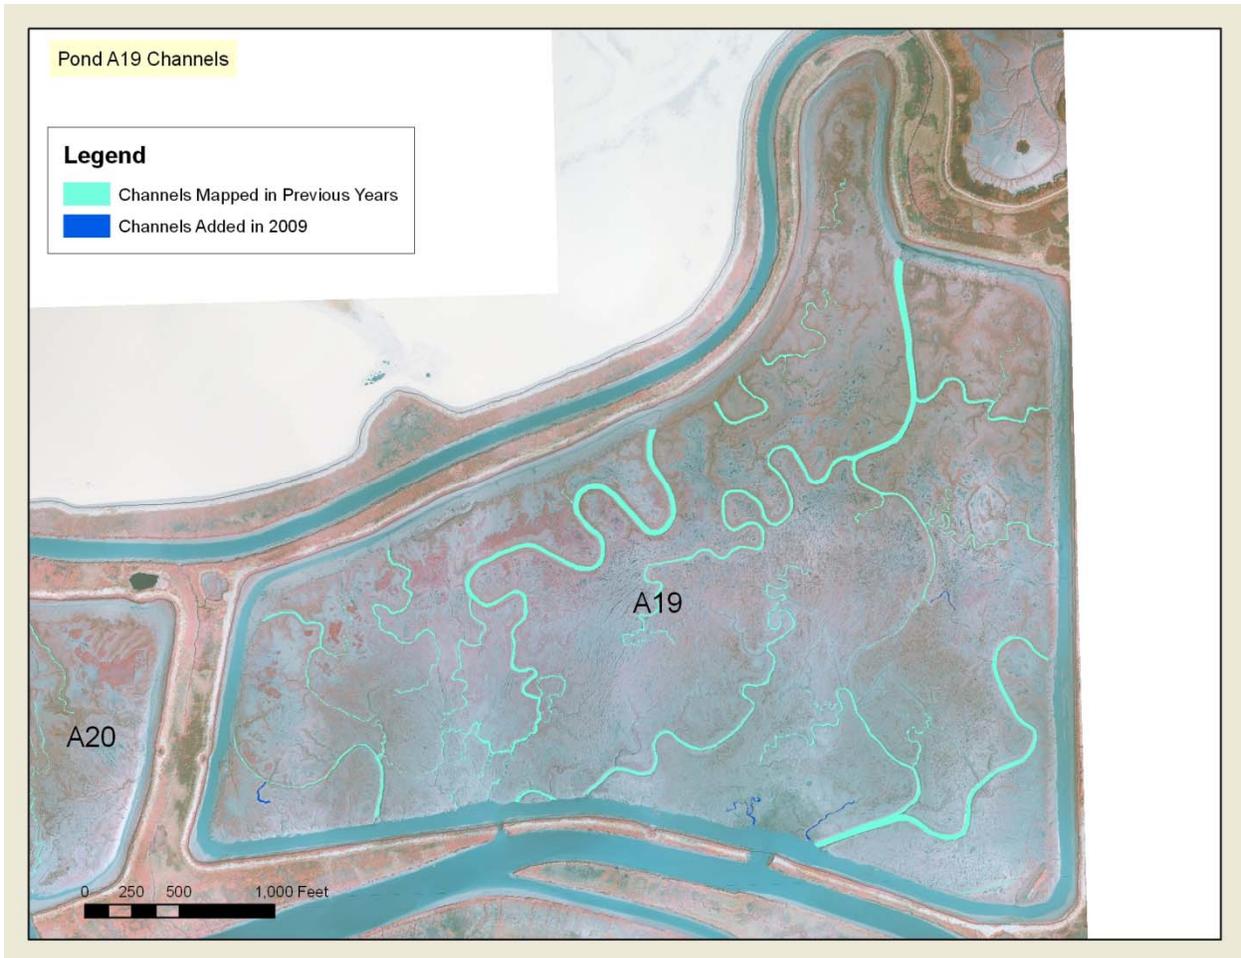
Figure 1: Channel Networking in Pond A19 during 2009 and in Previous Years.

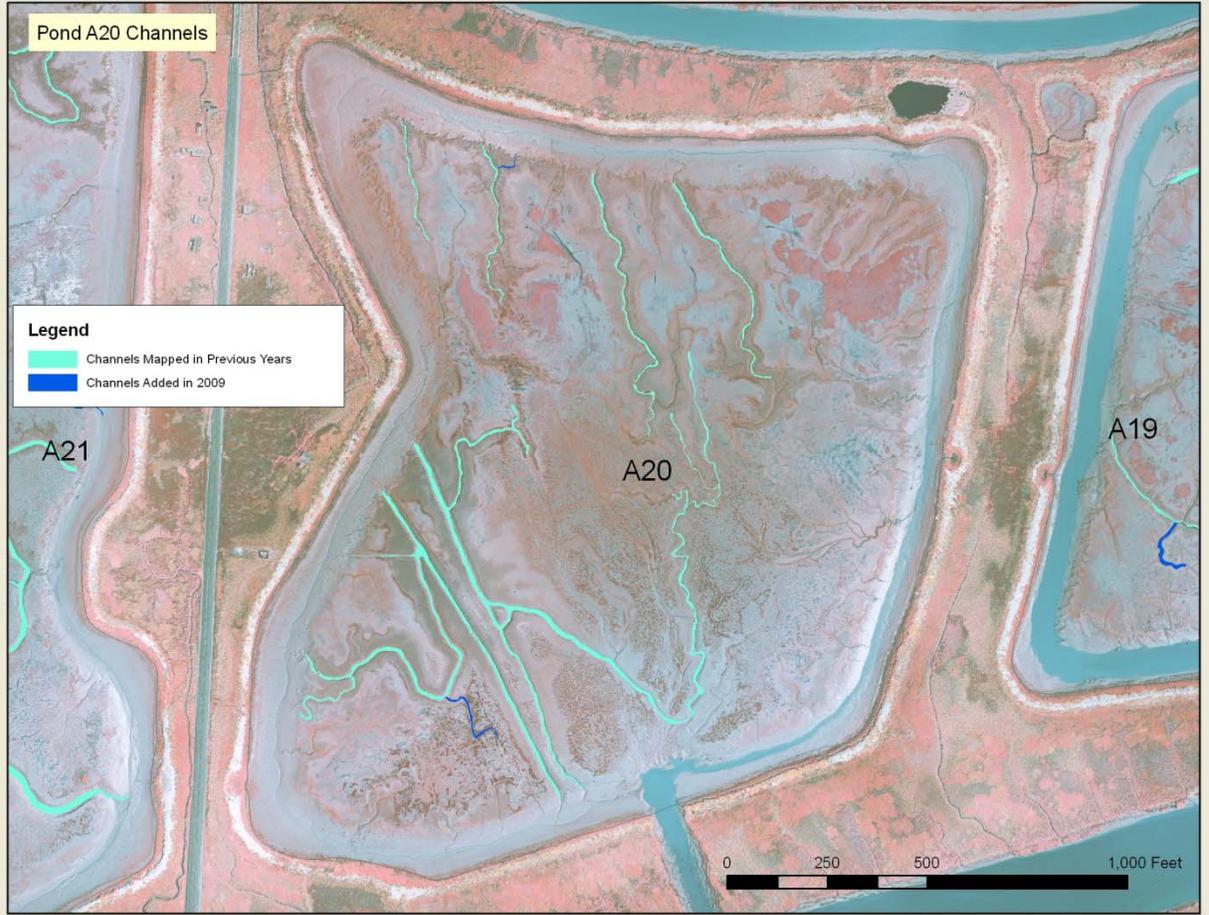
Figure 2: Channel Networking in Pond A20 during 2009 and in Previous Years.

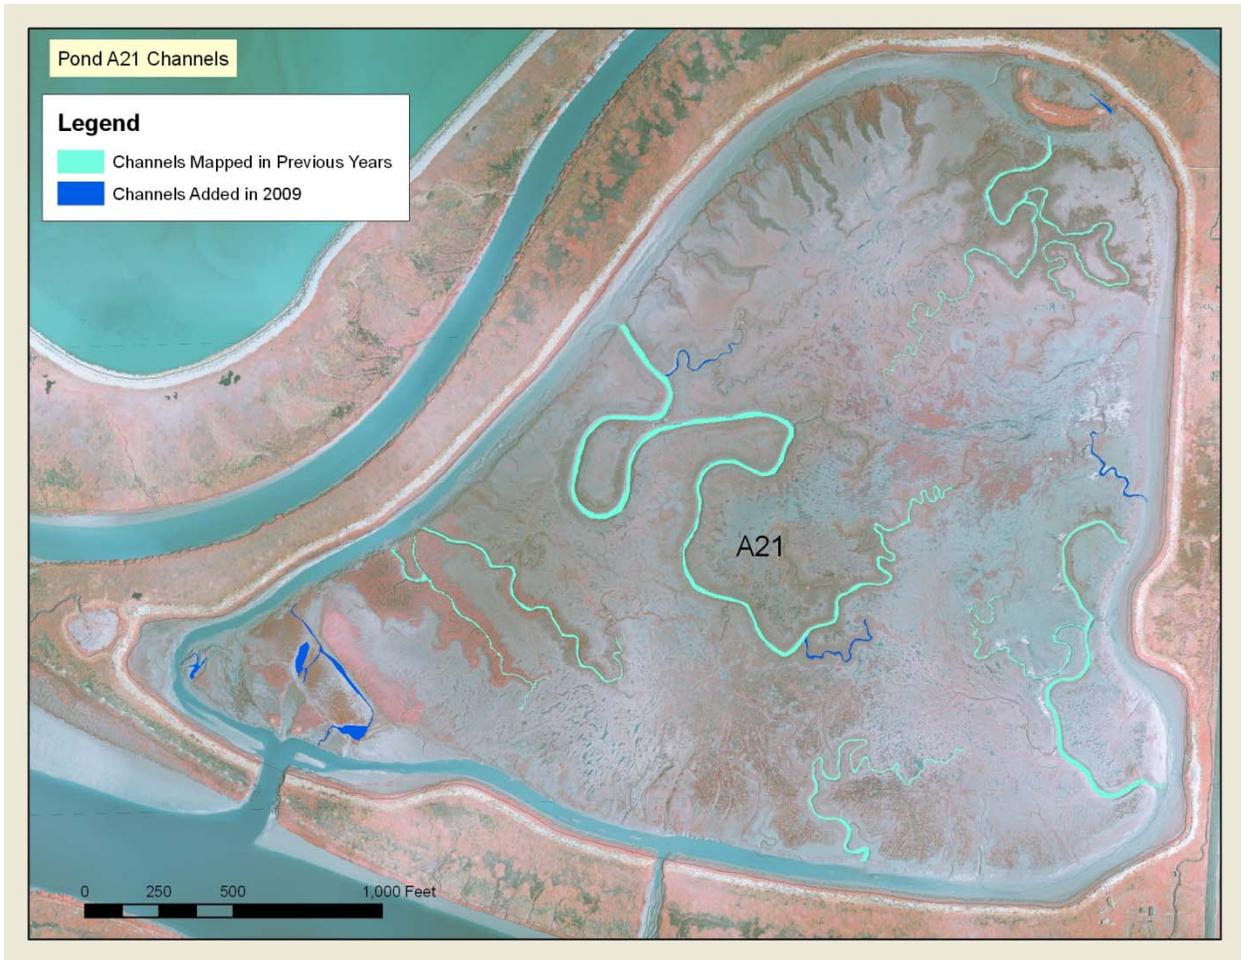
Figure 3: Channel Networking in Pond A21 during 2009 and in Previous Years.

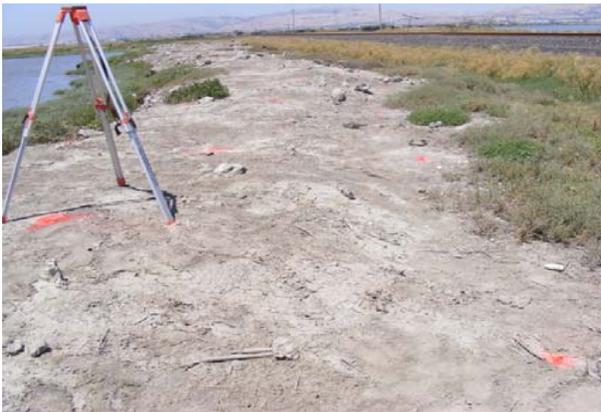
Data collected from 2008 to 2009 indicates there is some deterioration occurring along the southeast levee of pond A21. The inboard levee slope is starting to recede; however, there has been virtually no change to the levee height. Since the timeframe between the two site visits was only 7 months and considering that the 2009 winter season was relatively light, more data is needed to understand the long term prognosis of the erosion occurring at this location. This site will again be monitored in 2010.

2009 photo looking northerly
with section 4 and 5 in the background

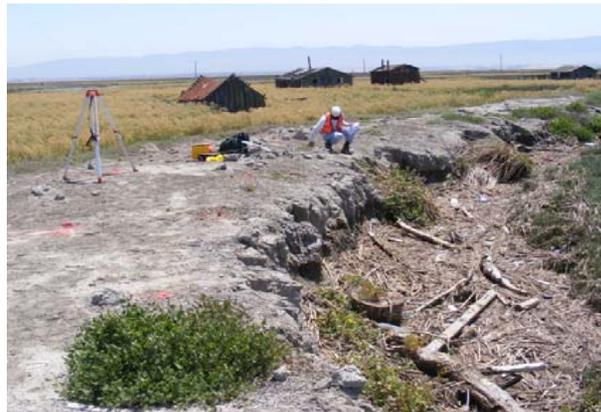
In addition, visual observations of the site reveal that a large deposition of debris has collected in the southeast corner of the pond, along the inboard levee slope. The debris was made up of decaying vegetation, litter and other floating objects. Since this observation occurred on a single site visit, it is unclear whether or not this debris has contributed and will continue to contribute to future slope erosion (wave break) or if the debris is a temporary condition.

2009 photo looking westerly
of marking stakes and debris pile inboard of levee
