ISLAND PONDS MITIGATION MONITORING AND REPORTING YEAR 3 - 2008

Santa Clara Valley Water District U.S. Fish and Wildlife Service - Don Edwards National Wildlife Refuge

January 2009

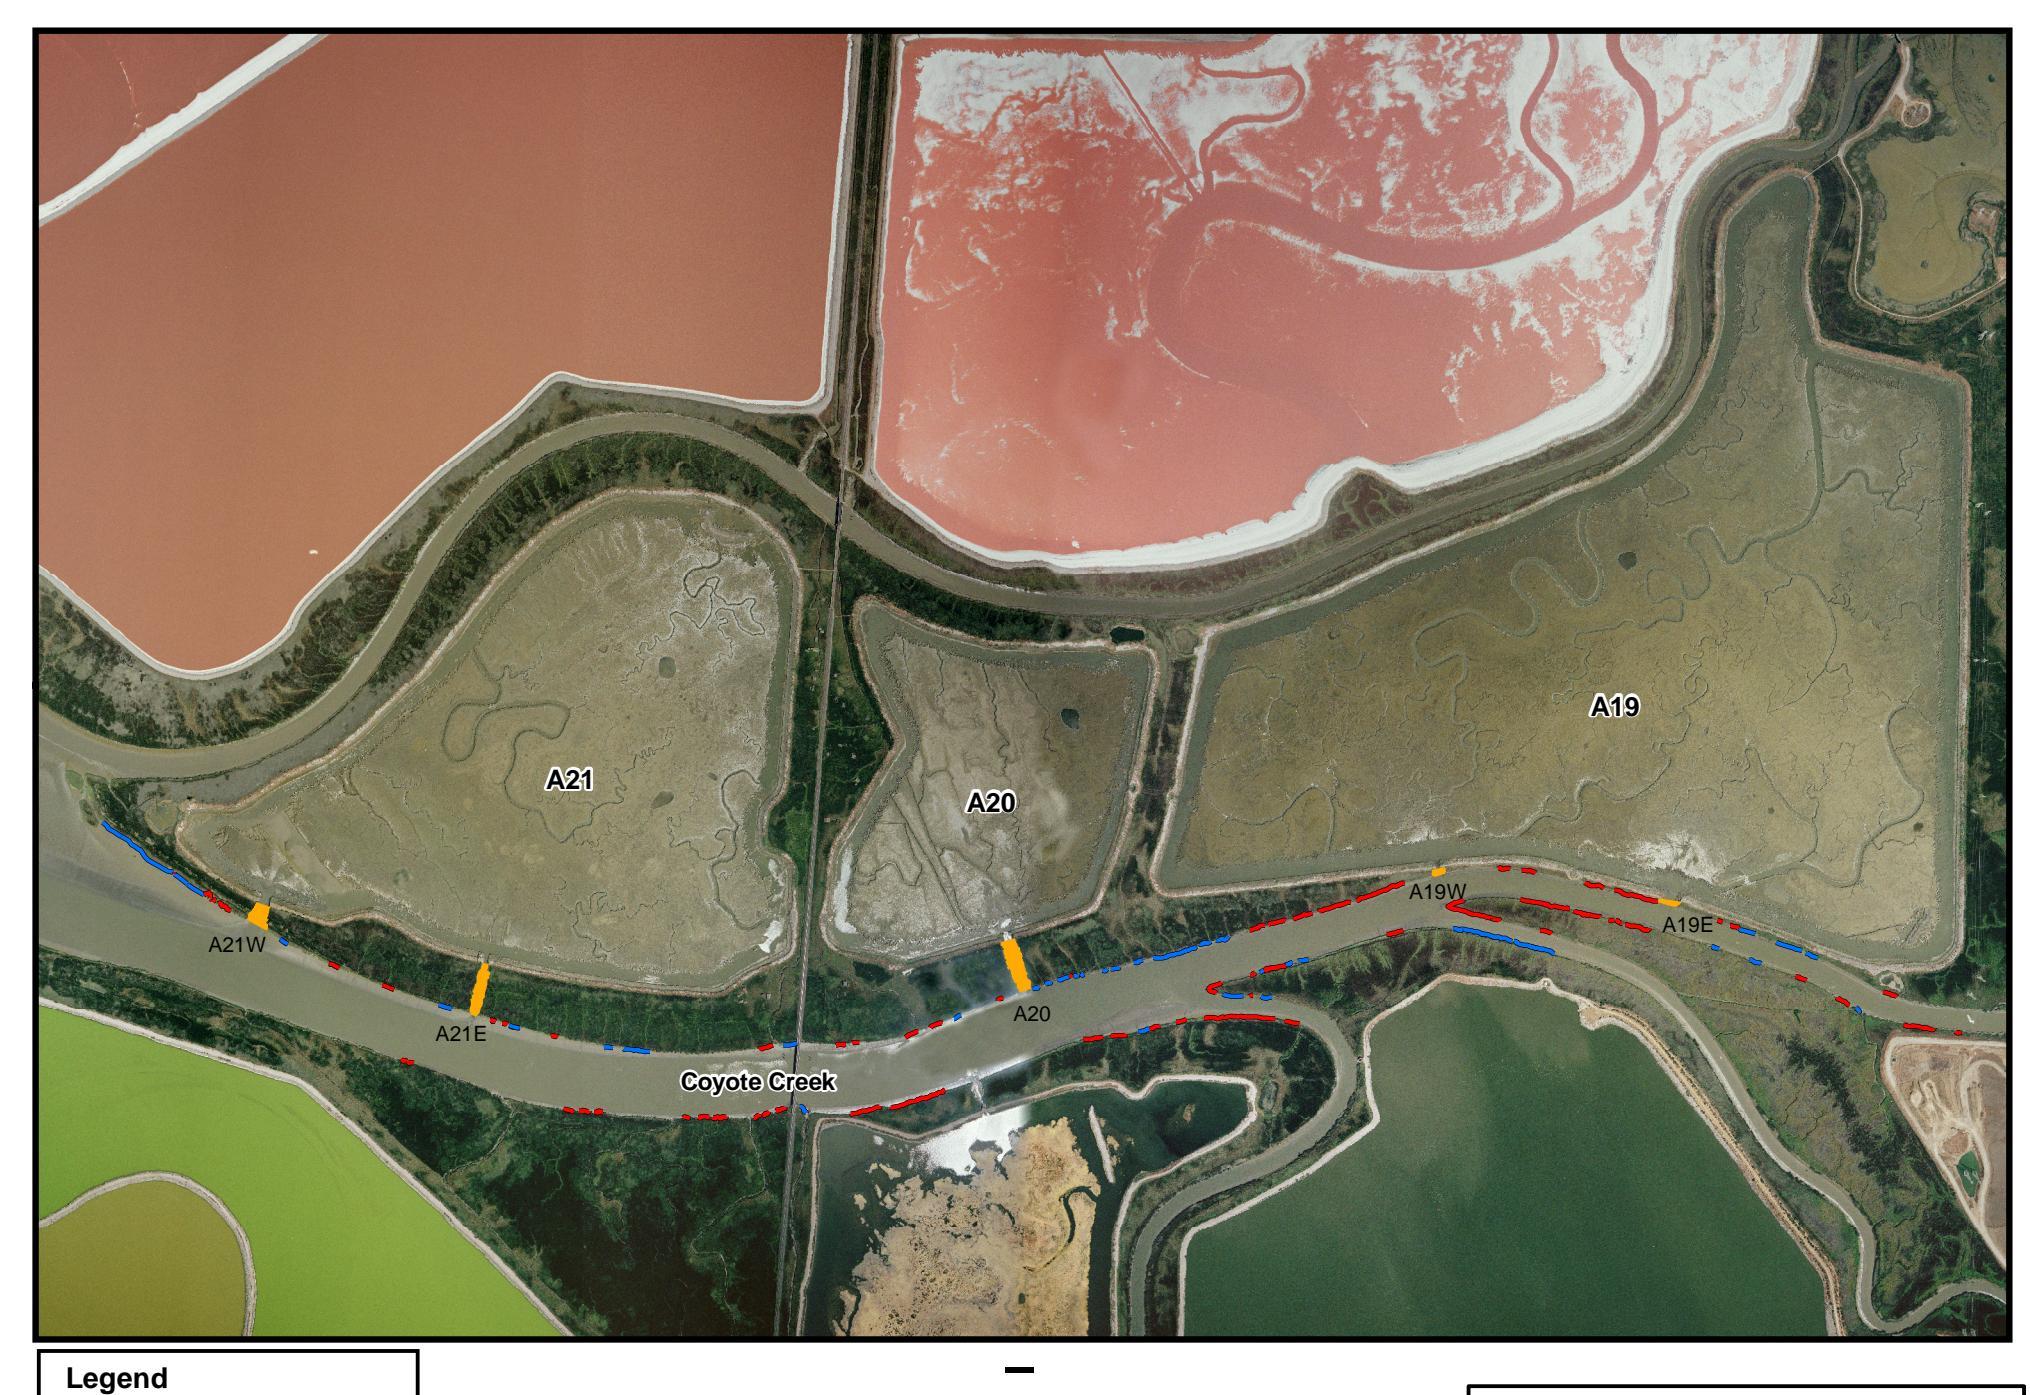
Figure 2. Breach and Fringe Marsh Scour

Continued widening of the five levee breaches was observed between 2006, 2007, and 2008 (Table 3-1). Total marsh loss from 2006 through 2008 associated with scour of the outboard tidal channels totaled 0.12 acres (Table 3-2). Total marsh loss to date at the five breaches, including marsh loss associated with construction impacts, totaled 1.35 acres (Table 3-2).

Fringe Marsh Loss 2006-2008 Breach Scour 2006-2008

Fringe Marsh Gain 2006-2008

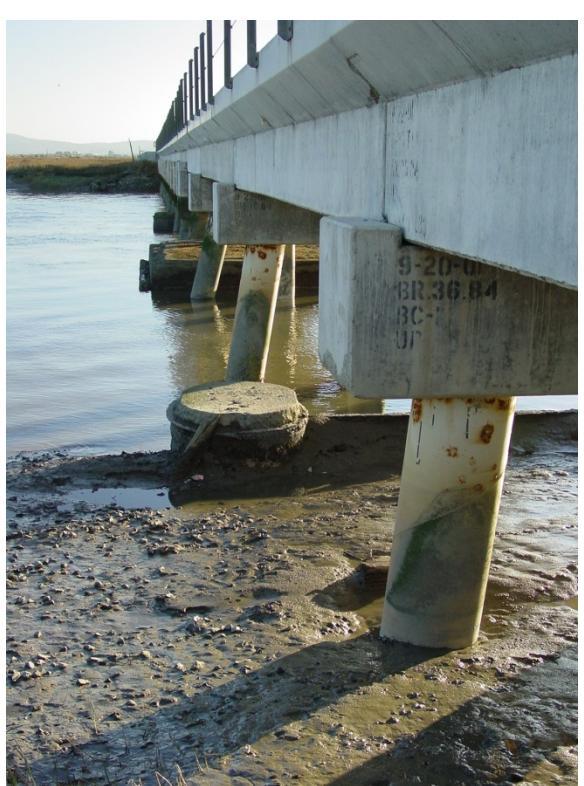
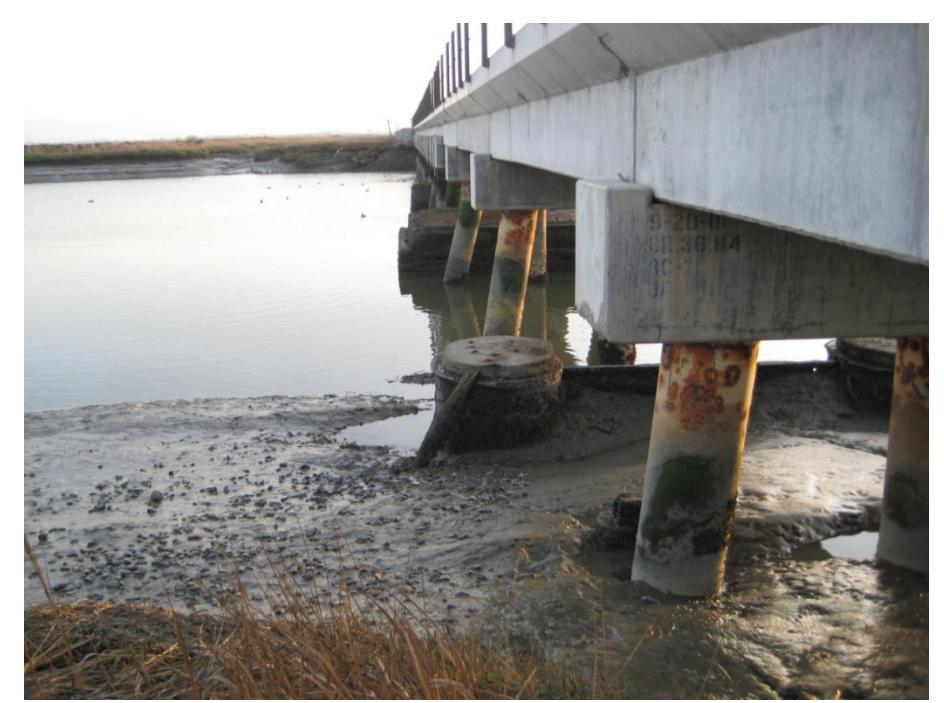
There are no structural criteria to assess the significance of observed scour relative to pile function. However, the amount of scour at the base of all the piles appears to be less than one foot deep and is probably within the design allowance.

Photo 1. East Side of Bridge Looking South. Pile 1N-C in foreground – 11/29/06

Photo 2. East Side of Bridge Looking South. Pile 1N-C in foreground -12/8/08

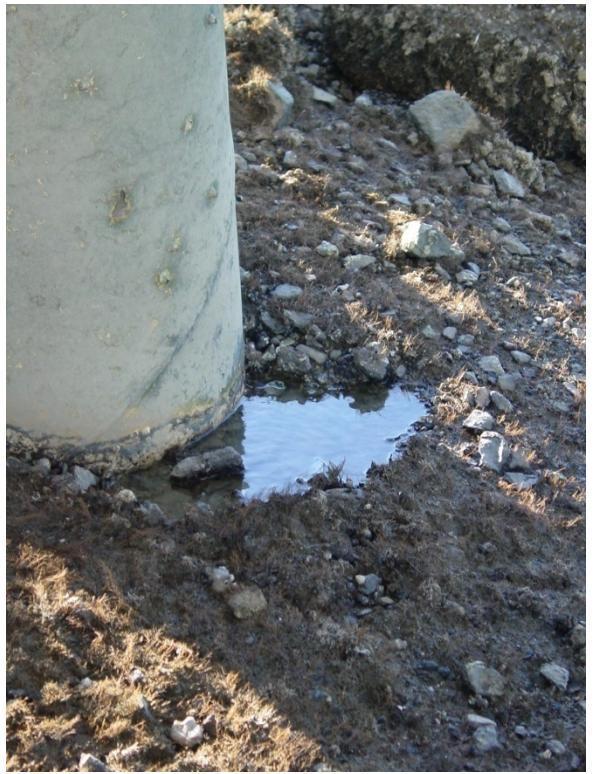
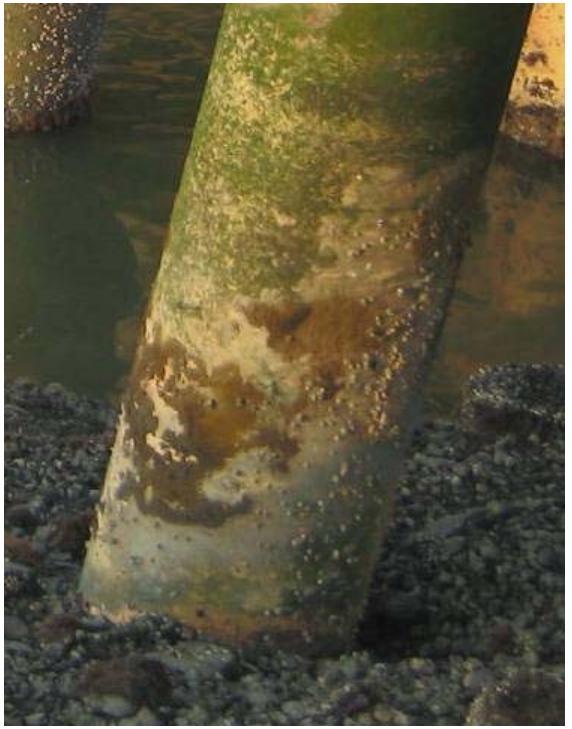
Photo 9. Close-up of pile 1S-A – 11/29/06

Photo 10. Close-up of pile 1S-A – 12/8/08

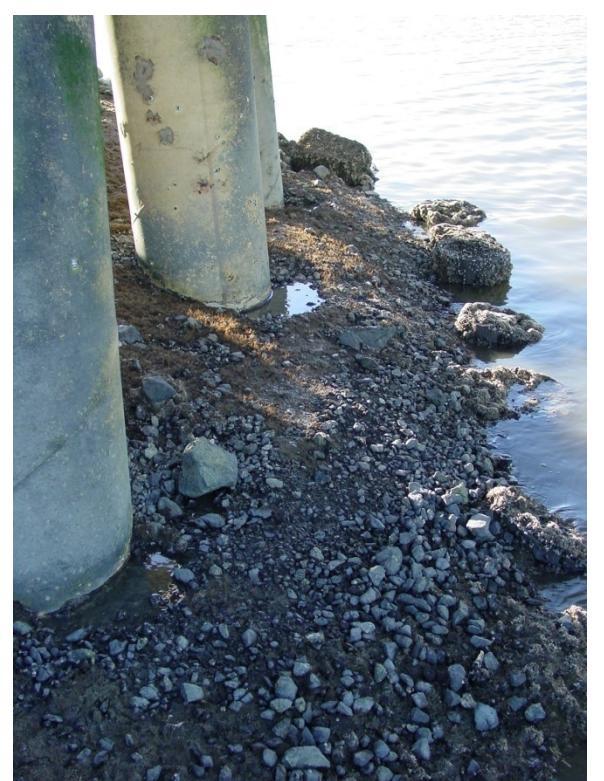
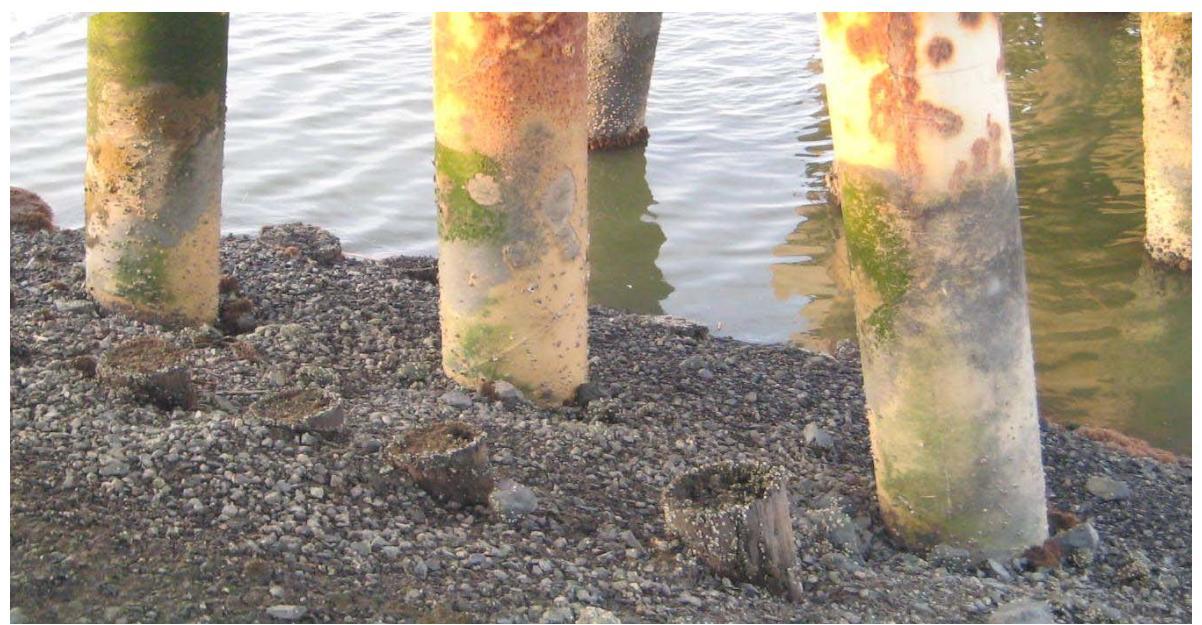
Photo 11. Close-up of piles 1S-C (foreground), 1S-B (centre), and 1S-A – 11/29/06

Photo 12. Close-up of piles 1S-C (right), 1S-B (centre), and 1S-A (left) – 12/8/08

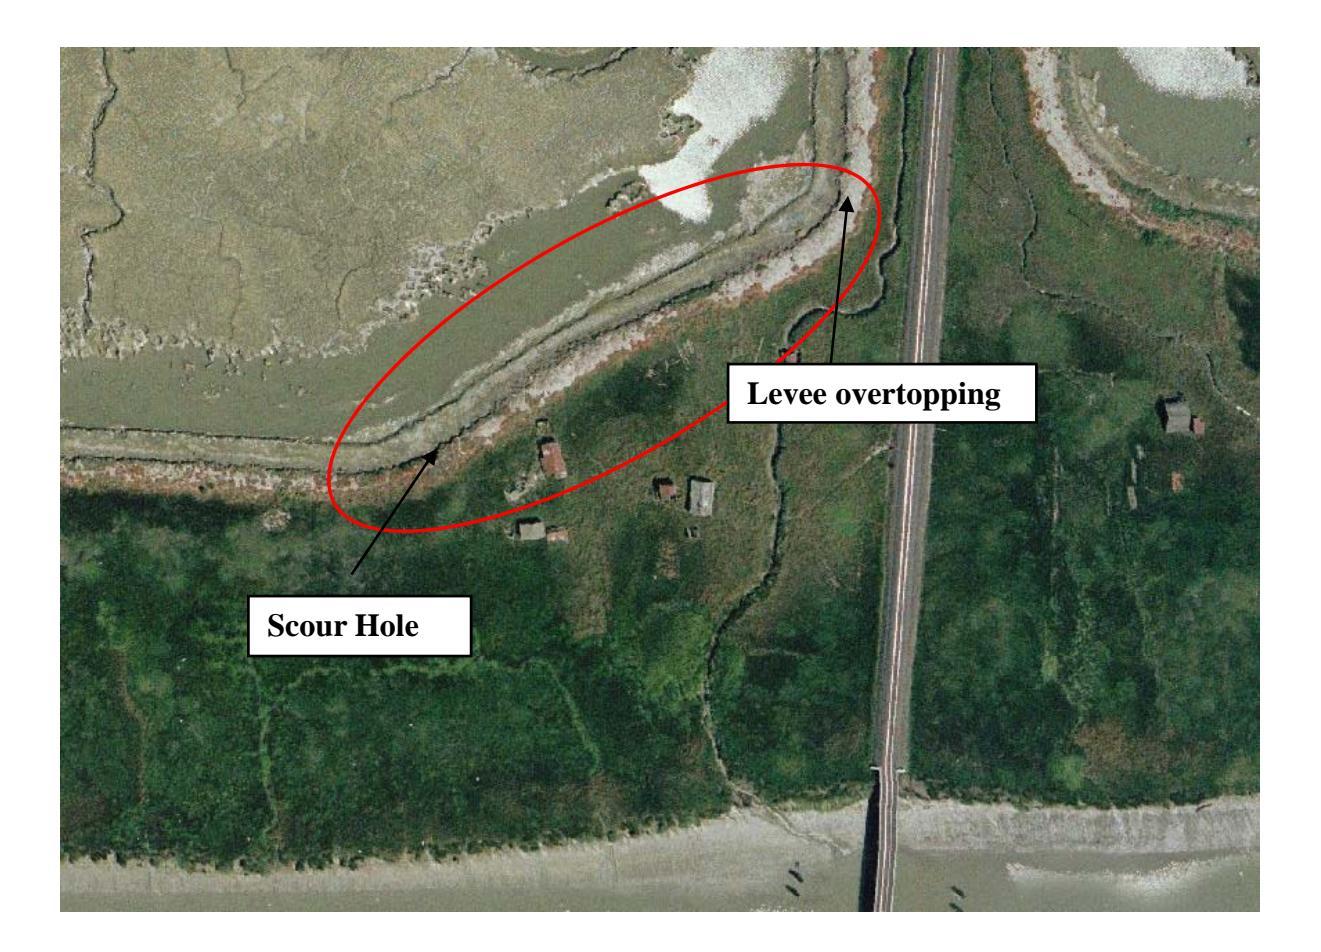
As mentioned above in Section 3.2.3, in both 2007 and 2008, it was observed that overtopping had occurred on the southeast levee of Pond A21 (Appendix B-3). Wave action during high tide is the most likely culprit as this condition has deposited a line of debris atop the southeast corner of the Pond A21 levee. This levee is adjacent to the Town of Drawbridge however, since the erosion is minimal at this time, no structures appear to be in imminent danger.

Photo 1. Aerial view of railroad and Town of Drawbridge. The red circle (southeast levee of Pond A21) depicts the area which is eroding.

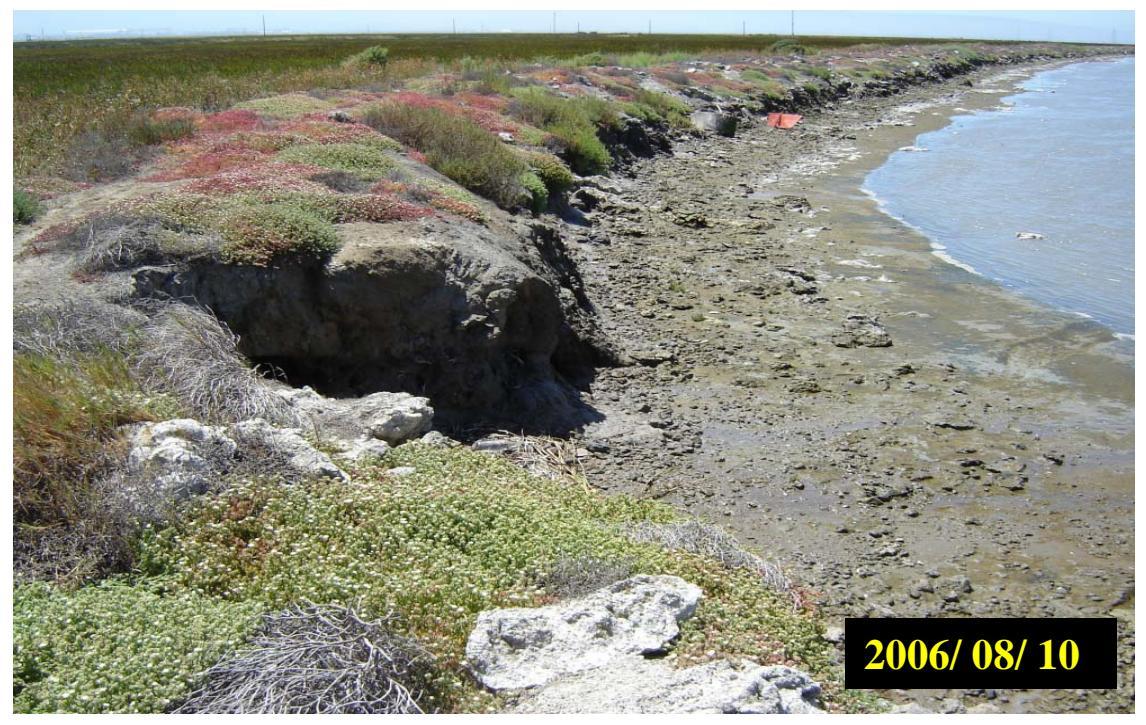
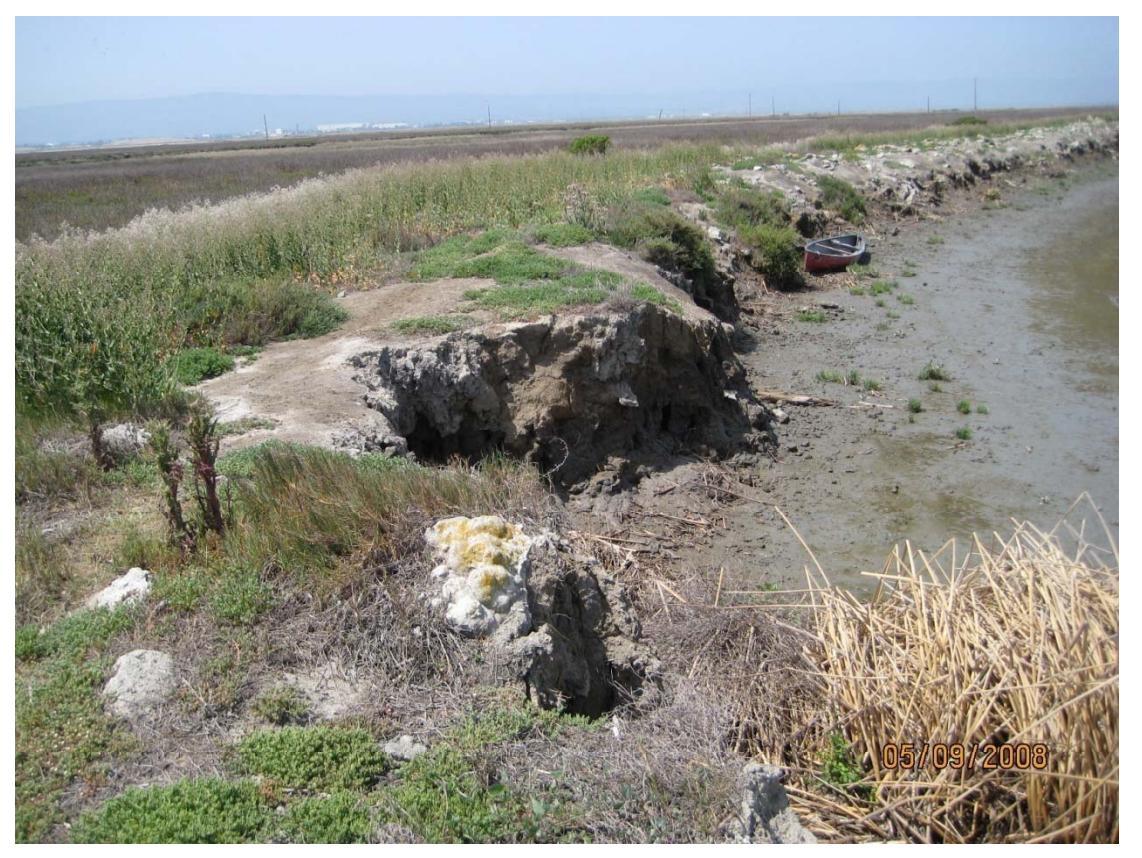
structure. We have continued to monitor and photo-document this location. Based on a comparison of the 2006 and 2008 photographs, minimal new erosion has occurred at this location (Appendix B-3). While the erosion appears to have slightly increased in size, the levee is still a barrier between the pond and the outboard marsh. At this time, it appears that there is no evident deterioration of any drawbridge structures due to the breaching of the salt ponds. A comparison of the 2006 and 2008 photographs are included in Appendix B-3.

Photo 2. Close up of scour hole in the southeast corner of Pond A21, view looking west – August 10, 2006.

Photo 3. Same location as above – May 9, 2008.

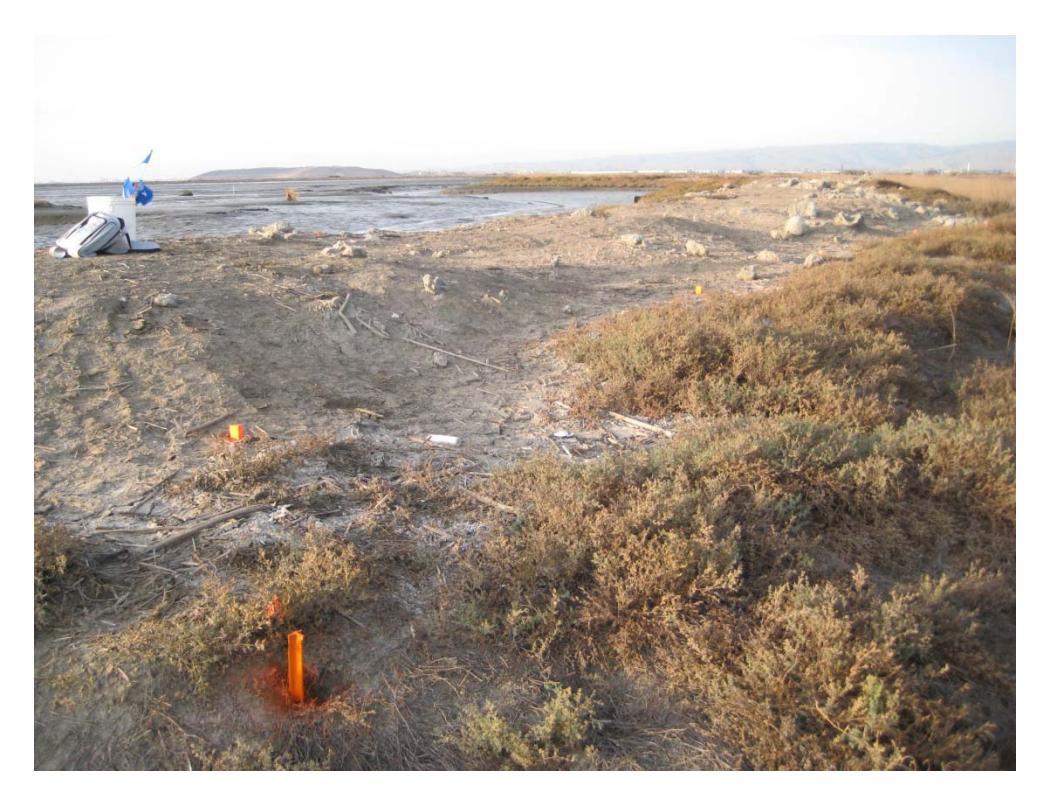
Photo 4. Southeast corner of Pond A21, looking northerly, newly installed benchmark to be used to monitor elevation changes in the levee where overtopping and wave action have been documented – December 8, 2008

Per the Year 2 report recommendations, on December 8, 2008, a benchmark and location stakes were installed in the south-southeast corner of Pond A21 to enable more accurate tracking of erosion advancement along this levee from wave action and levee overtopping.

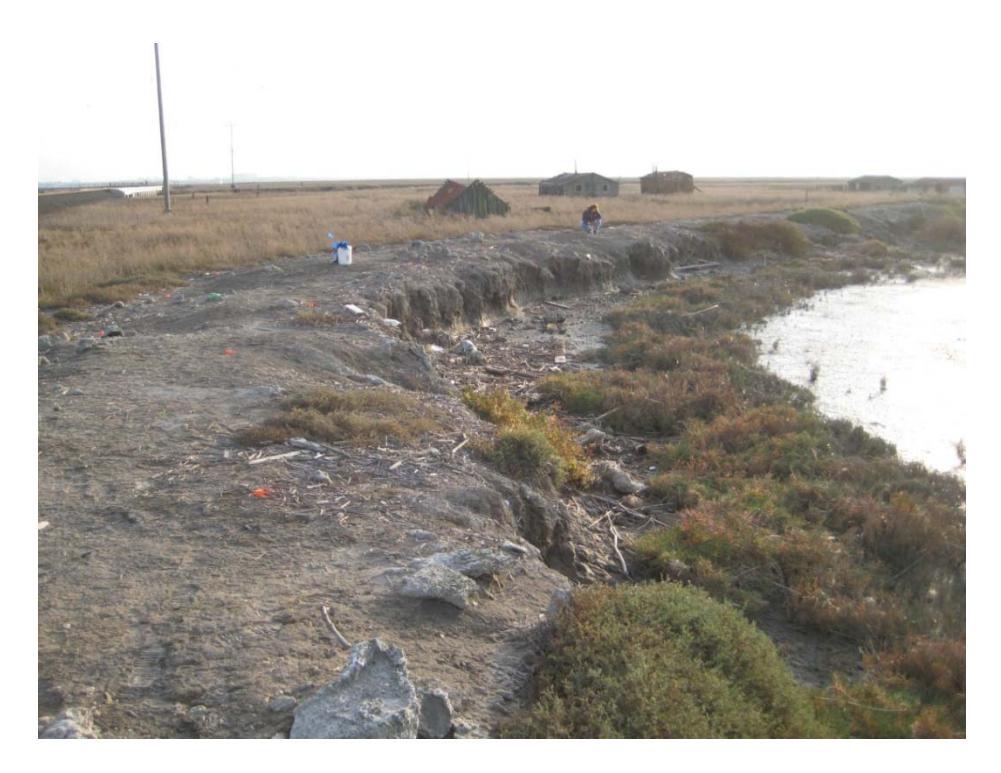
Photo 5. Southeast corner of Pond A21, looking southerly, installation of markers to track top of levee erosion/scour from wave action and levee overtopping– December 8, 2008

In both 2007 and 2008, it was observed that overtopping had occurred on the southeast levee of Pond A21. As a result, in December 2008, a benchmark and location stakes were installed along this levee to enable more accurate tracking of the erosion. The elevations of these stakes will be monitored in future years, in relation to the benchmark, to document any changes in the levee elevations.
