South Bay Salt Pond Restoration Project

URBAN LEVEE FLOOD MANAGEMENT REQUIREMENTS

DRAFT
(March 2004)

MOFFATT & NICHOL ENGINEERS

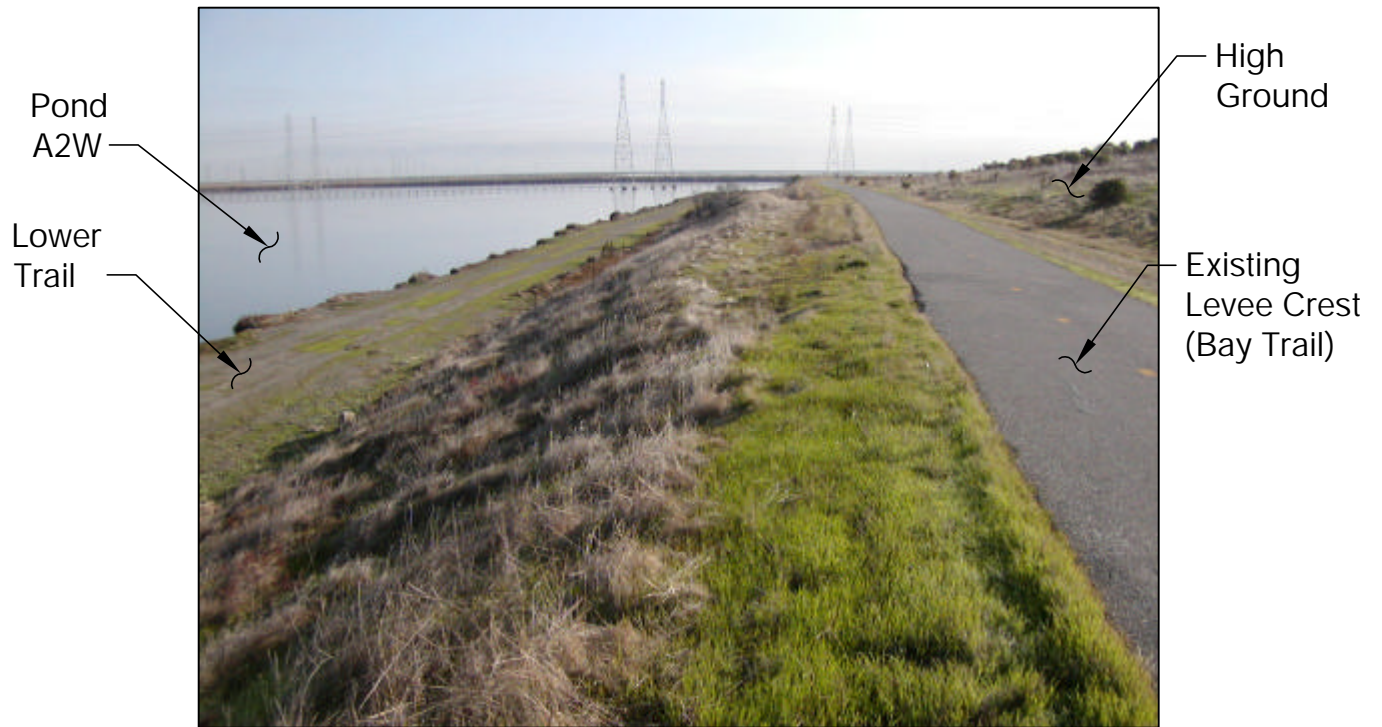
STATION 20+00±
LOOKING EAST

POND A2W

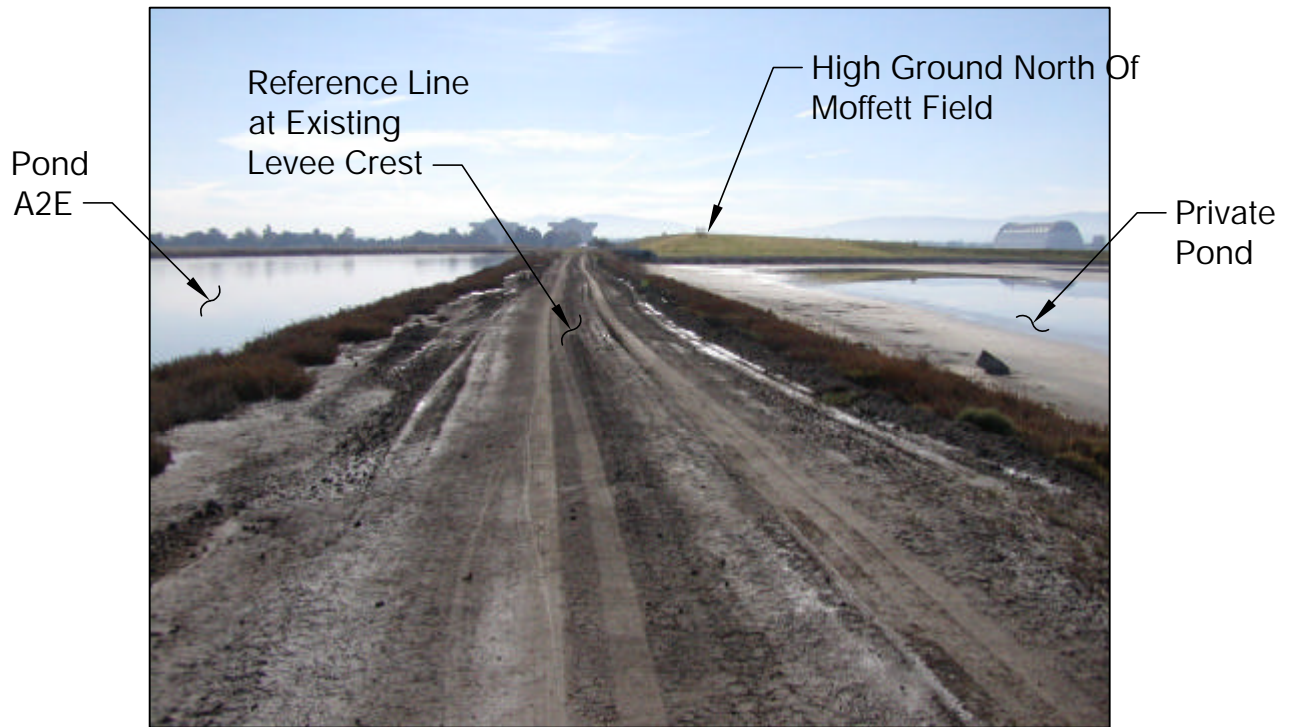
STATION 45+00±
LOOKING SOUTHEAST

POND A2E

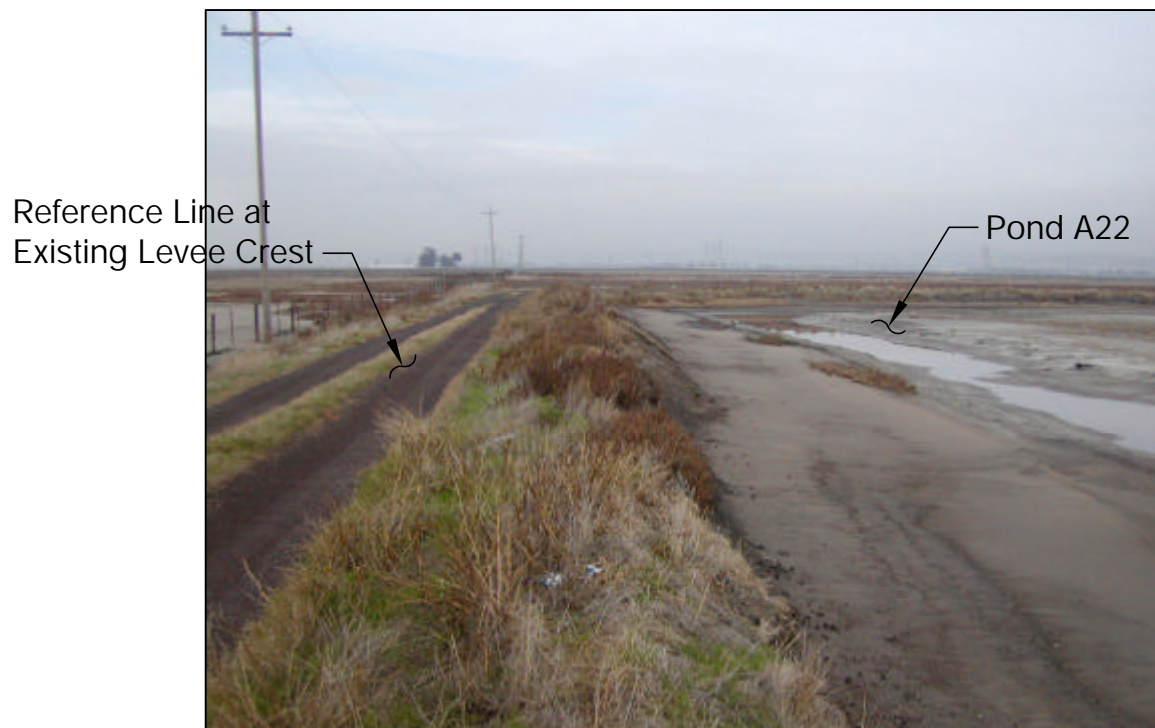
STATION 30+00±
LOOKING NORTH

POND A22

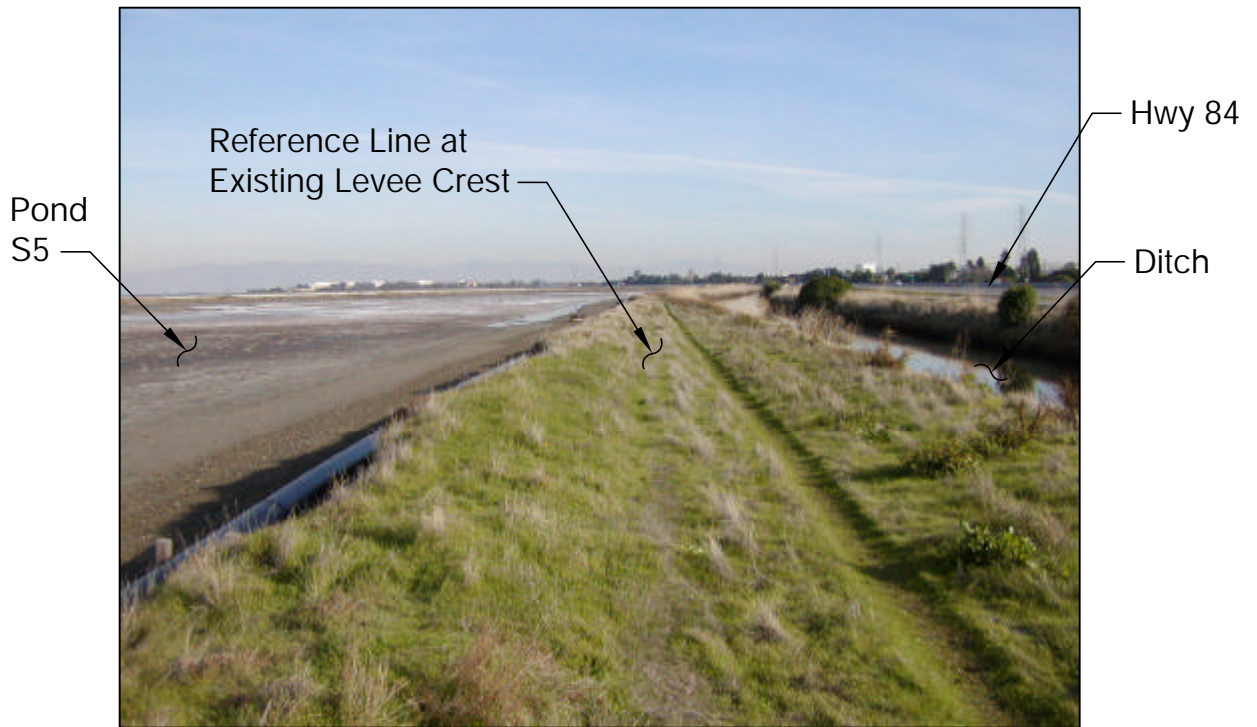
STATION 14+00±
LOOKING EAST

WEST BAY POND S5

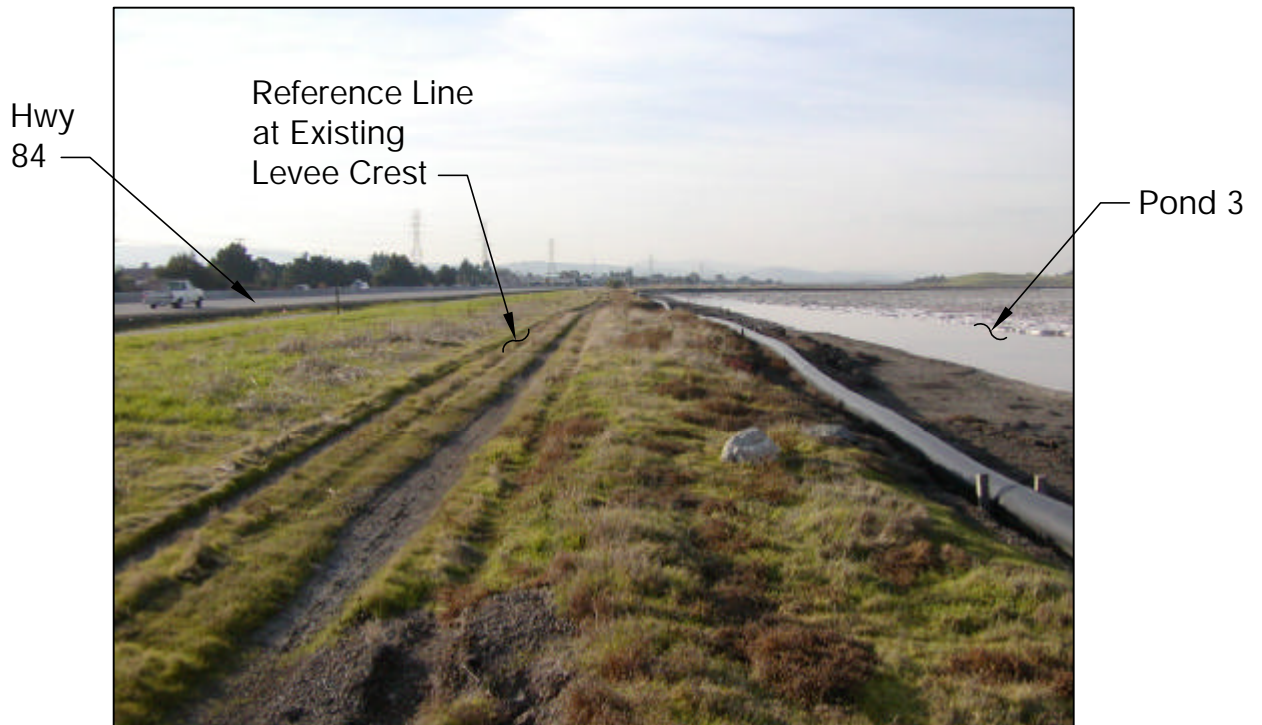
STATION 48+00±
LOOKING WEST

WEST BAY POND 3
