# South Bay Salt Pond Restoration Project

## URBAN LEVEE FLOOD MANAGEMENT REQUIREMENTS

**URBAN LEVEE FLOOD MANAGEMENT REQUIREMENTS  
SOUTH BAY SALT POND RESTORATION PROJECT**

July 2005

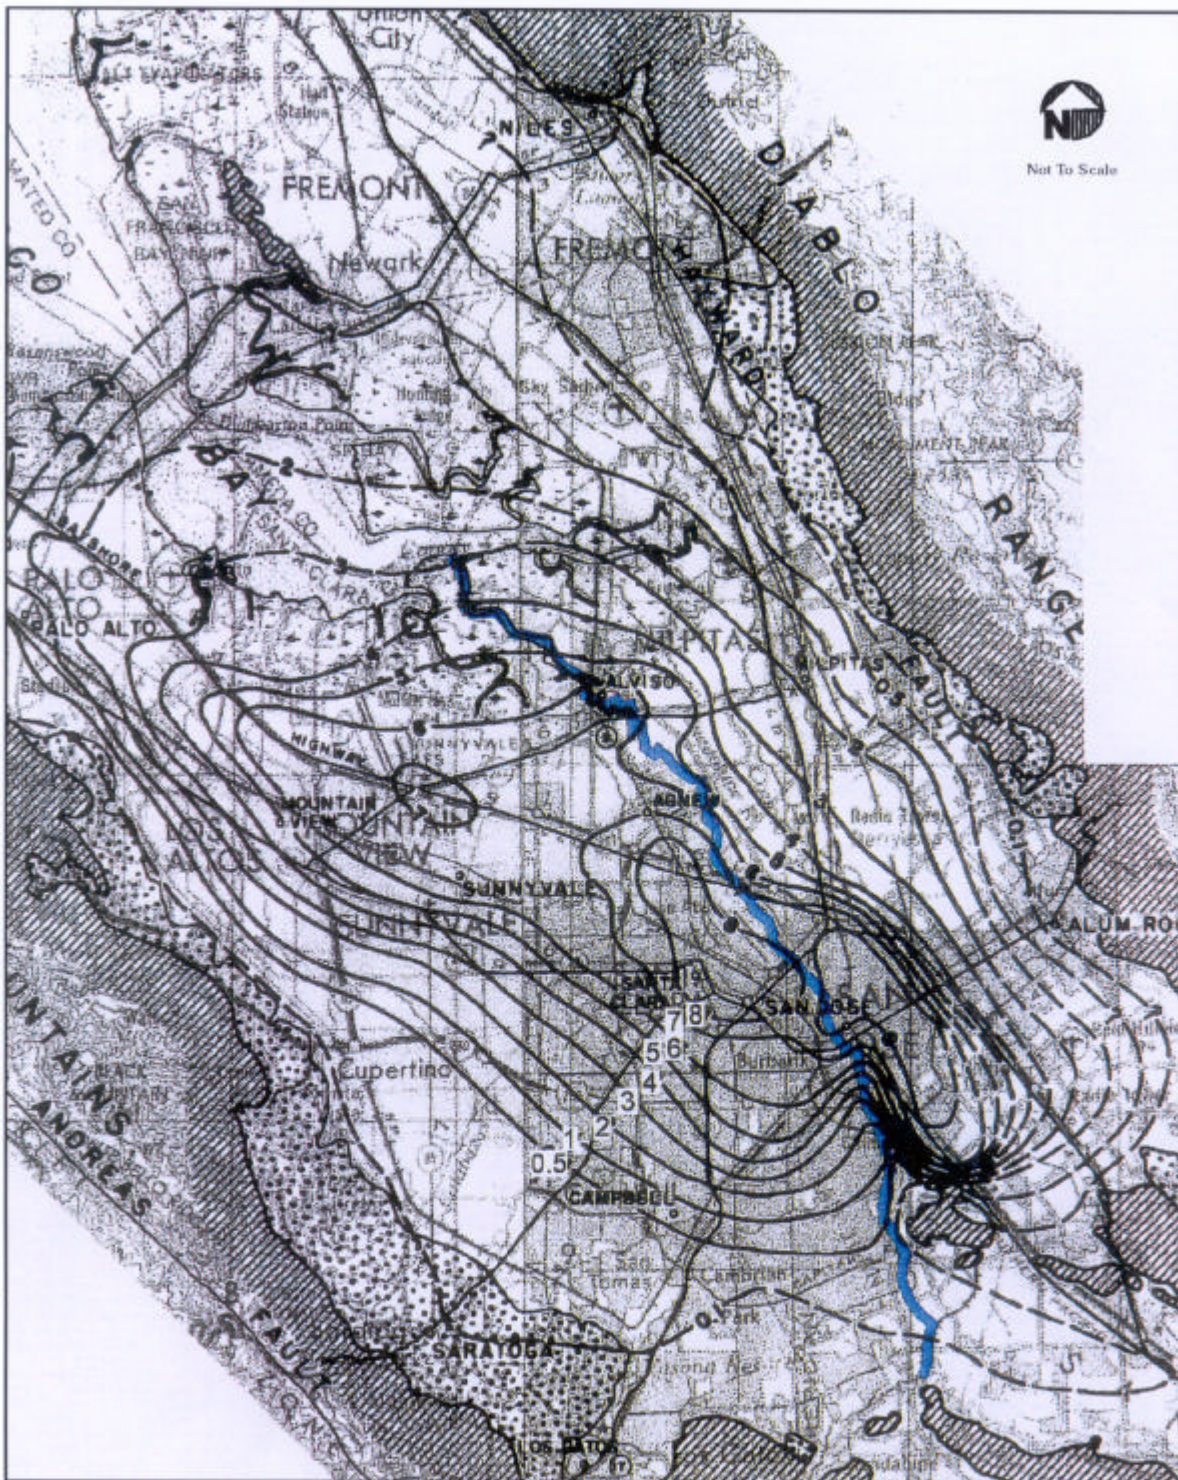
Figure 3.2.3a

Map showing equal lines of land subsidence (in feet) in Santa Clara Valley from 1934 to 1967 (from Poland and Ireland, 1968) overlaid onto topographic mapping from the USGS. Guadalupe River is highlighted in blue.
