# Physical Processes and Tidal Marsh Evolution: Cooley Landing and Warm Springs Marsh

South Bay Science Symposium  
June 6, 2006

Philip Williams, PWA

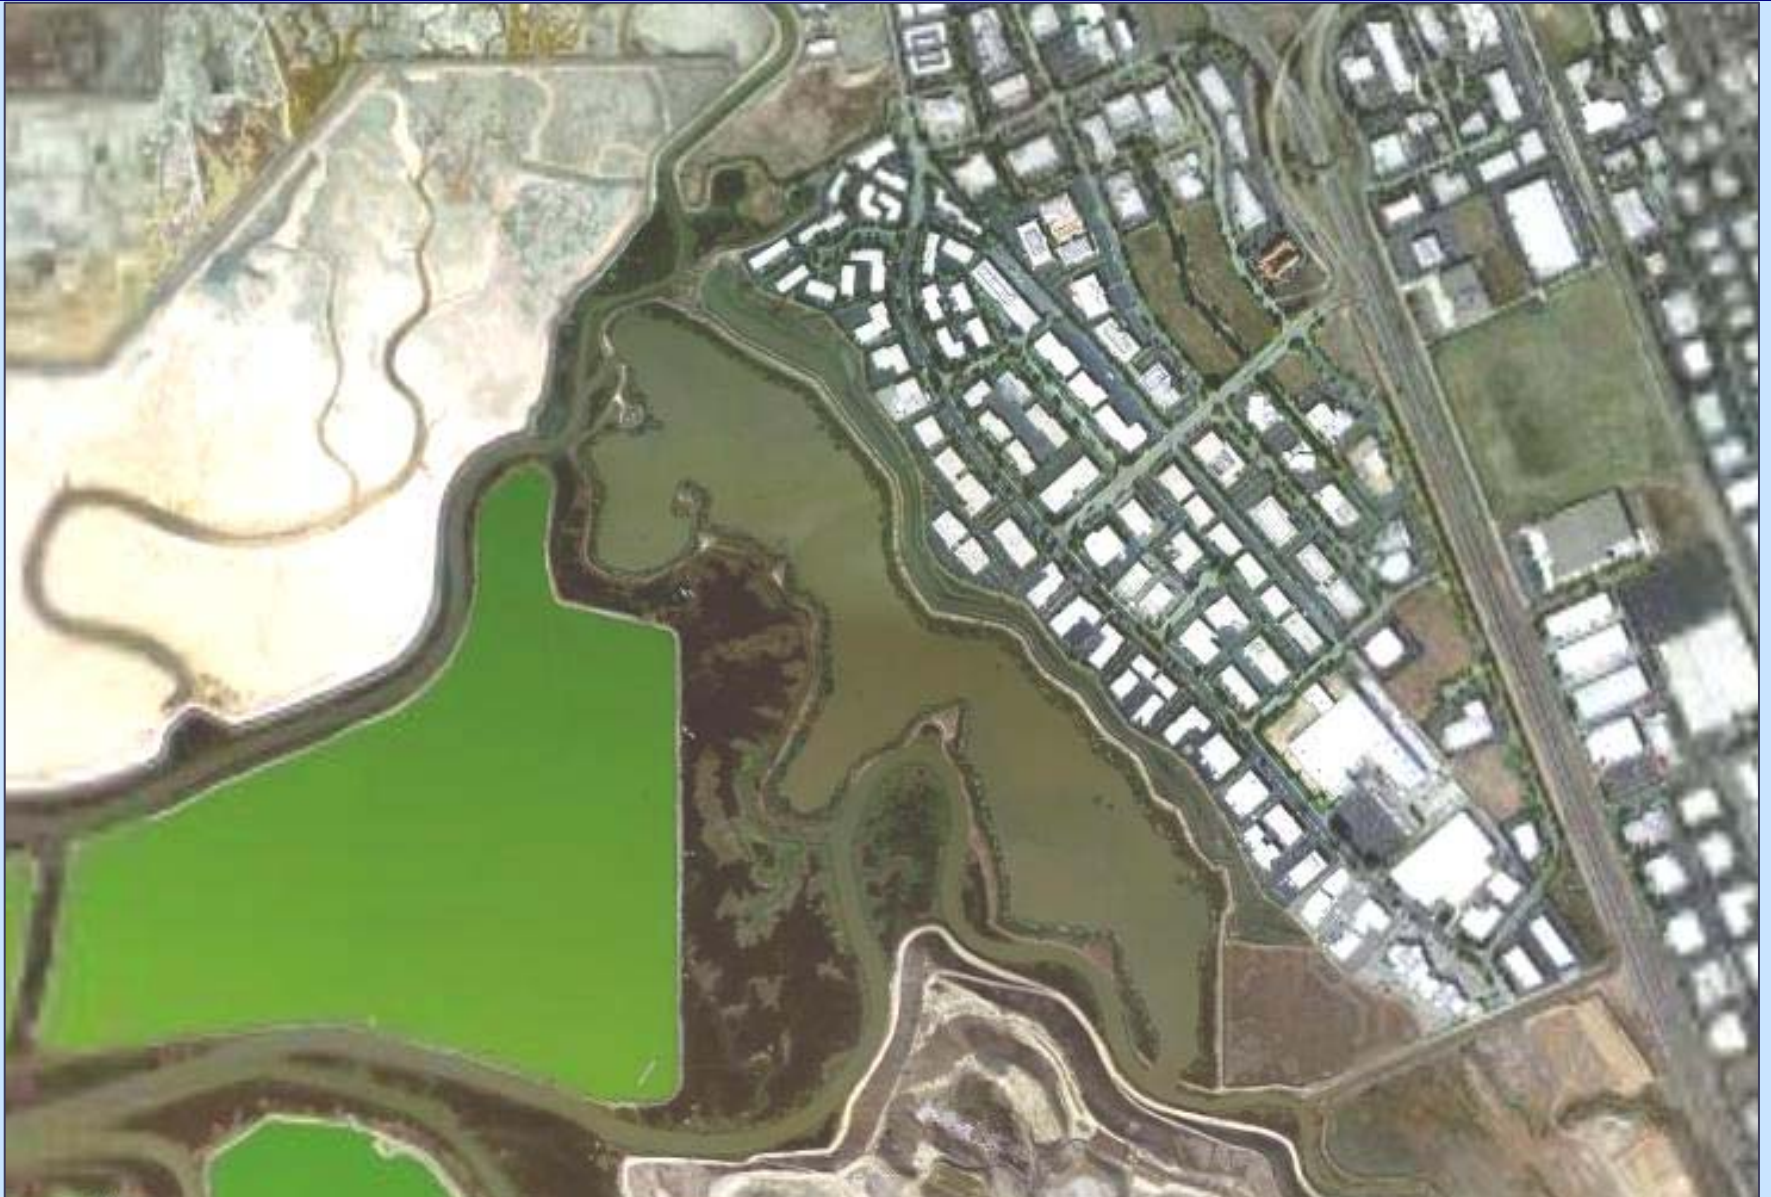
# Warm Springs: 15' Deep Borrow Pit PWA

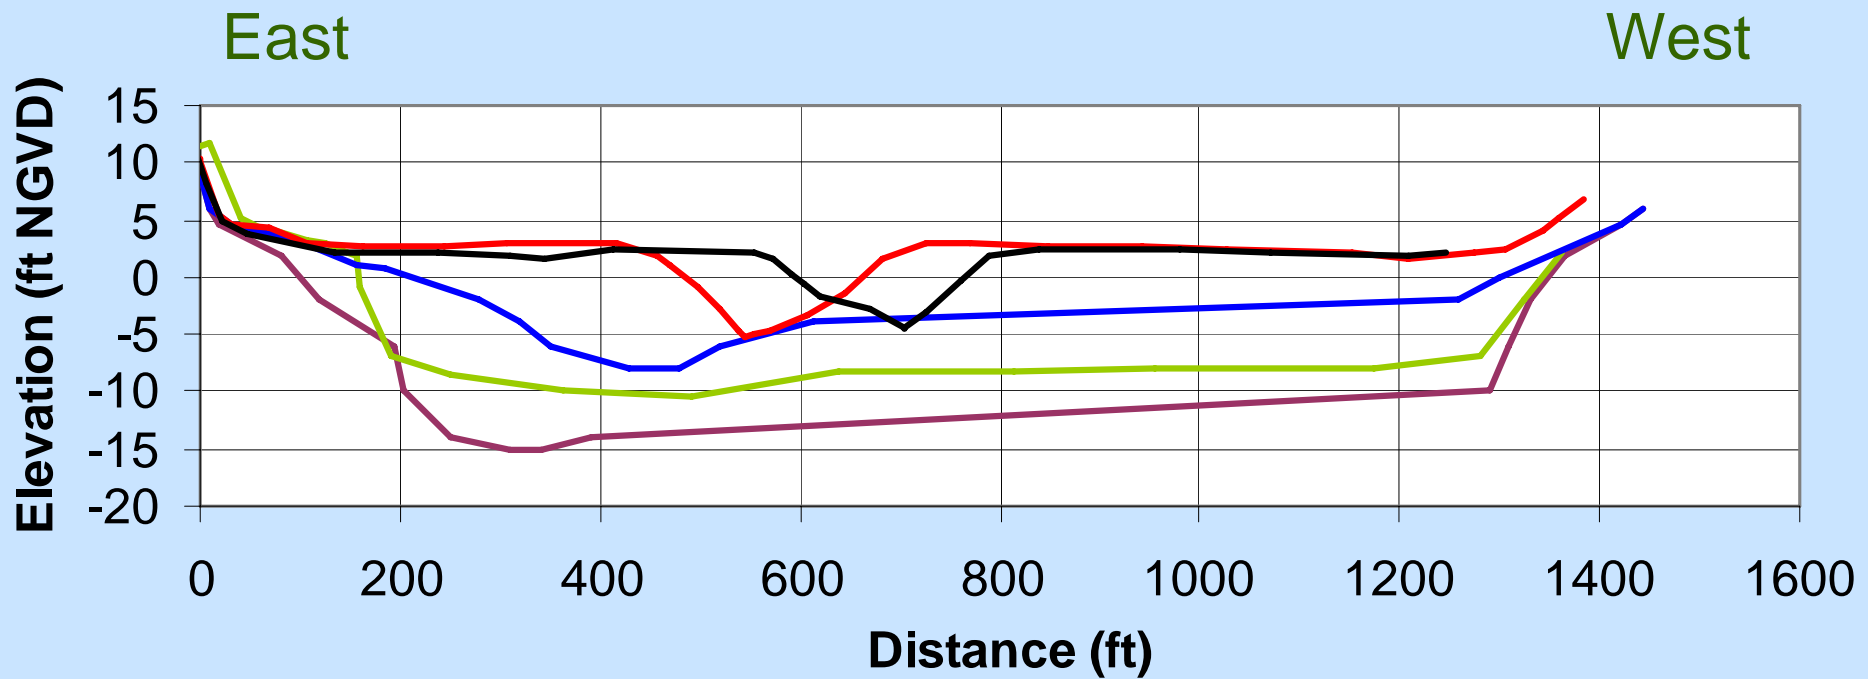
# Cross-section 200

— 1986 (pre-breach) — 1988 — 1992 — 1999 — 2002

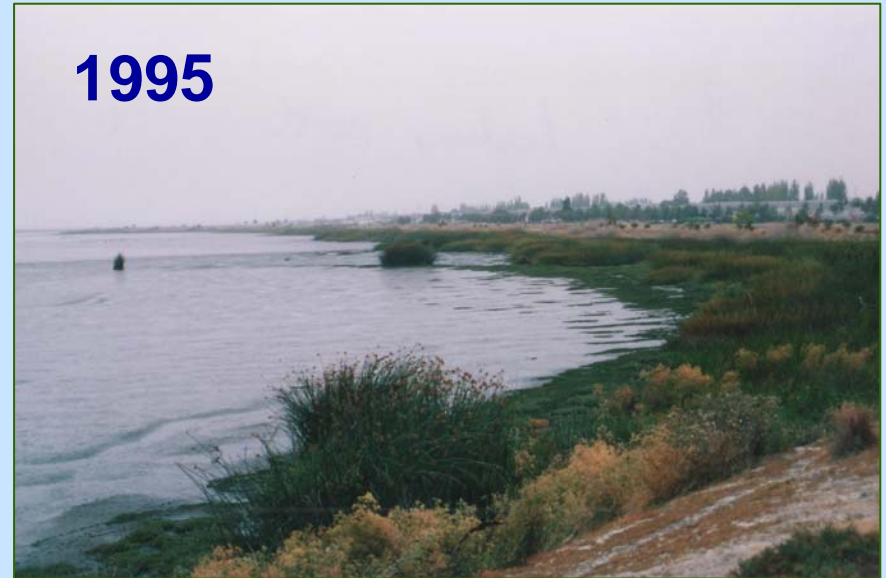
1995

# Looking North 2003, T+ 17

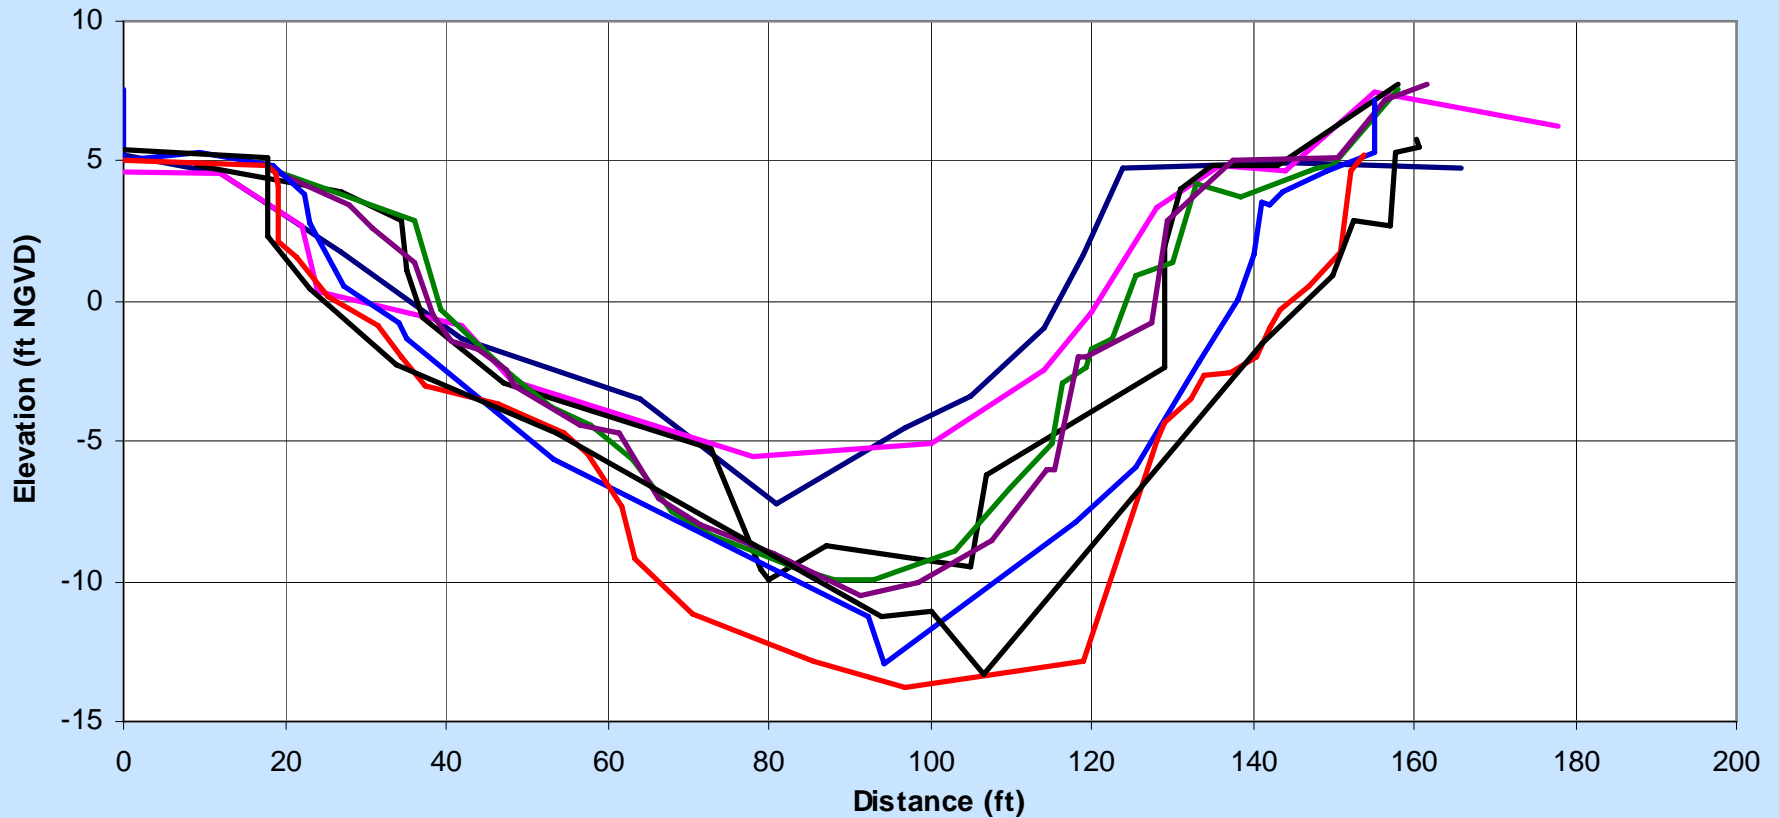
# Coyote Slough sections

South

North

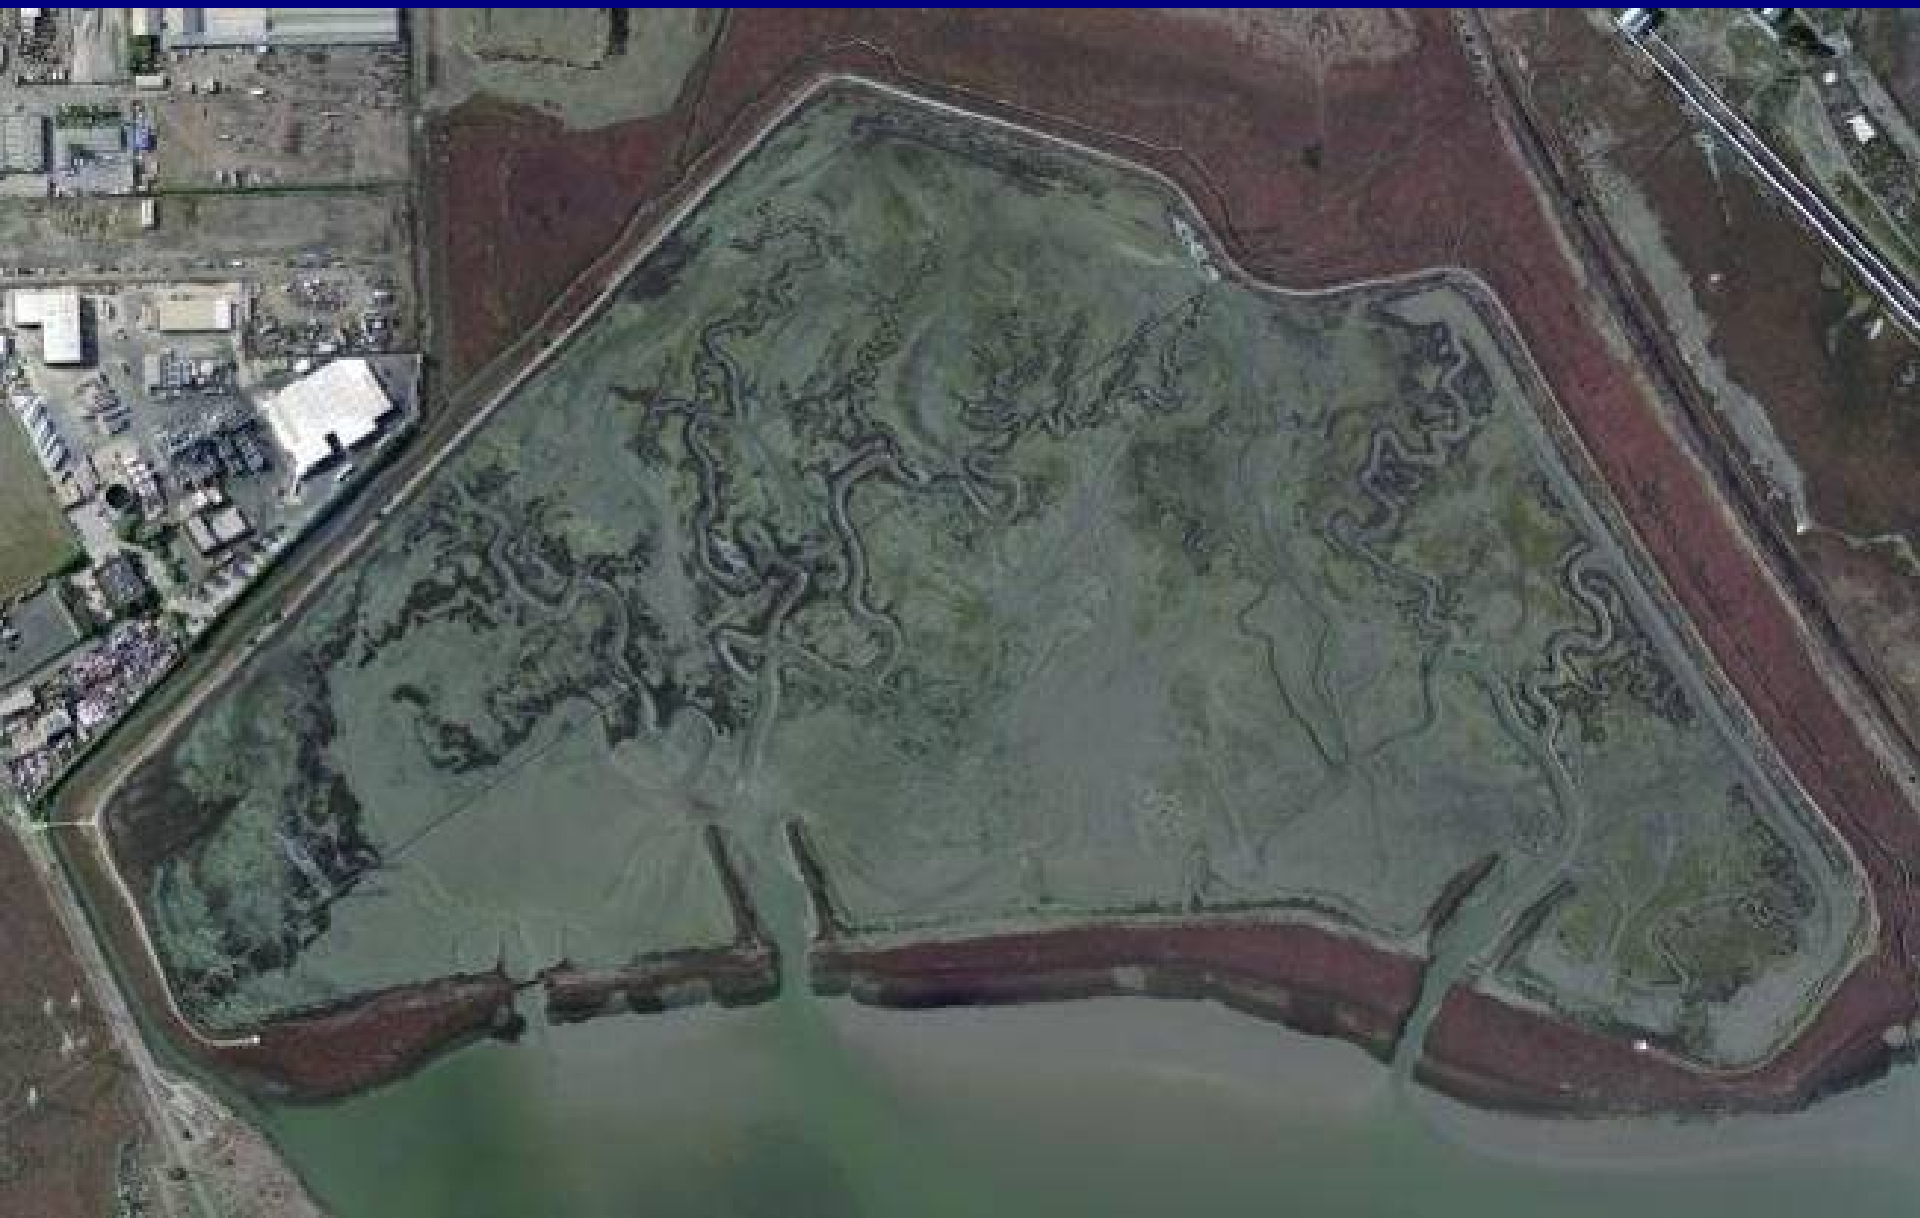
# Restoration Design

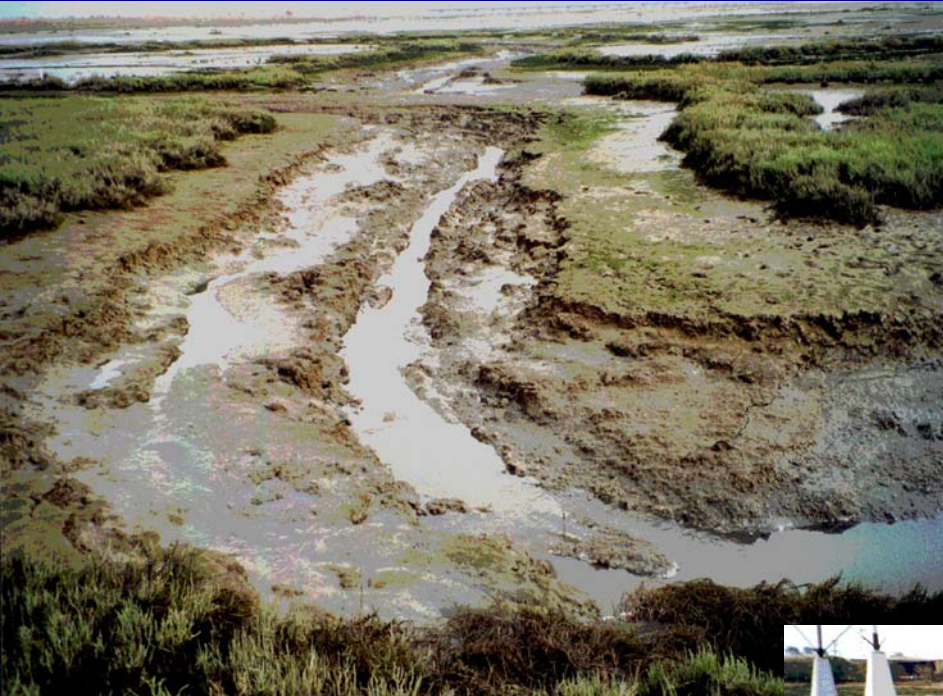
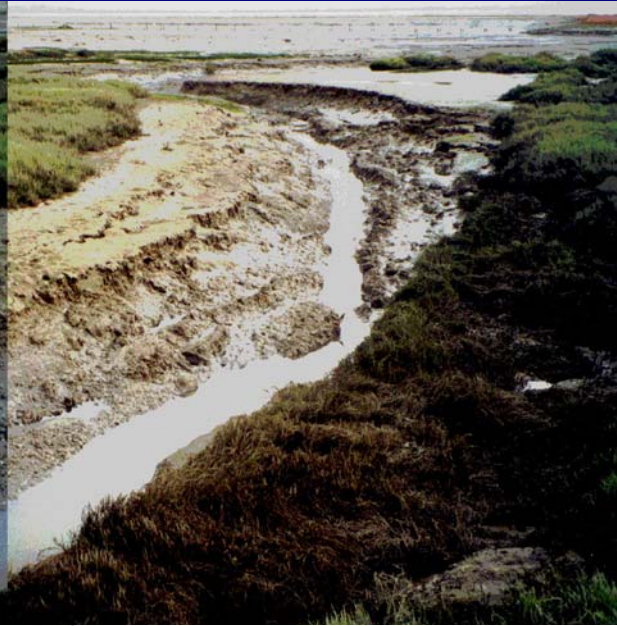
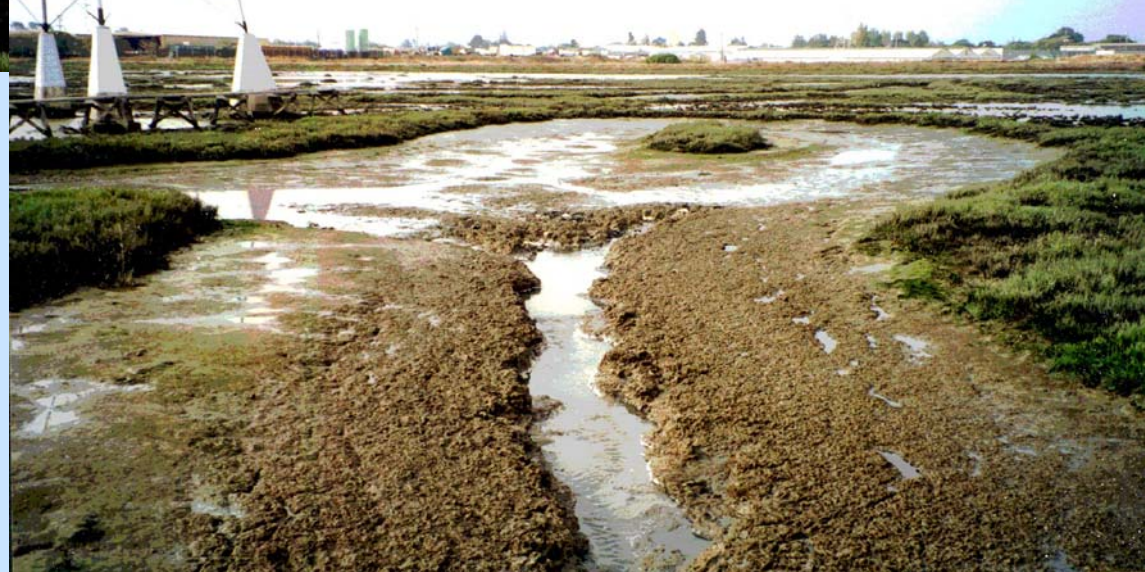
# Channel nickpoint, bed erosion and side slumping

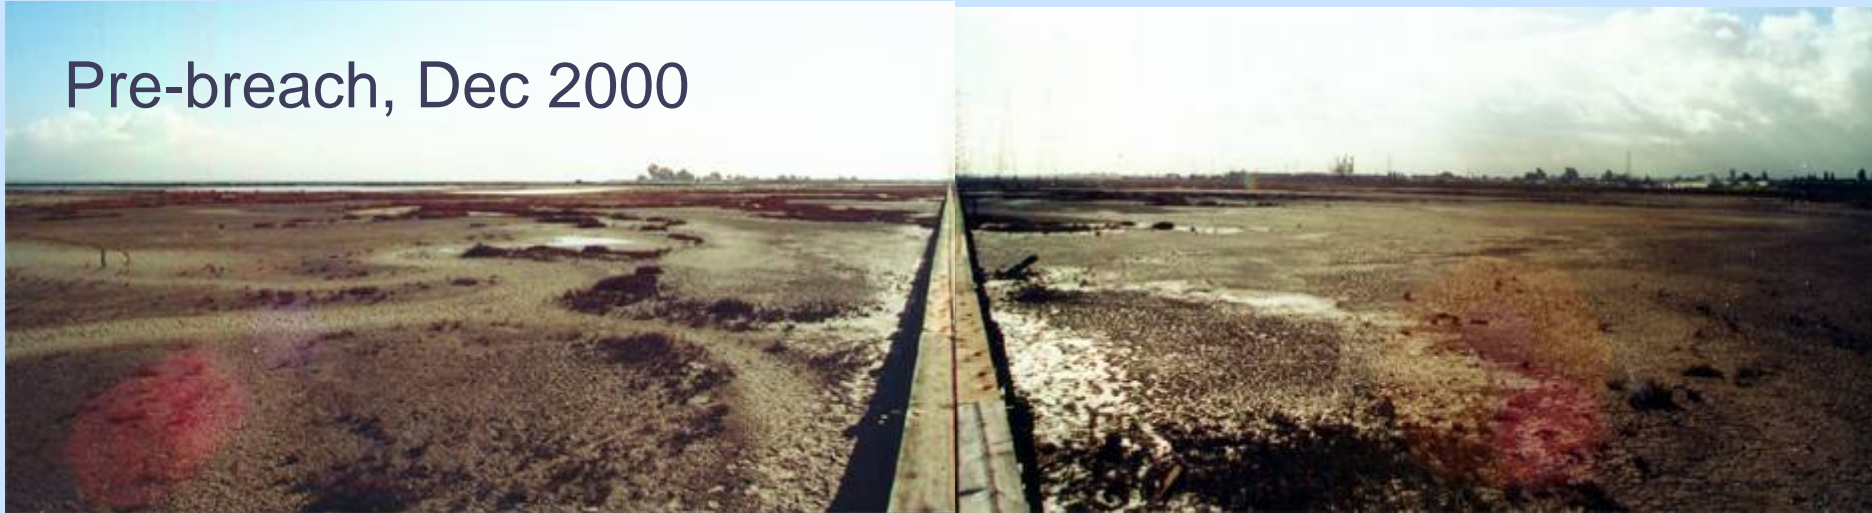
Pre-breach, Dec 2000

# First order channel re-occupation

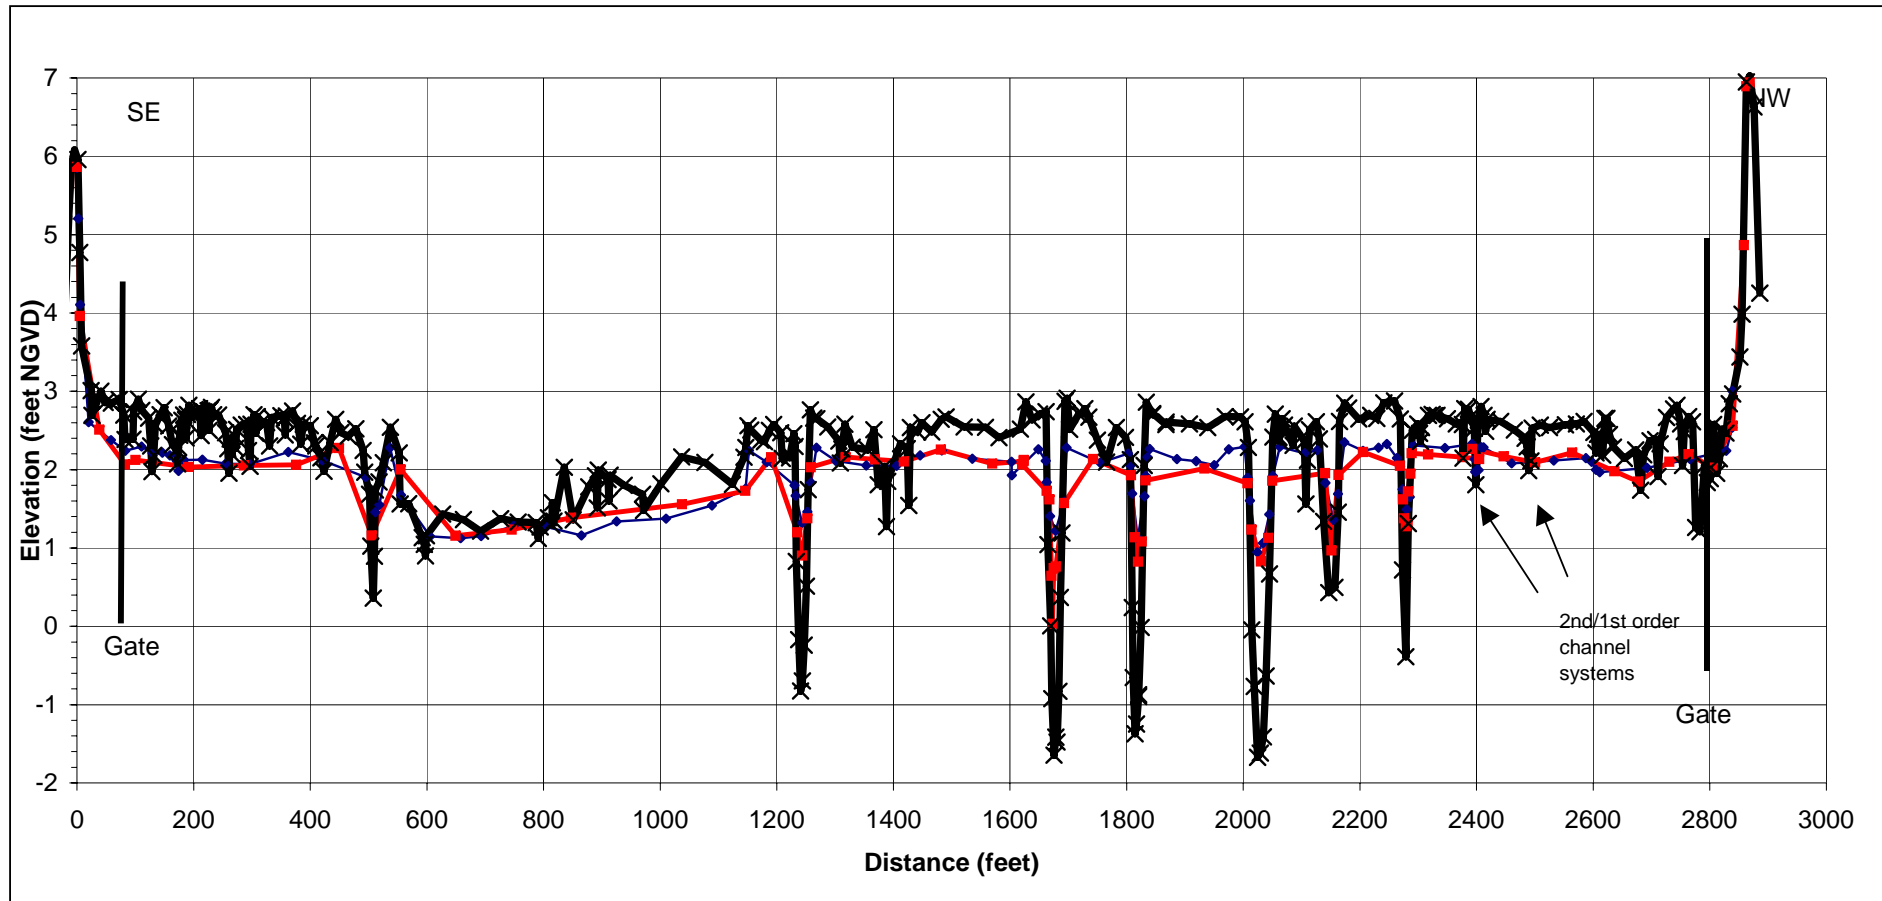
# Marshplain Transect Across southern part of site

Cooley Landing  
Interior Boardwalk Transect  
Elevation Transect is 6' from Ely edge of Bdwk

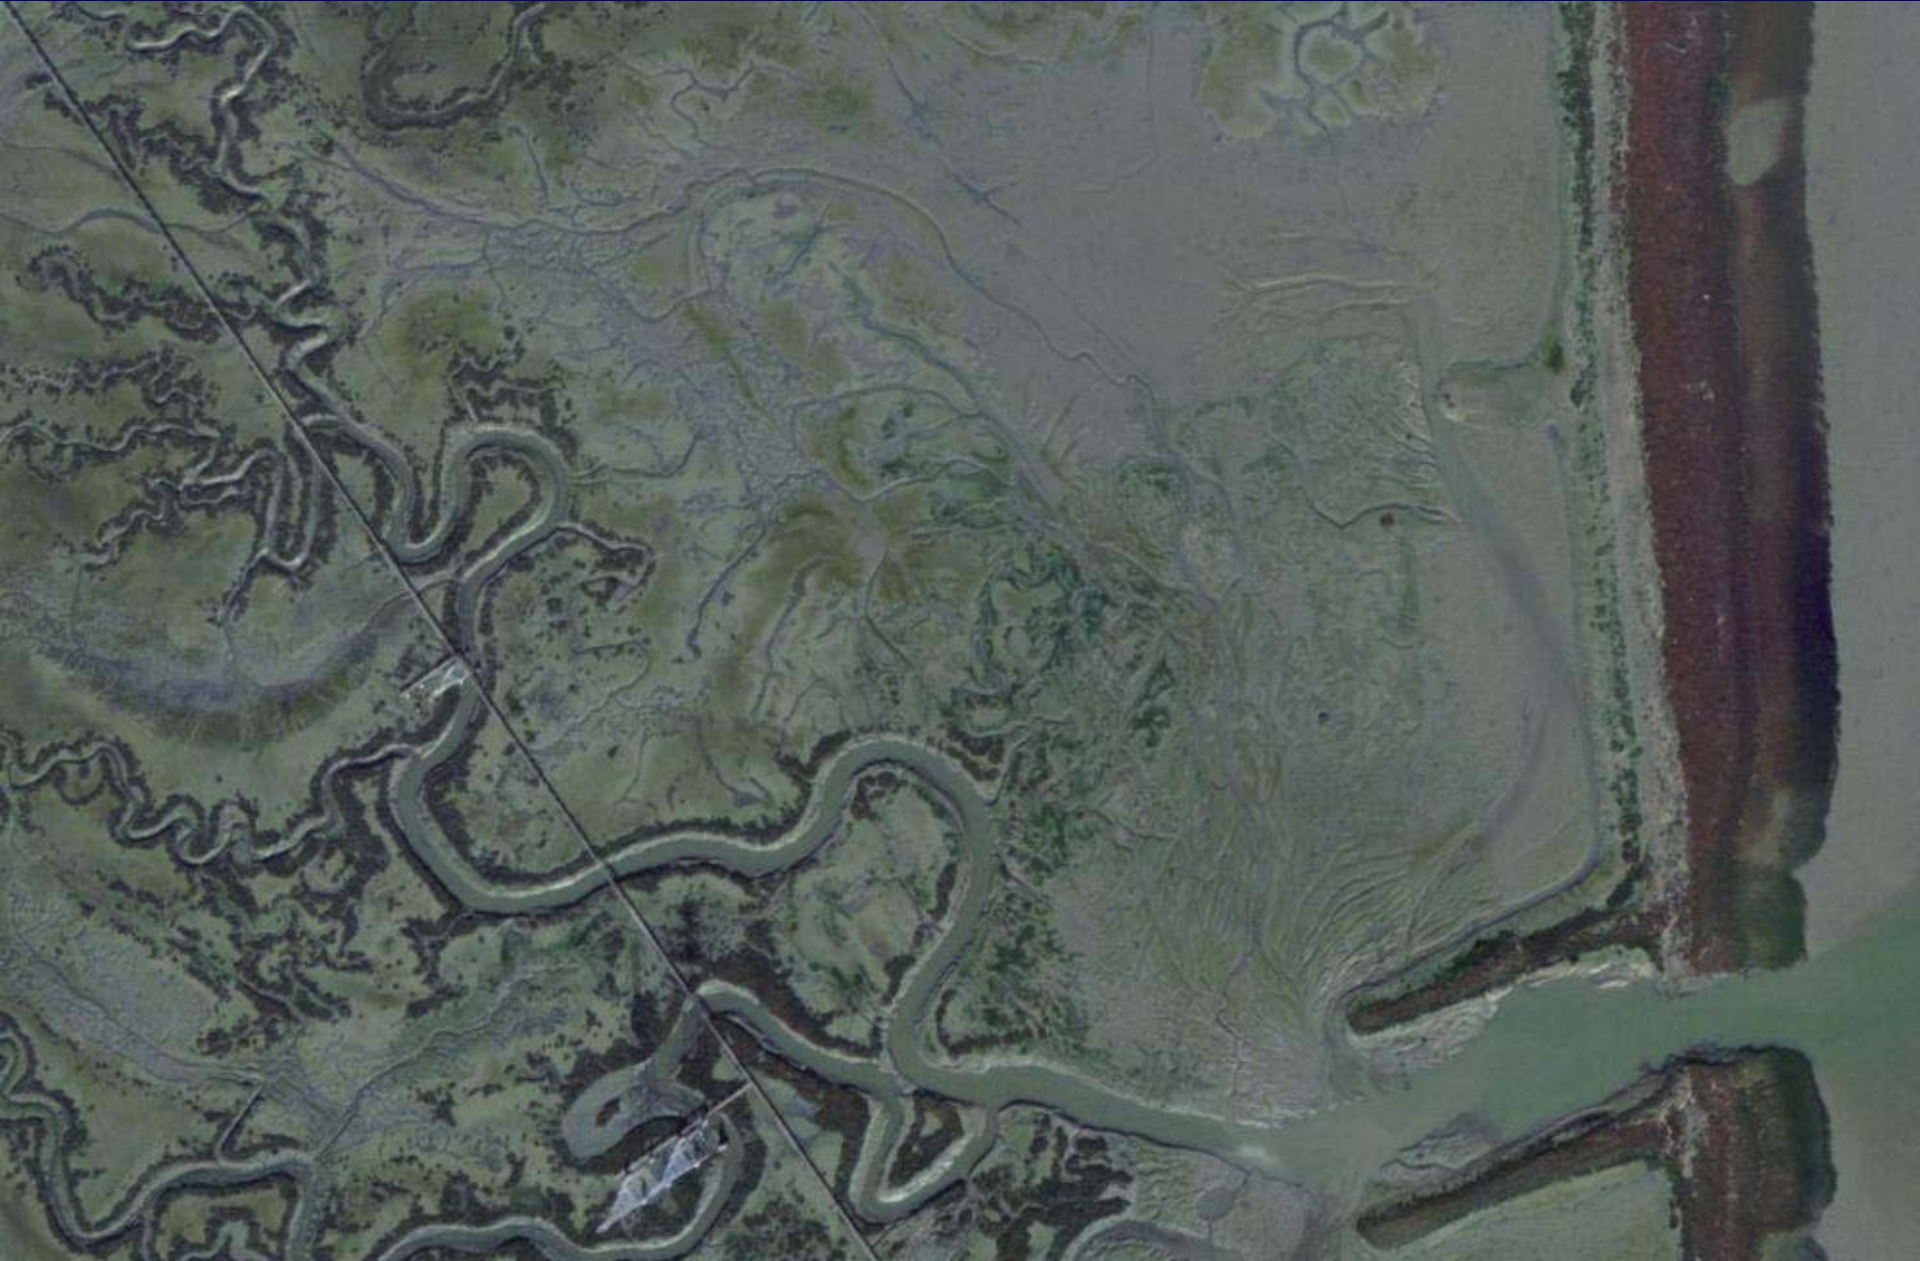
# Performance of Ditch Blocks, T+3

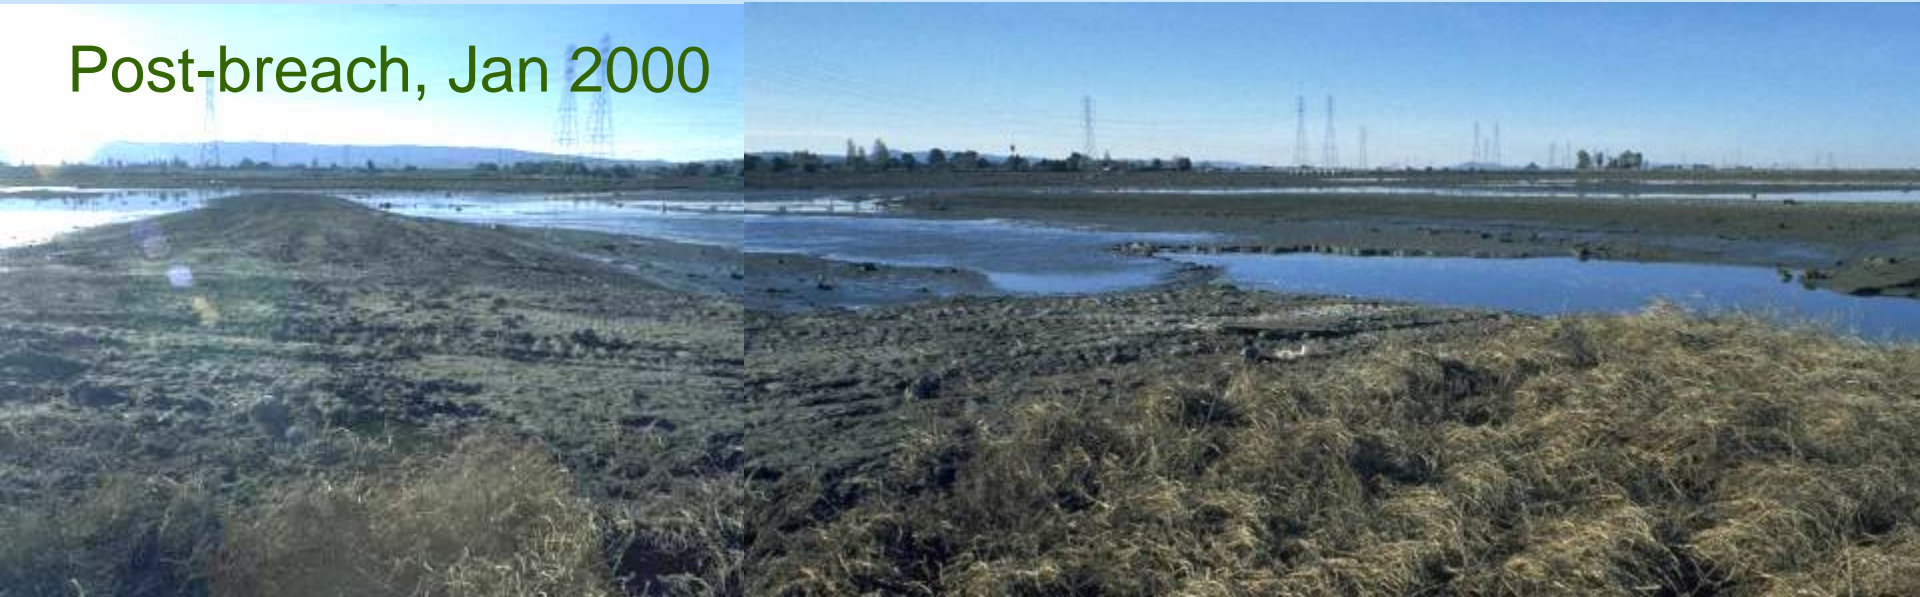
Post-breach, Jan 2000

# Headward erosion of nickpoint
