# TRANSITIONAL PLANT COMMUNITY RESTORATION **AROUND POND A6**

### DAVID THOMSON, AIDONA KAKOUROS SFBBO HABITATS PROGRAM

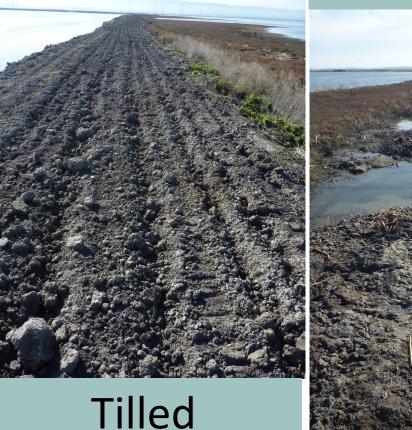
### Figure: Proportion of recruits found in each soil compaction class

Excessive <u>compaction</u> is known to inhibit establishment of plants. Although plants can establish in highly compacted soils their success will be higher in less compacted soils. Our data suggests that soil compaction may be playing a role in the seeding's success.

Construction specifications must include: not lowering levees below transition zone elevations, uncompacting the upper 1-3 feet of the soil surface, creating microtopography (roughness and small depressions) via tilling or other methods, reducing the slopes as much as possible through creating broad levee flanks,
