Vegetation Management in SBSP's Alviso Unit seeding high marsh and upland transitional habitats

Report to SCVWD Healthy Creeks and Ecosystems
Environmental Enhancement Grant Final Report (2011-13)
by David Thomson & Aidona Kakouros
San Francisco Bay Bird Observatory – Habitats Program

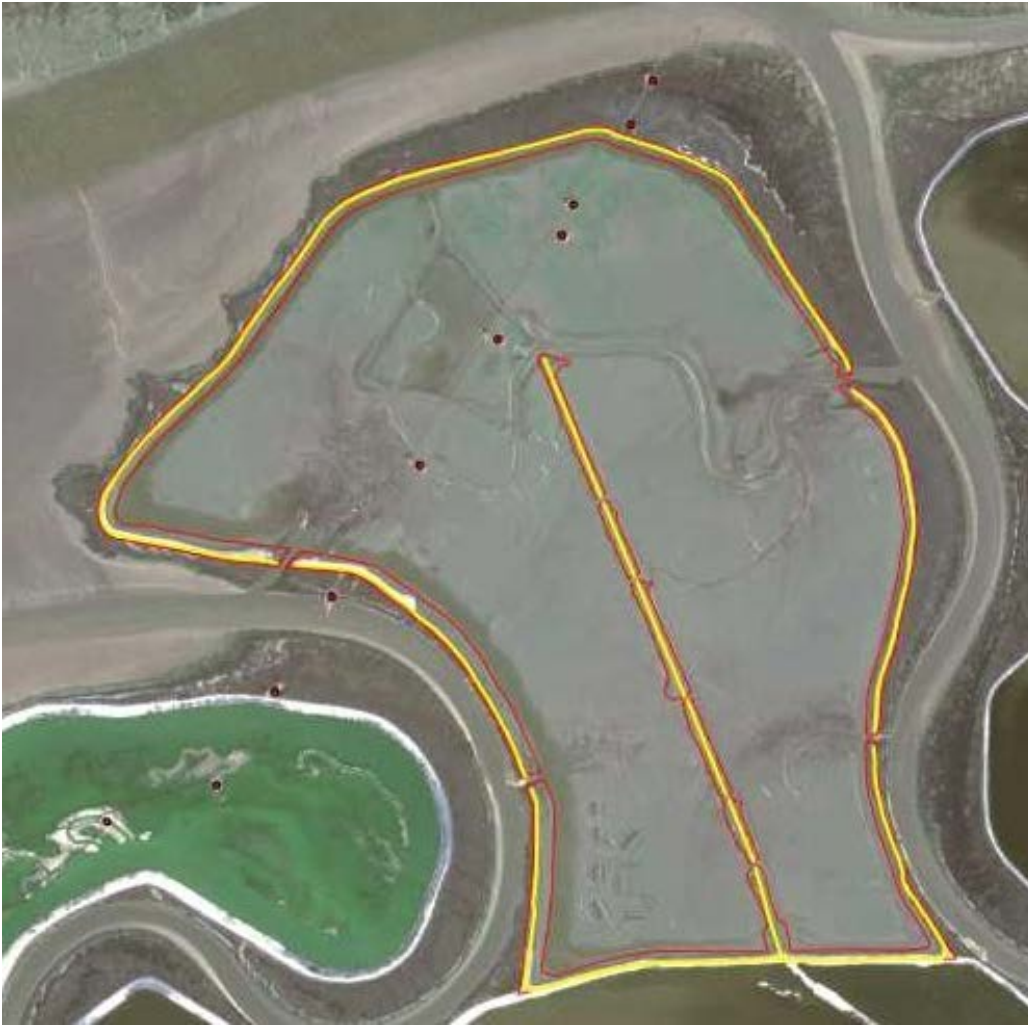
Figure 4. Primary Seeding Areas (yellow); original levee footprint outlined in red

We created site maps to guide AeroTech's hydroseeding (Figure 4 below) and gave their pilot a site tour so he could better visualize the seeding areas. AeroTech's "swath width", (the width of the hydroseed slurry as applied from the plane) is 27 feet, about the width of the seeding areas along the remnant levees, so the pilot's seeding had to be precise. The site consists of two basic areas: the outer perimeter levee and the marsh mounds or islands created from remnant levees within the pond (Figure 4). The purpose of the mounds was to create high marsh habitat to enhance the restored marshes in the near-term because the natural development of these elevations takes over a century.

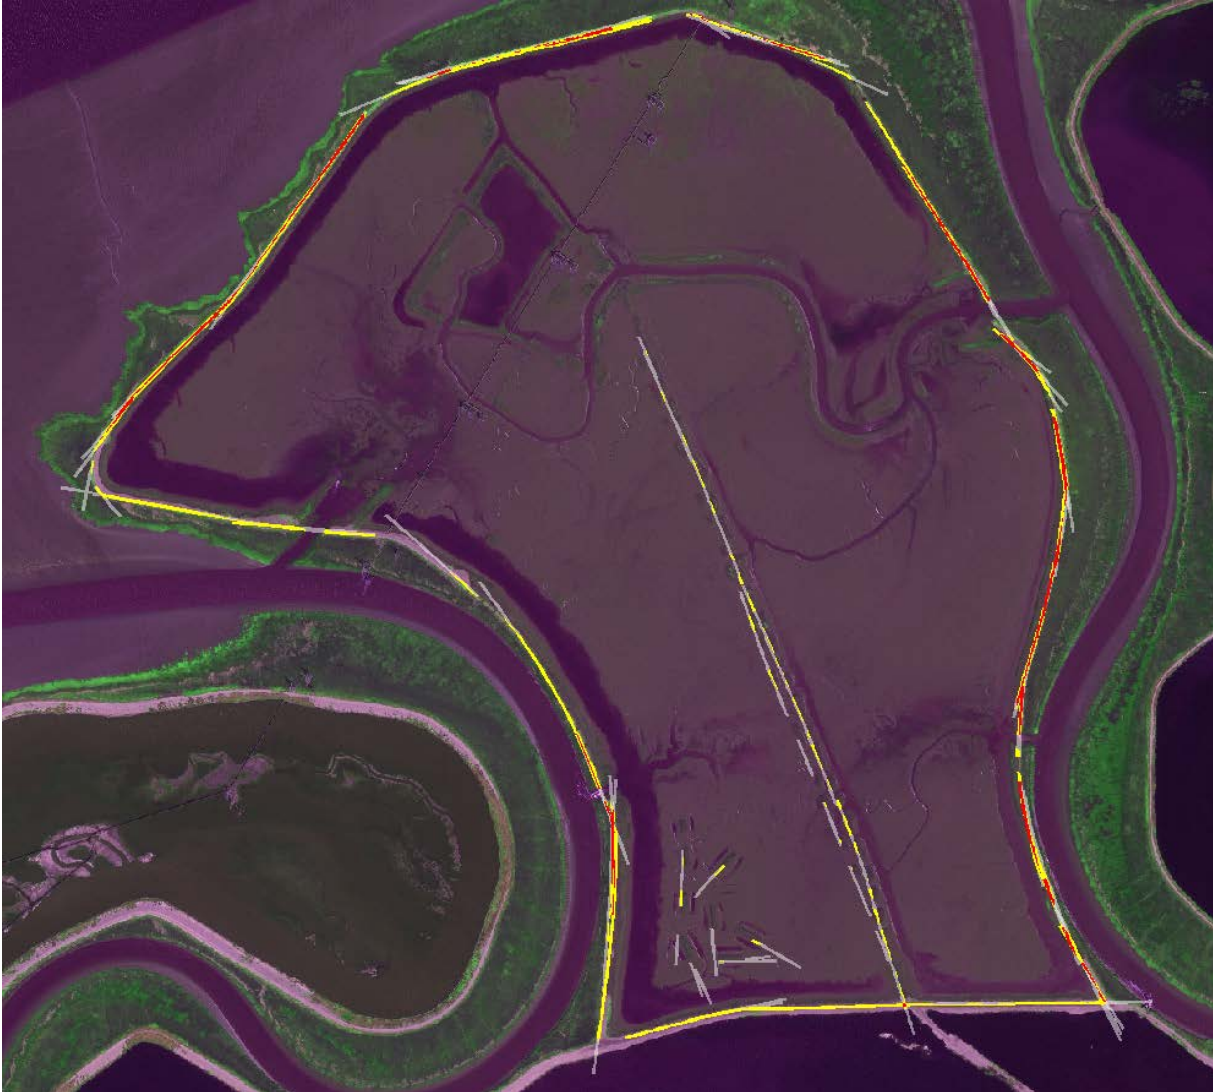
Figure 6. GIS tracks from AeroTech depicting hydroseeding extent

Key: blue lines are seeding areas, yellow shows where hydroseeding tracks intersect a seeding area, and red shows where they intersected multiple times

To assess the accuracy of the seeding work we observed almost all of the aerial hydroseeding from a boat, and subsequently walked the site to observe the seeding's extent (Appendix E contains additional photos that show some of this work). These observations were used to qualify the GIS tracks sent by AeroTech. The tracks are simply when the pilot starts the hydroseed equipment, and when he stops it, so there are differences as the slurry does not hit the ground where the line starts and generally stops hitting the ground before the equipment is stopped. Our observations indicated that the GIS tracks were adequately representative of the hydroseeding extent (Figures 5 & 6).

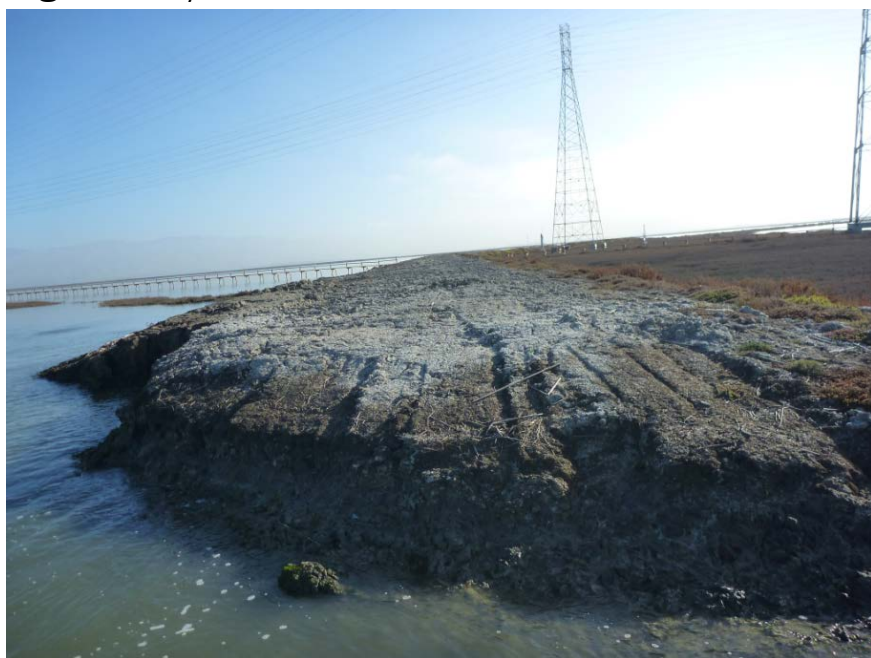
Figure 7. 1/2012 Photo of an unmodified A6 levee the first year during the drought

Year 1 monitoring methods and findings are summarized in Appendix C. Again, presumably due to the drought there was almost no recruitment in the first year (Figure 7), so the modified goals of monitoring were to describe vegetation found within the seeded area and document the persistence of hydromulch. Plant community structure visually corresponded to the height of the levee remnant above the tides, so we stratified the data to correspond with high marsh, transitional, and upland elevations created by the construction design (definitions in Appendix C). The results for Year 1 are presented in Figures 8-10 below.

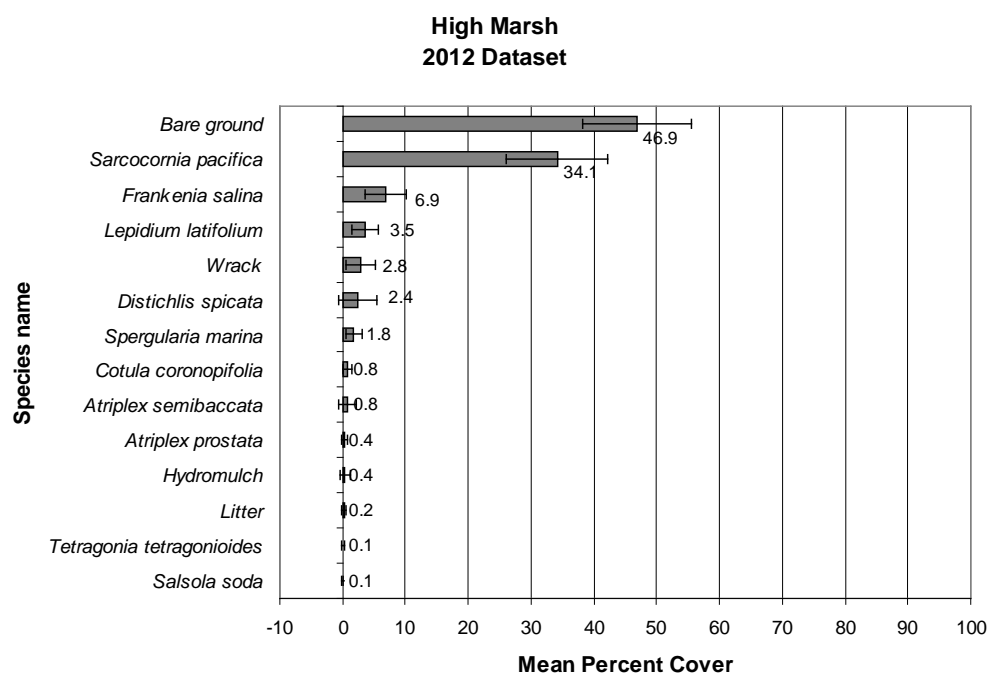
Figure 8. Mean cover values for species found at the lowest seeded elevations in 2012 - Error bars are 2x standard error of the mean, approximating a 95% confidence interval

The species found within each of the three strata are indicative of the habitat names assigned: salt marsh species in the “high marsh”, salt marsh and transitional species in the “transitions”, and transitional and upland species in the “uplands”. This verifies our habitat stratifications as reasonable approximations as understood by habitat ecologists in the region. Note that the “litter” found in the upland strata was predominantly from last year’s *M. nodiflorum*, which did not do well in the drought.

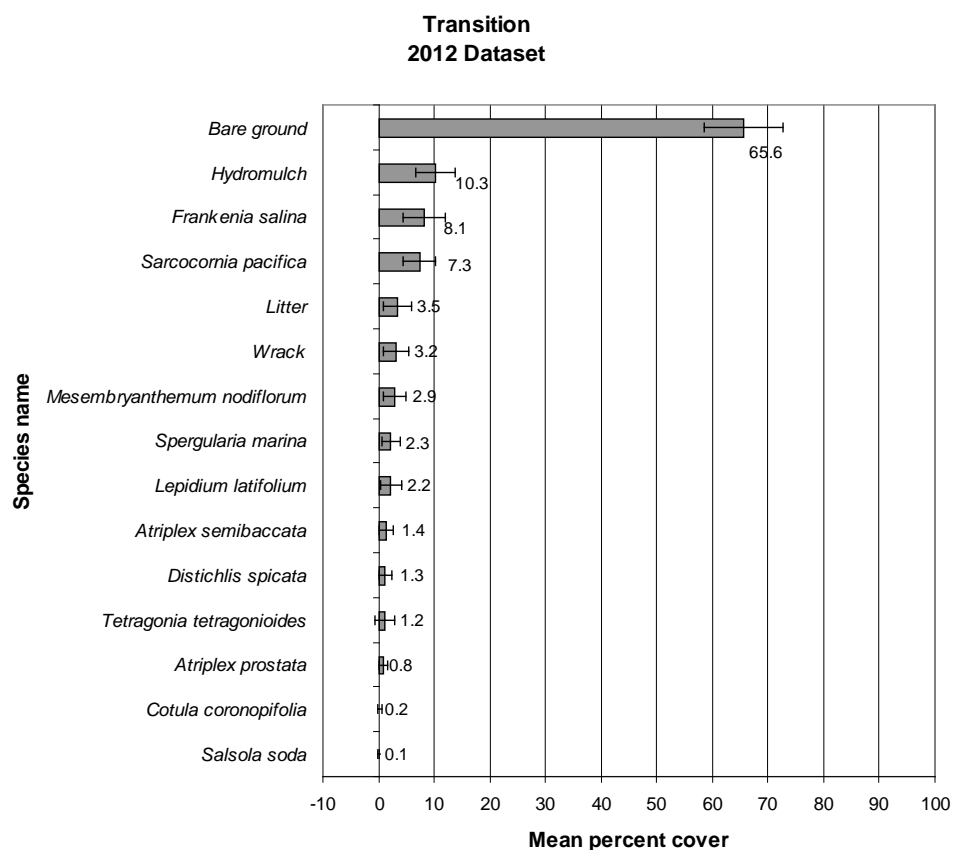
Figure 9. Mean cover values for species found in intermediate seeded elevations in 2012

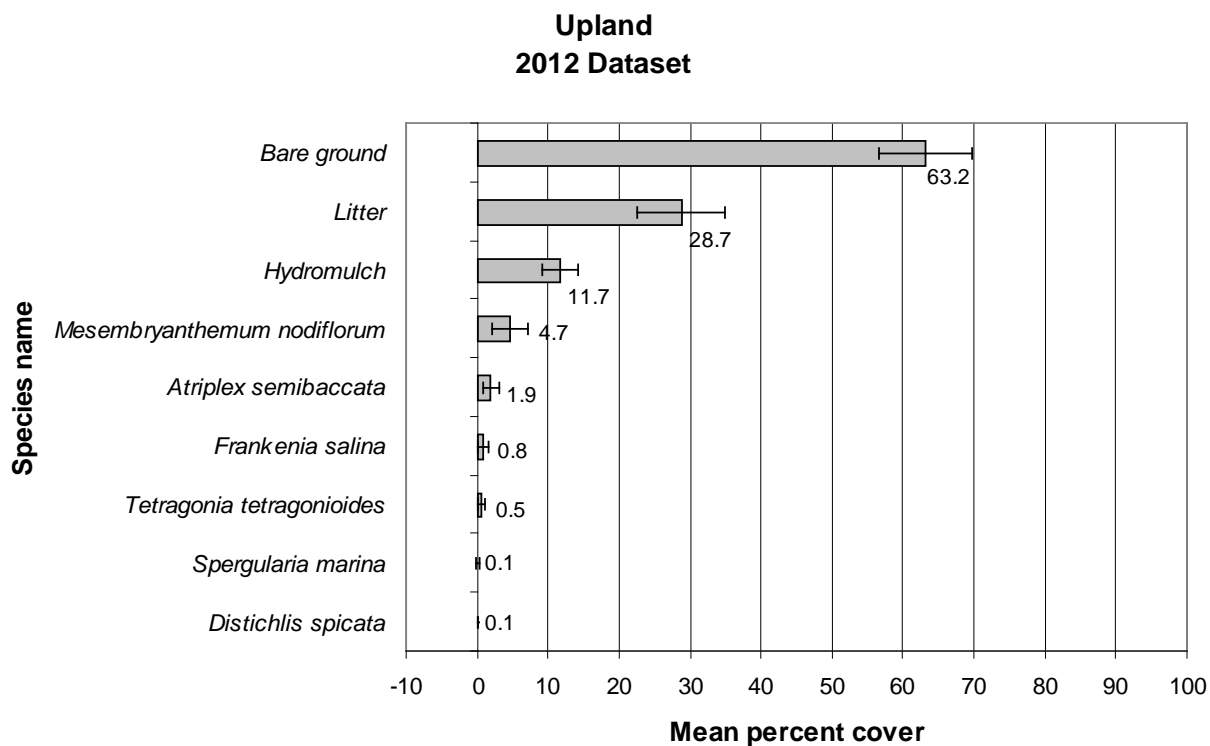
Figure 10. Mean cover values for species found at the highest seeded elevations in 2012

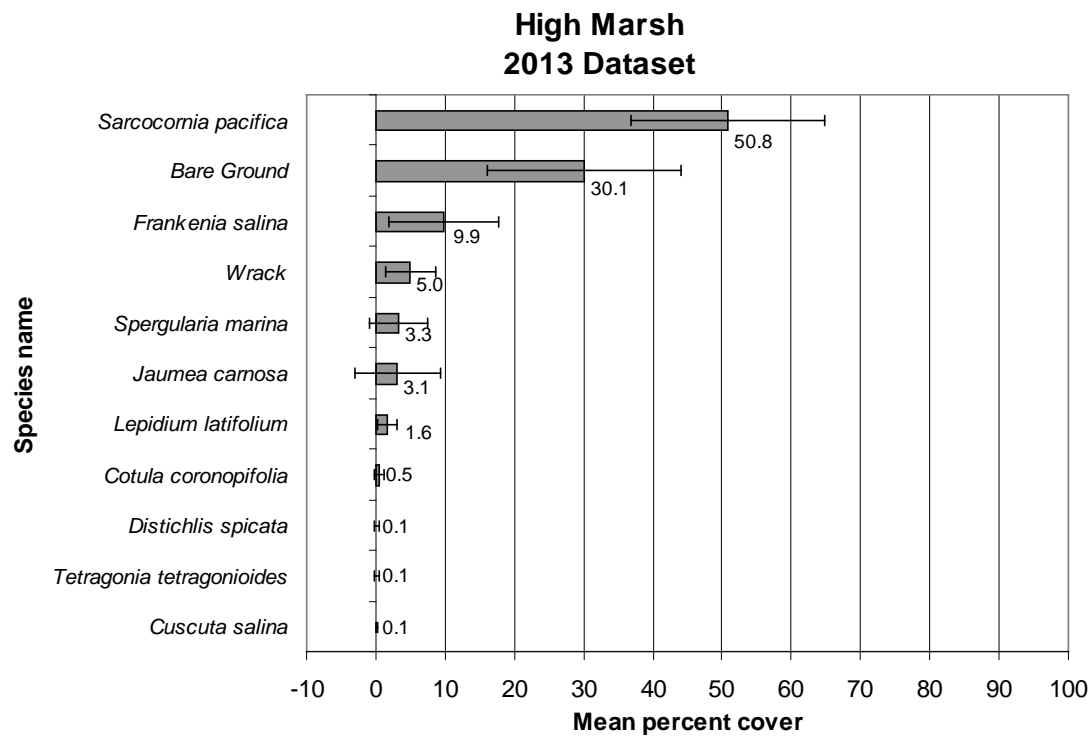
Figure 11. Mean cover values for species found at the lowest seeded elevations in 2013

A comparison of year 1 and year 2 data shows an increase in salt marsh species cover values in the high marsh strata, which is expected as tidal marsh generally passively revegetates well. The large change in bare ground versus *F. salina* in the transition likely indicates a sample size issue, or some effect of the methodology, but we generally feel the direction of the change is accurate, as it conforms to our casual observations of the site. The most informative data regarding our seeding project's effectiveness (or the impact of the 2011-12 drought) is in the upland strata: bare ground remained relatively constant, showing that nothing was capitalizing on the bare ground, including *M. nodiflorum*, which did rebound this year but not to its extent in 2011 prior to seeding. This discussion continues in the Conclusions section below.

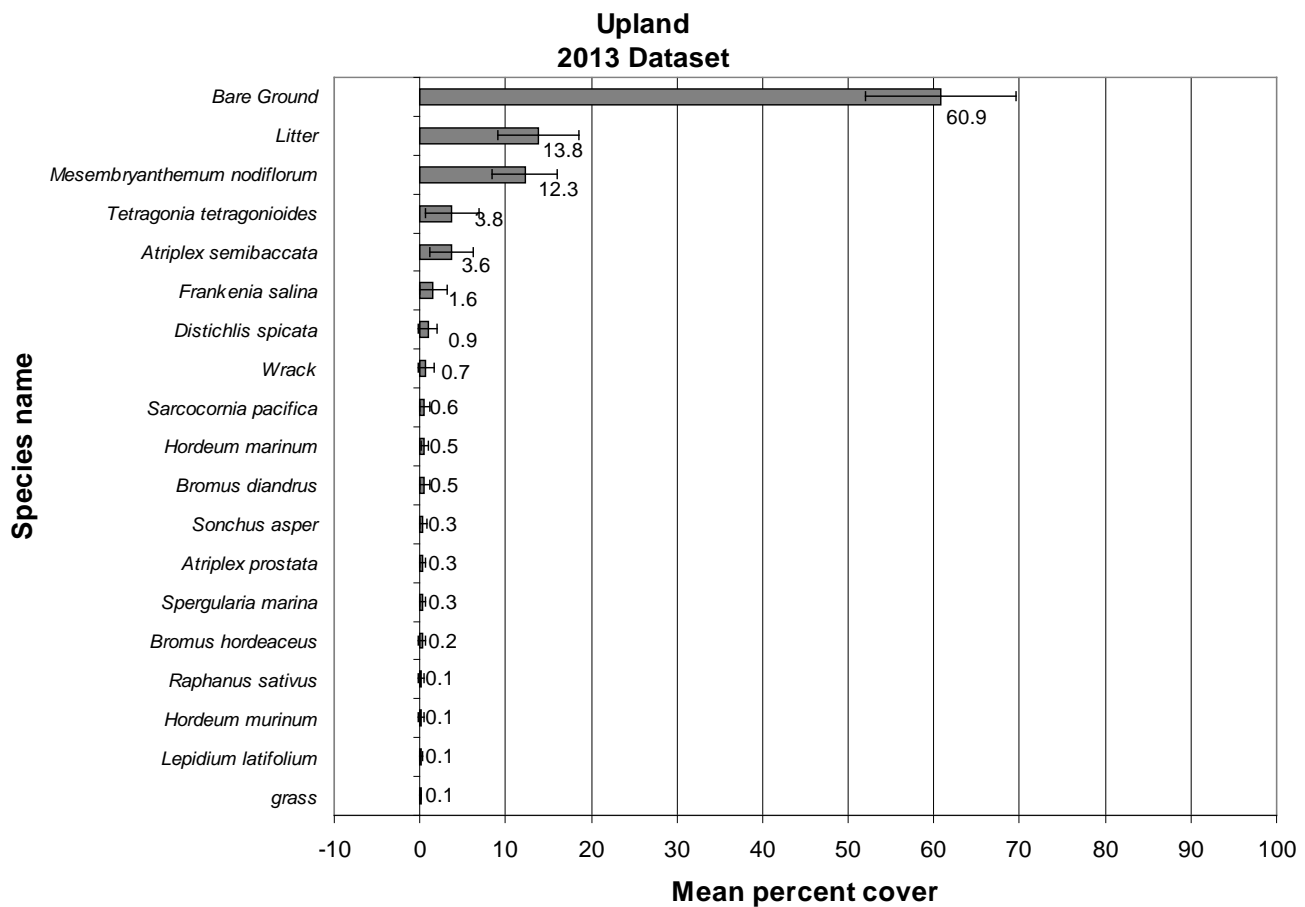
Figure 12. Mean cover values for species found at the highest seeded elevations in 2013

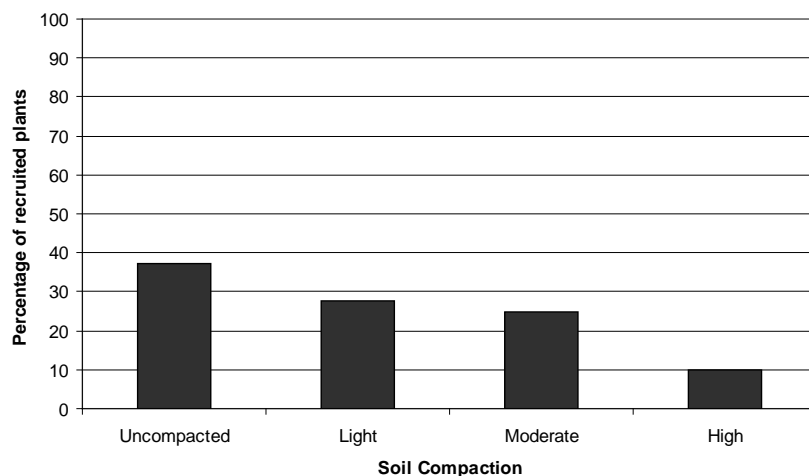
Figure 16. Proportion of recruits found in each soil compaction class

Excessive compaction is known to inhibit establishment of plants, and in this case is likely a contributing factor. Although plants can establish in highly compacted soils their success will be higher in less compacted soils. Our data suggests that soil compaction may be playing a role in the seeding's success.

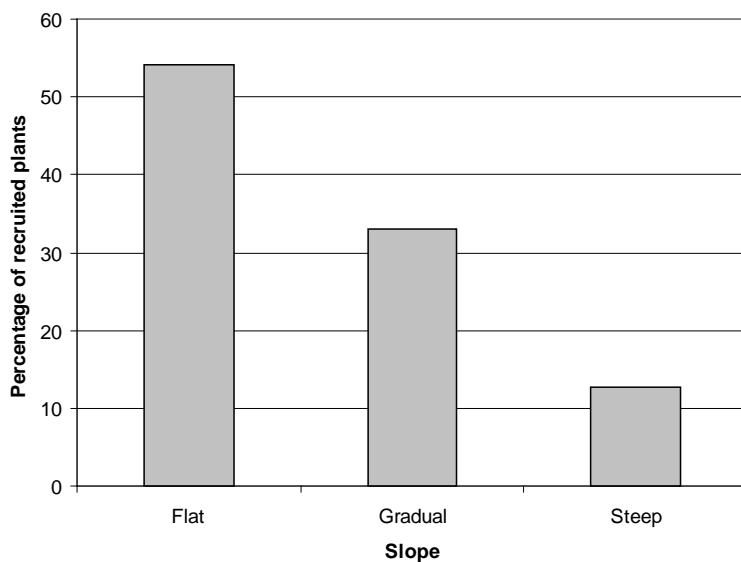
Figure 18. Proportion of recruits found in each slope class

Slope alters solar aspect, influences soil moisture through altering infiltration and retention, as well as influence the ability of seeding to stay put until germination. Our data suggests that slope influenced recruitment from our seeding.

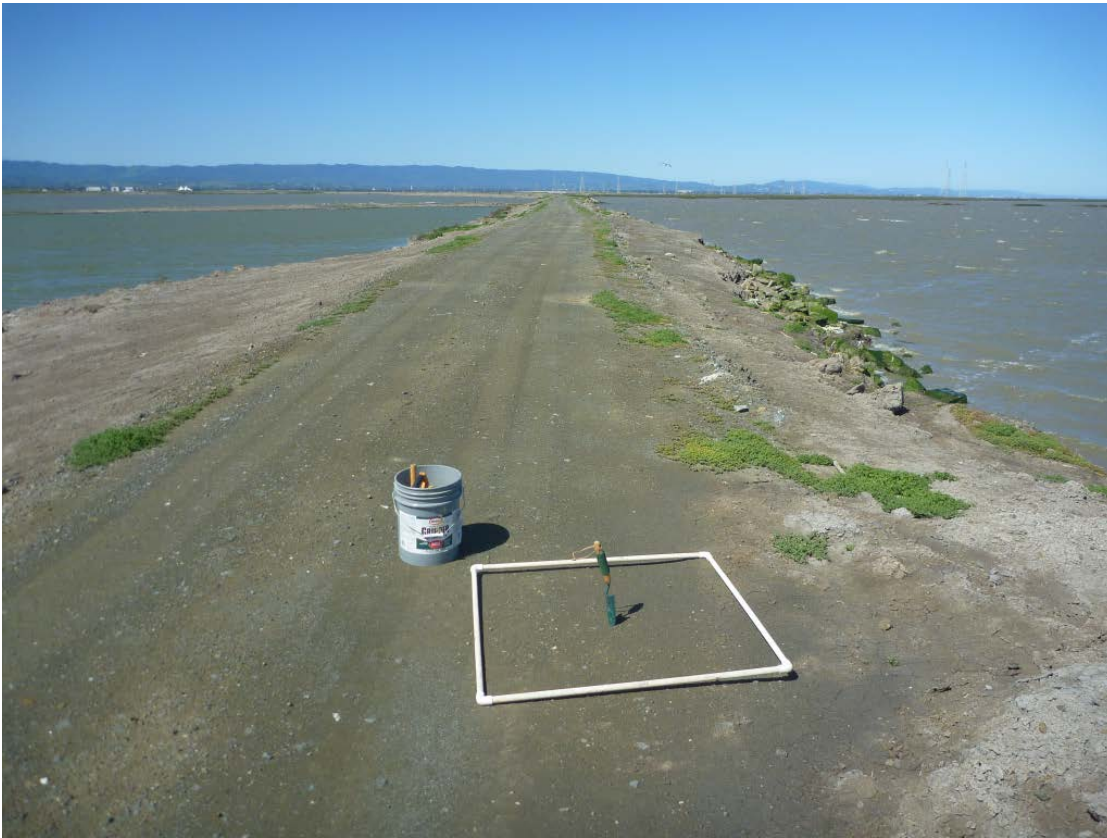
Figure 20. 04/2012 Photo of an unmodified section of the A6 levee showing a sample site

That said, even levees that were scraped, and may have included some type of tilling or soil loosening, did not recruit seed well (Figures 20 and 21 below), which indicates the potential for an uncontrolled factor such as soil chemistry. In most cases the recruits were found on levee flanks, amongst pre-existing vegetation, suggesting that perhaps soil conditions were better and/or microhabitat conditions were created by other vegetation. This is discussed further in the Conclusions below.

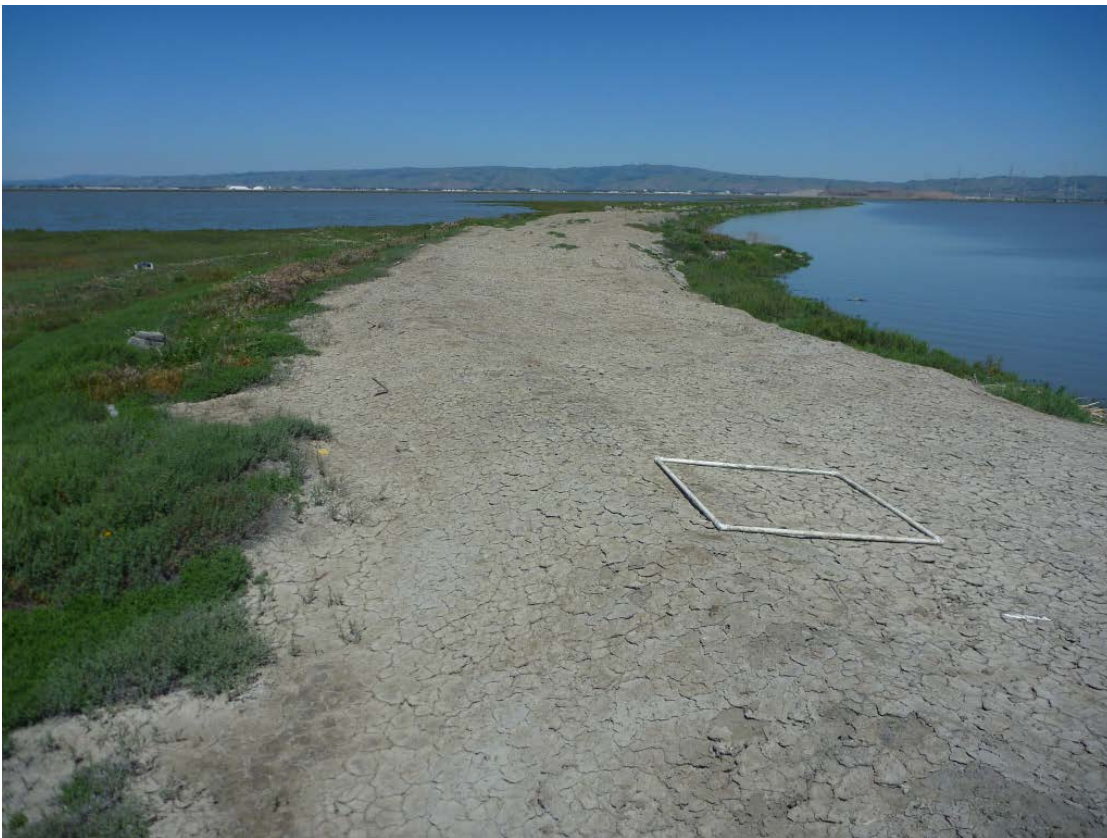
Figure 21. 4/2012 Photo of a scraped levee result showing a sample site

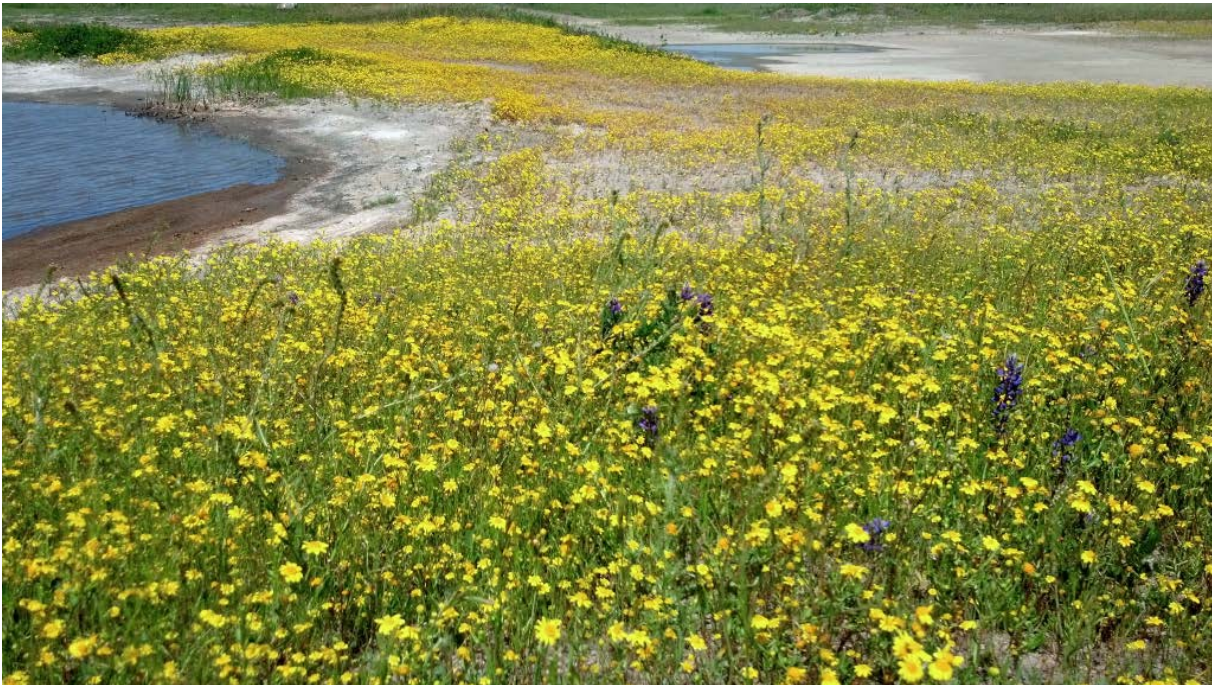
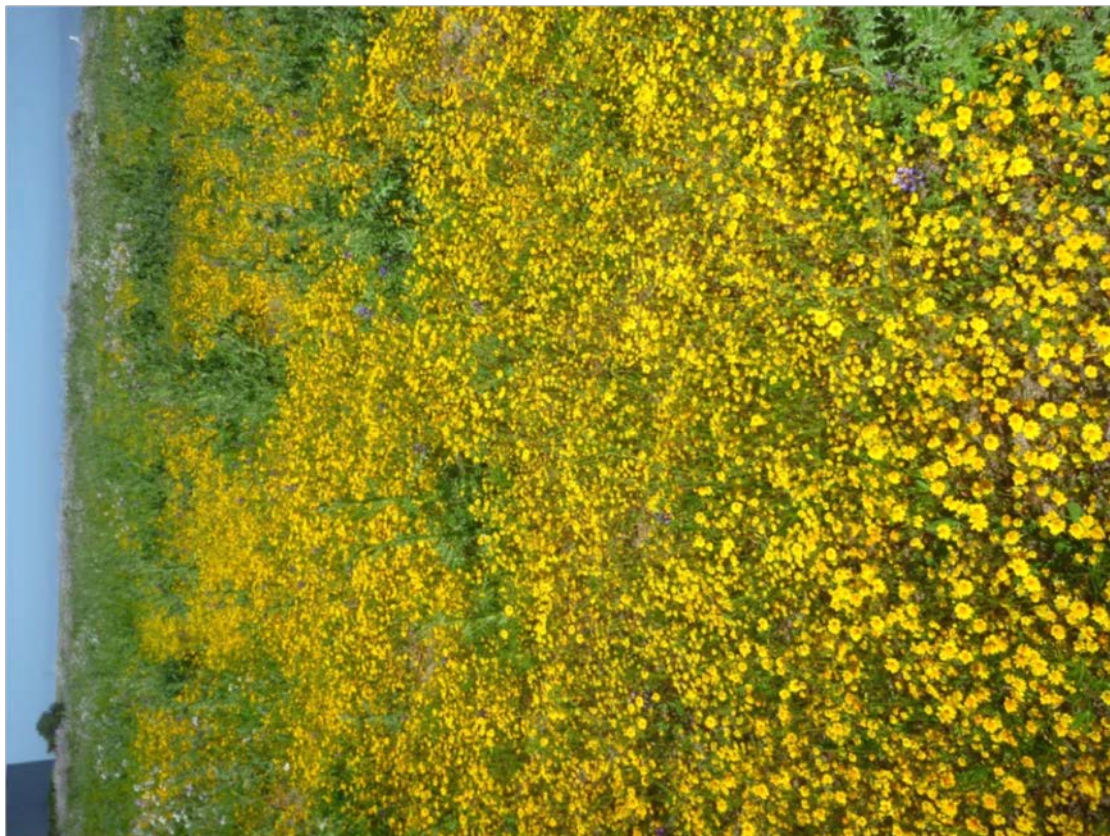
Figure 22 and 23. 2012-13 results from a similar seeding project at Moffett Field
Note: The dominant species shown here, goldfields (*Lasthenia* sp.) were not part of our mix in 2011.

In summary, even considering this year's drought we did not see the quantity of recruitment in Year 2 that was seen at another site seeded in 2012 (Moffett Field, Figures 22 & 23 below). And we did expect to see more than was found based on the data collected (extent of persisting hydromulch, continuing presence of viable seed, and more germination in year 2 than year 1). The lack of recruitment could be due to a year of waiting for precipitation combined with construction design changes, second year of drought, as well as seed viability losses, seed losses due to animal browse, and/or seed losses due to tackifier failures.

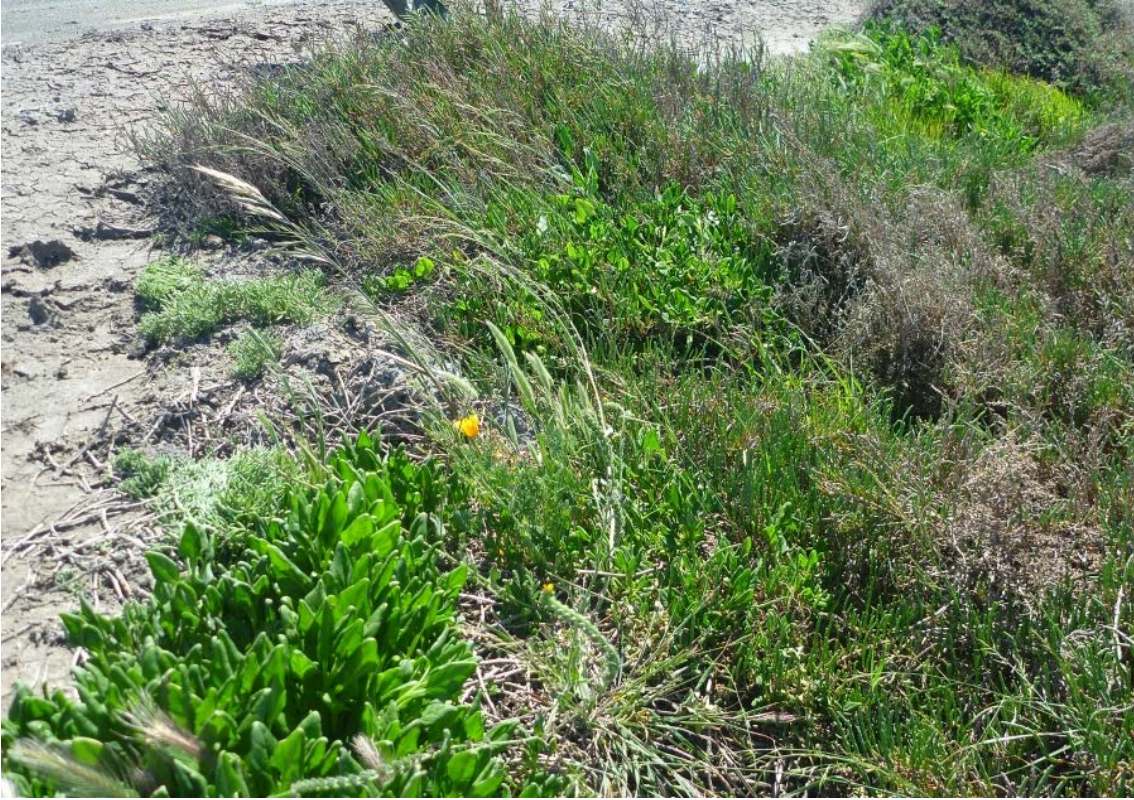
Photo A. A high diversity of species recruited from seed in 2013, including common fiddleneck, California poppy, alkali barley, small fescue, and California brome; also present are New Zealand spinach, perennial pickleweed, and alkali heath, among others.

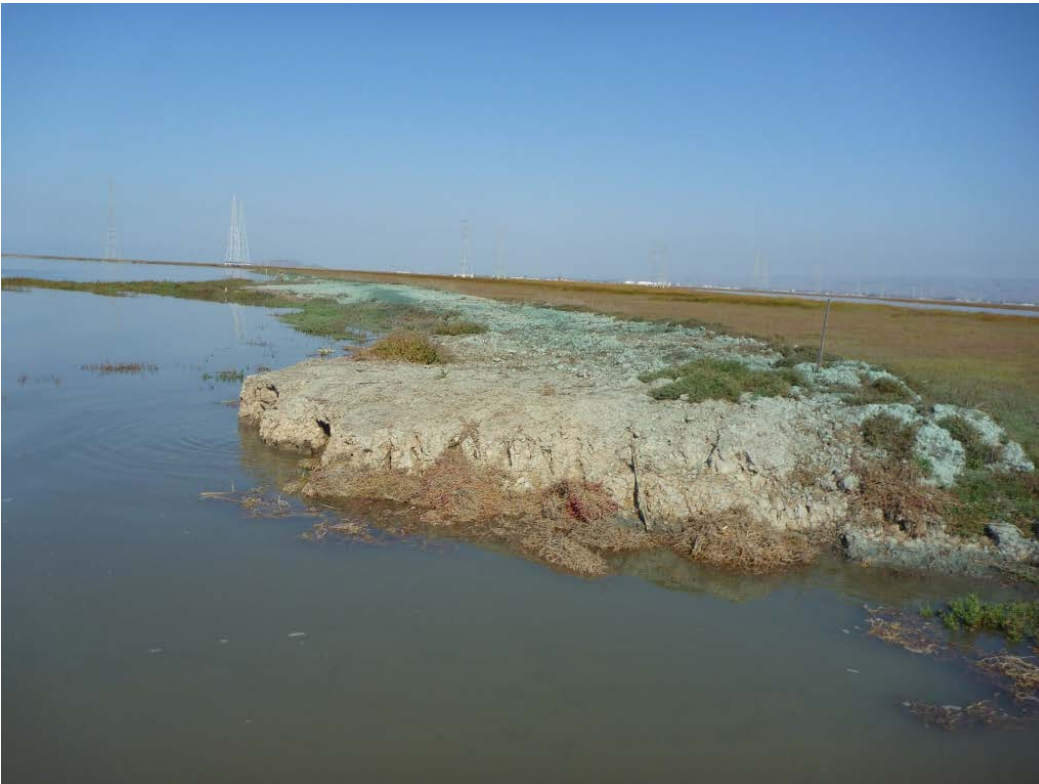
Photo B. Hydromulch still obvious in the early spring of 2012

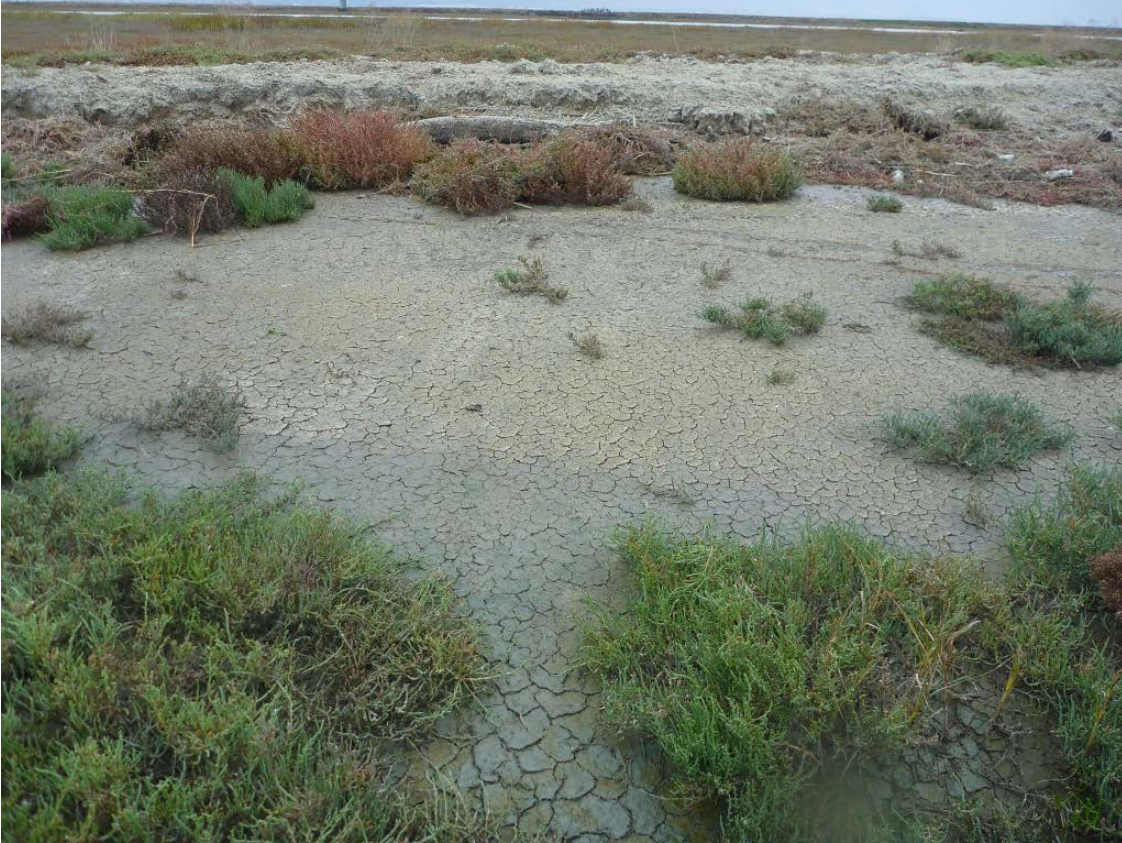
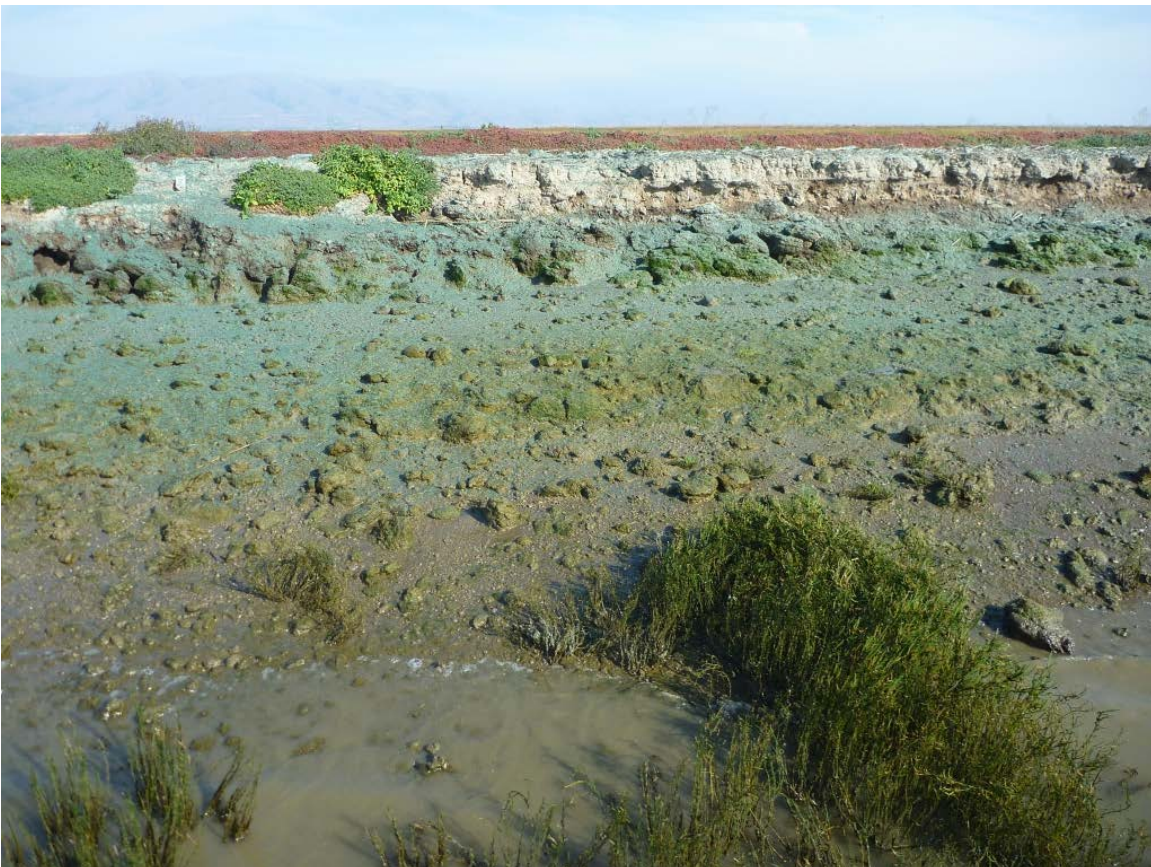
Photos C & D. Hydromulch comparison between the spring of 2012 and fall of 2011; light beige color shows mulch presence in the lower area in 2012, which was green in 2011.

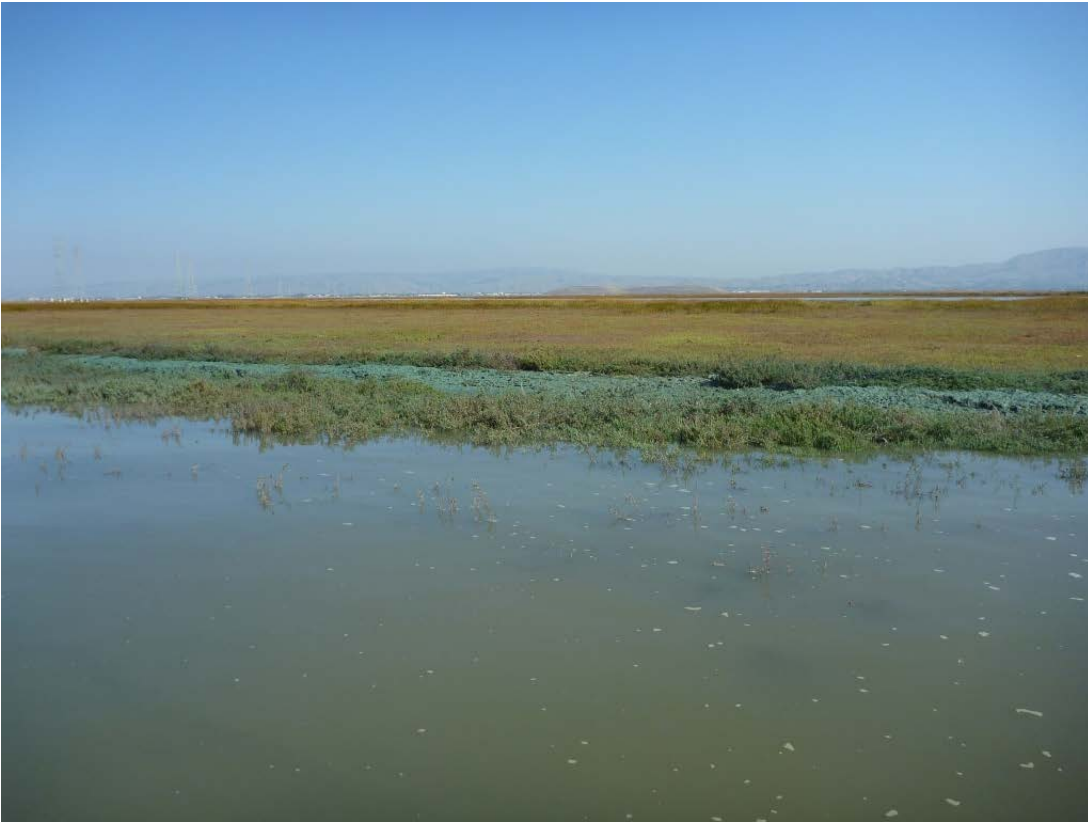
Photo E. Hydromulch in fully lowered section during the fall of 2011 shortly after seeding

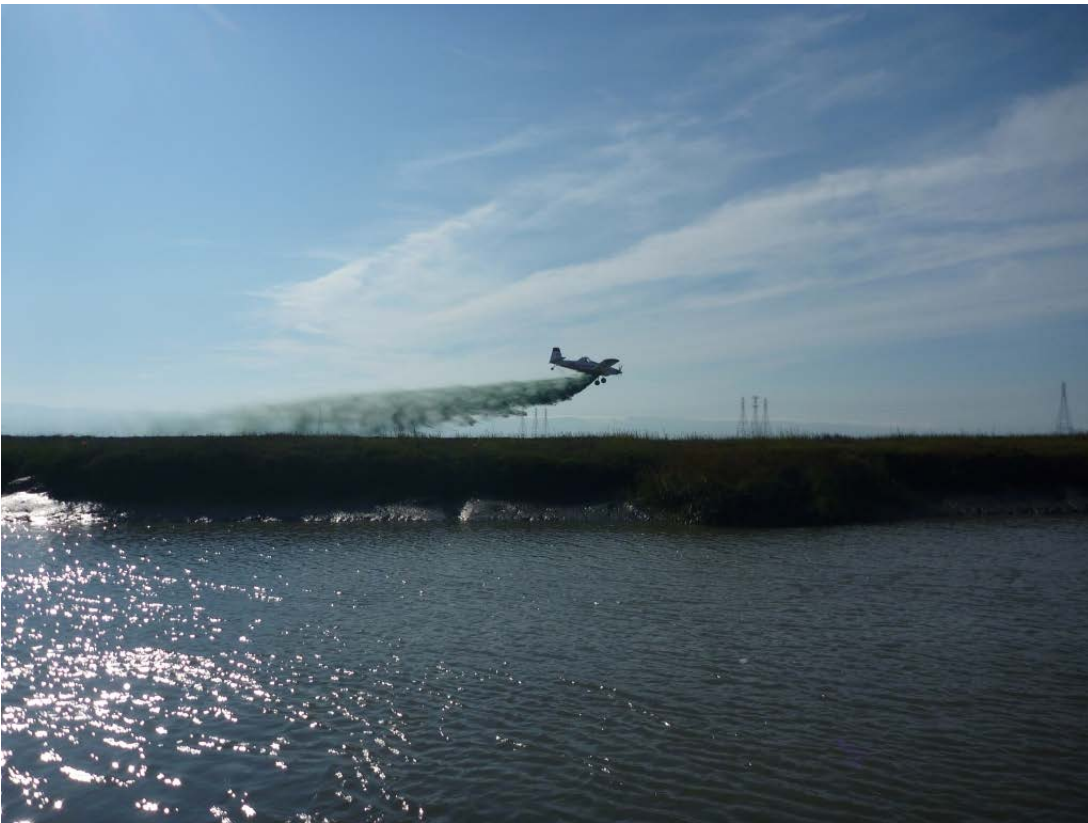
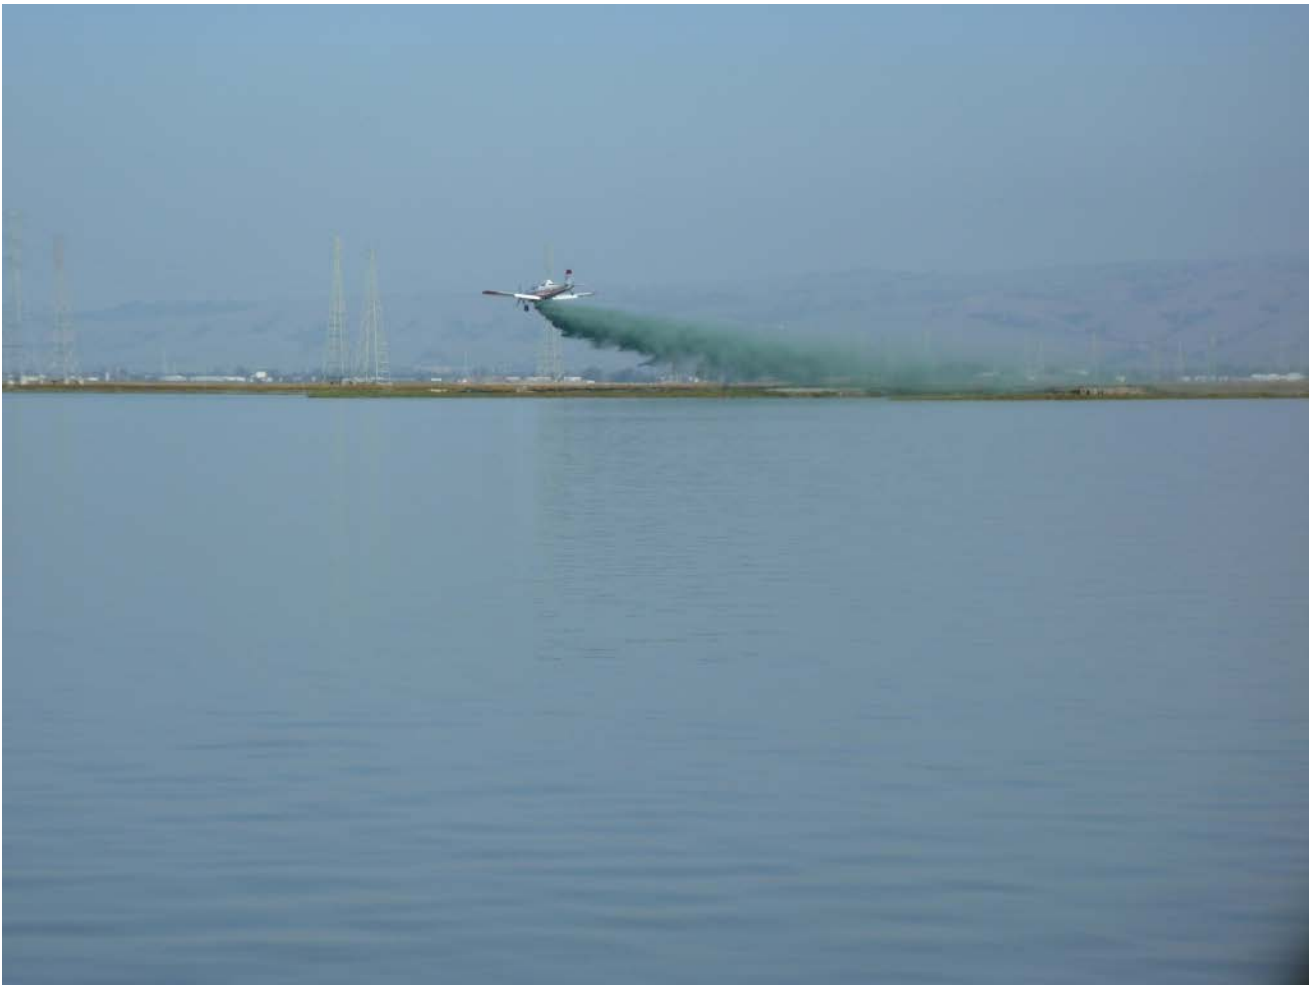
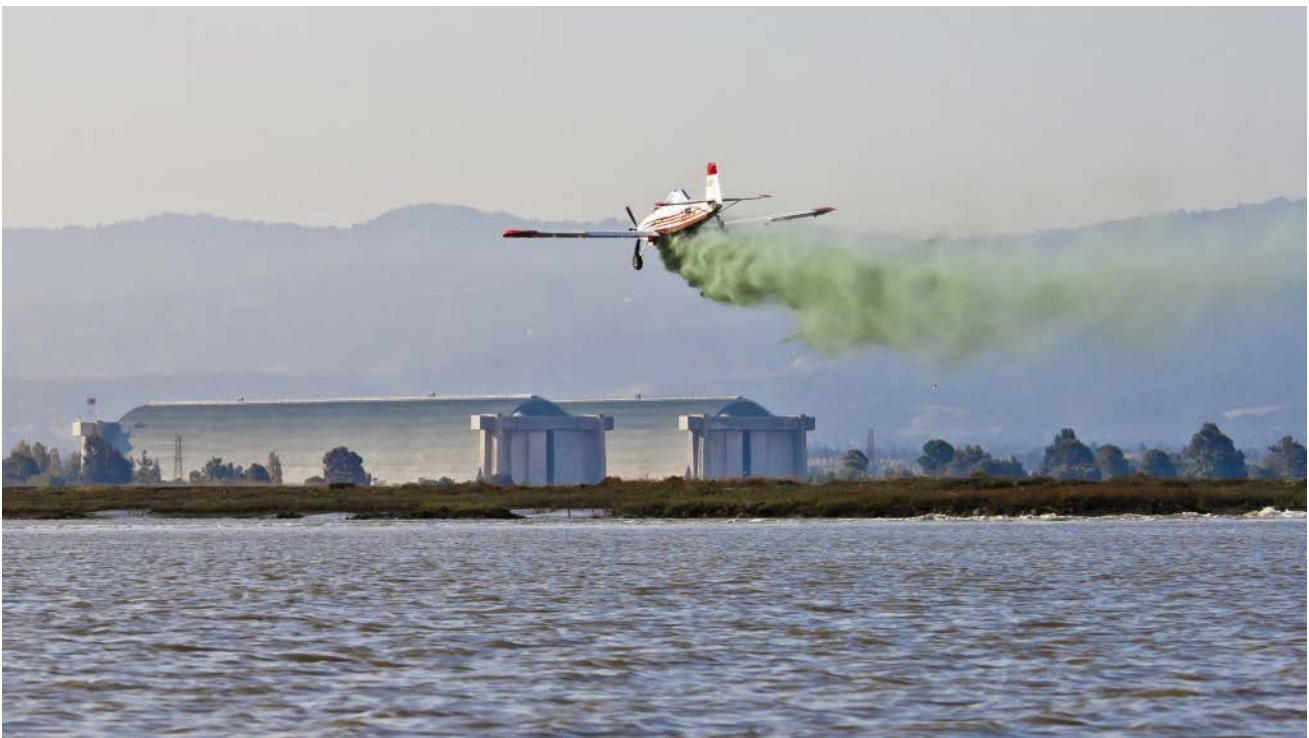
Photos F - H. Aerial Hydroseeding in action

Seeding was performed on October 24th and 25th, 2011. We visited the site periodically afterwards to verify that the distribution of the hydroseed matched the GIS files sent by AeroTech, and to observe the behavior of the hydroseed mulch, particularly in tidal areas. The distribution of the hydroseed slurry appeared to correspond to the GIS files. The hydroseed slurry held up somewhat to limited tidal action when it was applied to a dry surface so the tackifier could set up. This is not a recommendation to hydroseed in tidal zones, as all hydroseed tackifiers eventually release when kept wet, and most seed floats, but in our case we were hopeful that some of the high marsh seed might have the opportunity to recruit. Further monitoring results are below.
