Vegetation Management in SBSP's Alviso Unit seeding high marsh and upland transitional habitats

Report to SCVWD Healthy Creeks and Ecosystems
Environmental Enhancement Grant Final Report (2011-13)
by David Thomson & Aidona Kakouros
San Francisco Bay Bird Observatory – Habitats Program

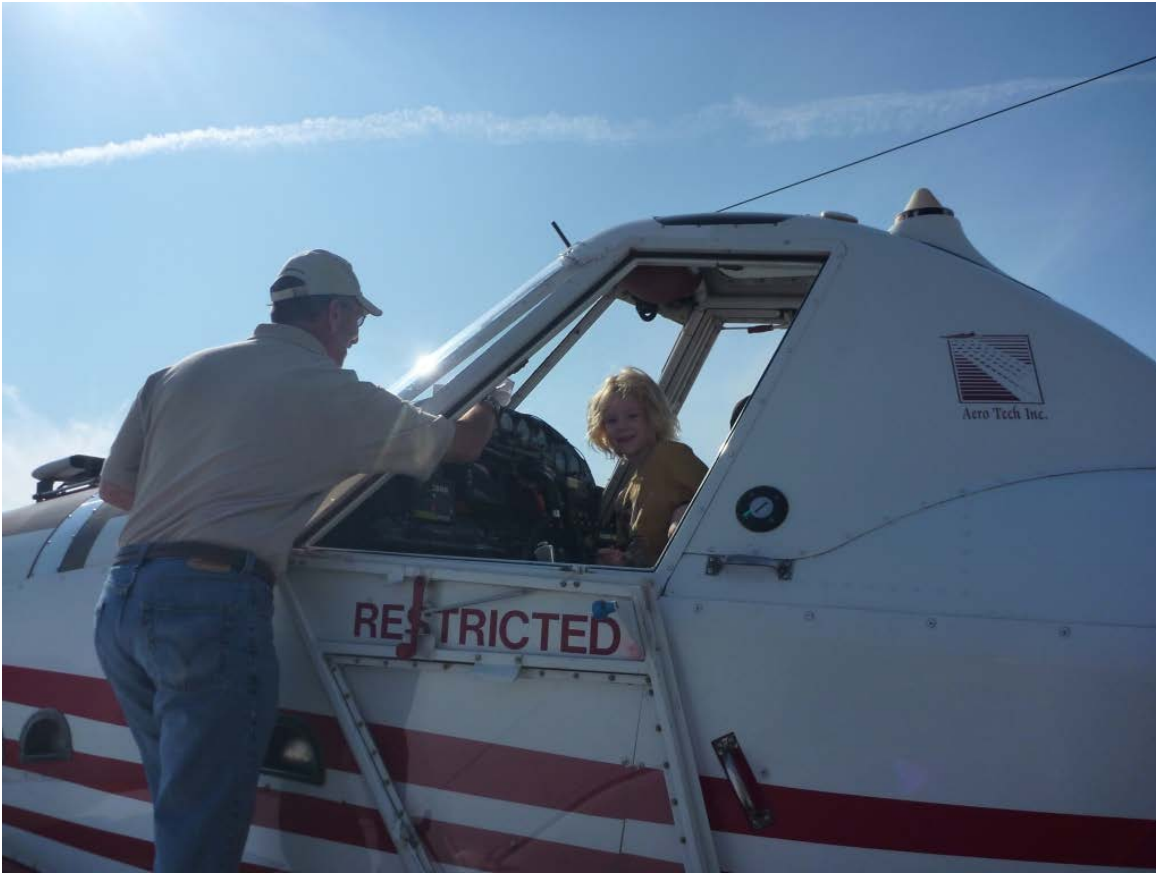
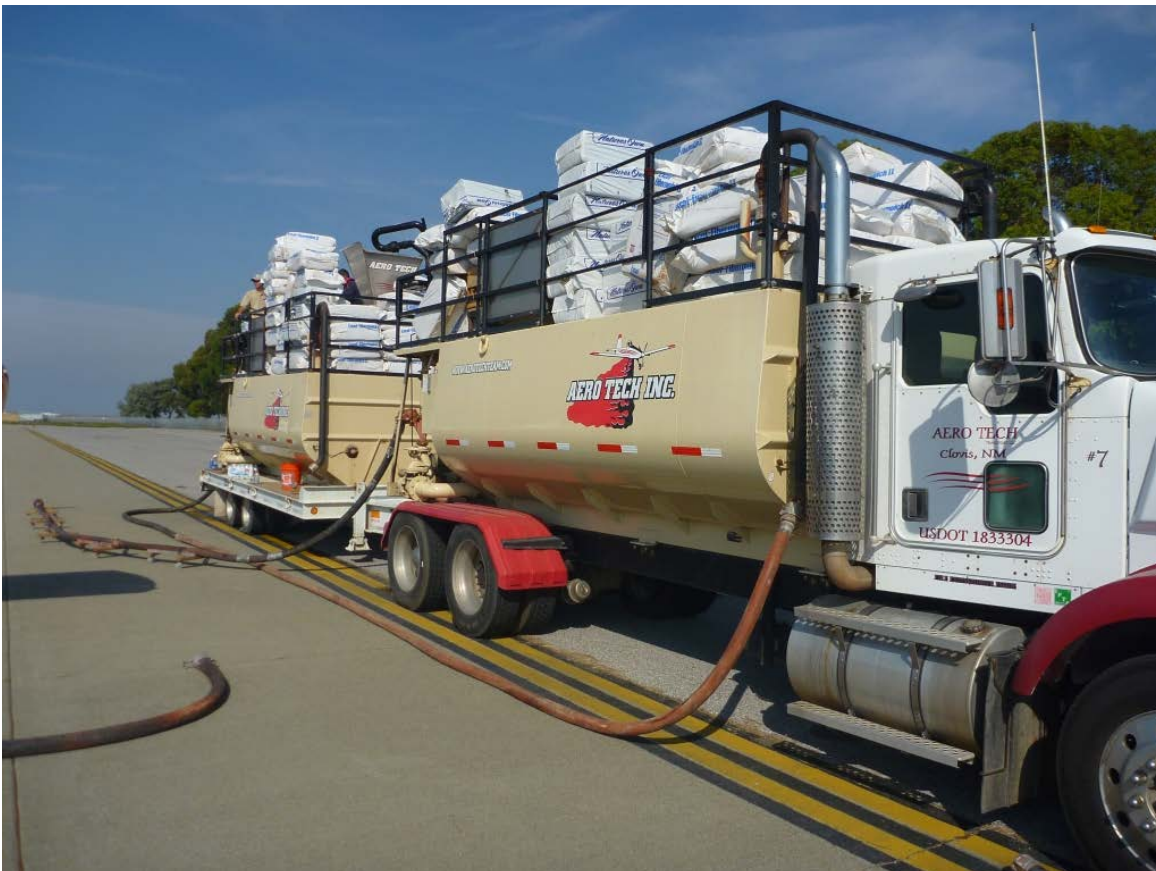
Photos I and J. Aerial Hydroseeding equipment (please note: pilot standing outside of the plane)

After substantial planning and preparations there still remained a need for staging the aerial hydroseeding firm, AeroTech Inc., at an airport that would best suit their needs. Although they can stage at county airports, their frequent take-offs and landings can cause difficulties. We wanted to optimize this for the owner of AeroTech Inc., Mr. Ted Stallings, because he stood by his quoted price per acre for aerial hydroseeding, even after our initial estimate of the seeding acreage was cut in half, affecting his bottom line by tens of thousands of dollars. Regardless of this, I highly recommend AeroTech Inc. for their technical expertise and professionalism; it was a pleasure working with them.

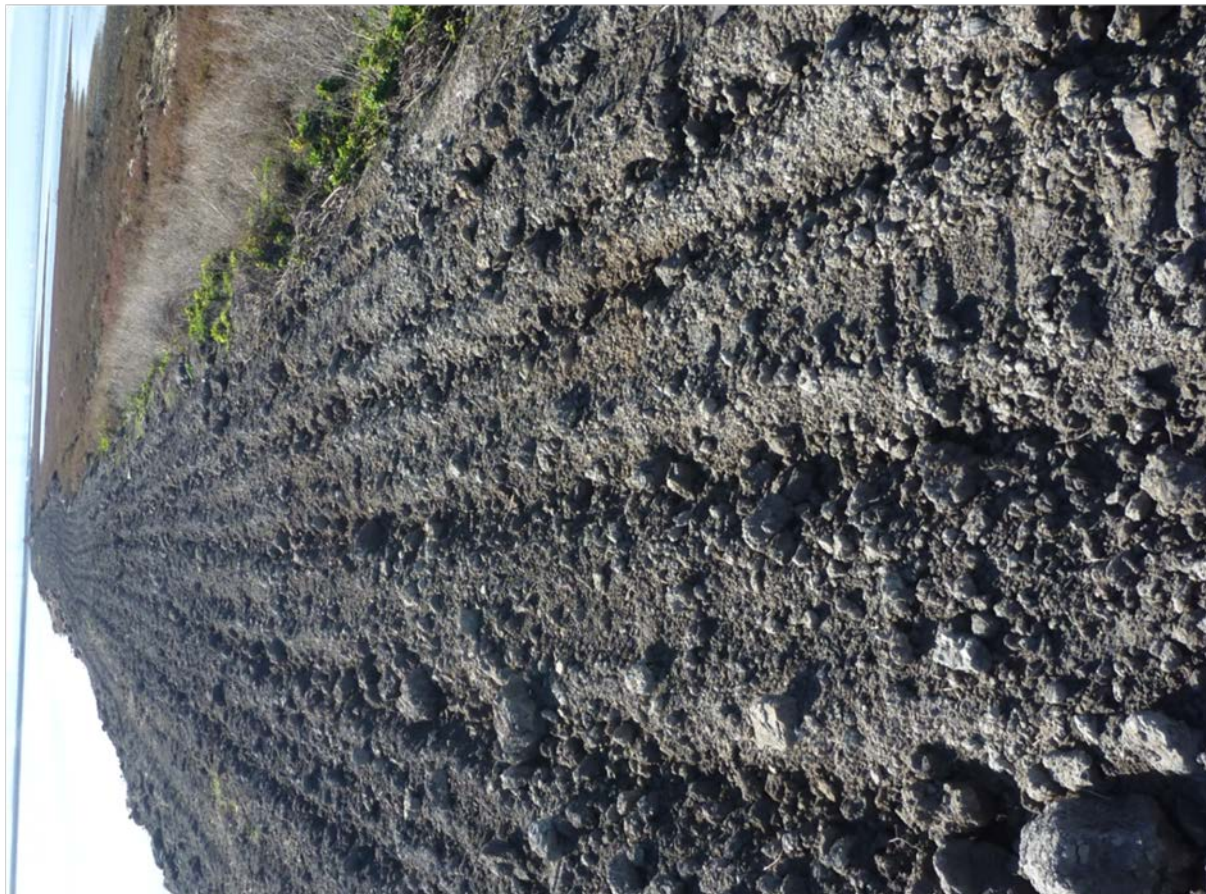
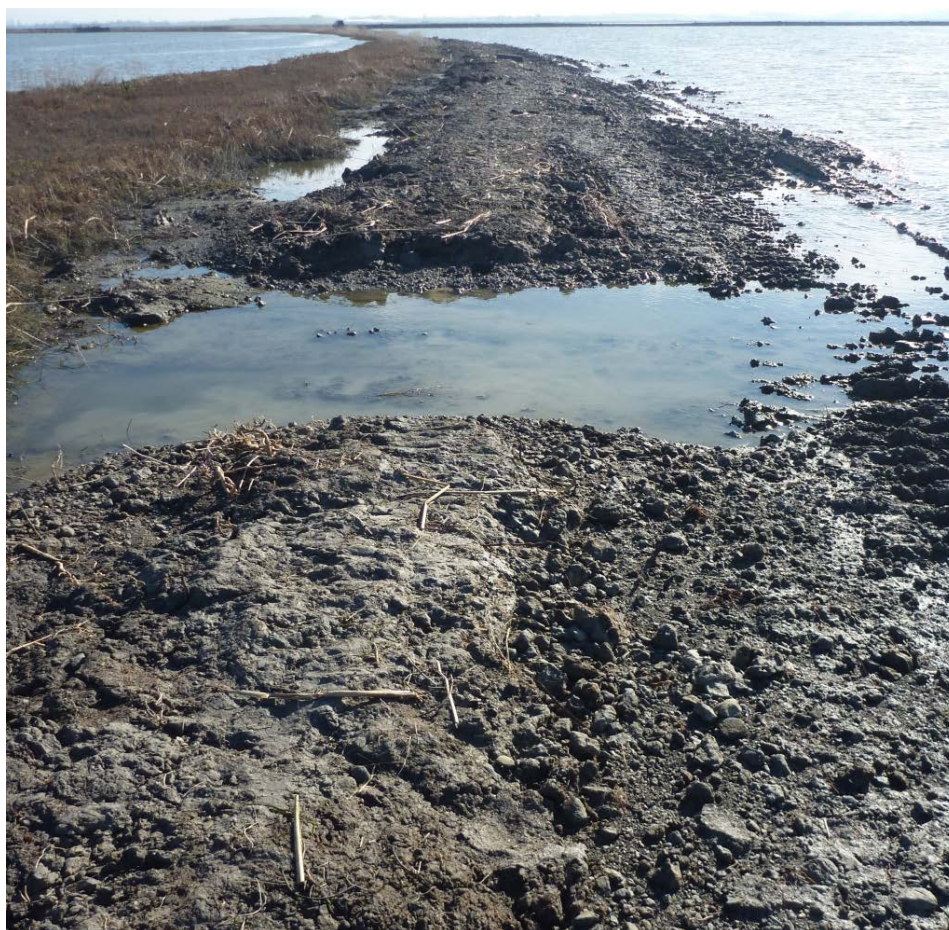
Photos K and L. Post-construction conditions (winter of 2010), showing tilled higher elevations and somewhat smoothed lower elevations
