# Bathymetric change within Alviso Slough as salt pond restoration progresses: 2010 - March 2017

Amy C. Foxgrover, Theresa A. Fregoso and Bruce E. Jaffe **USGS Pacific Coastal and Marine Science Center, Santa Cruz, CA**

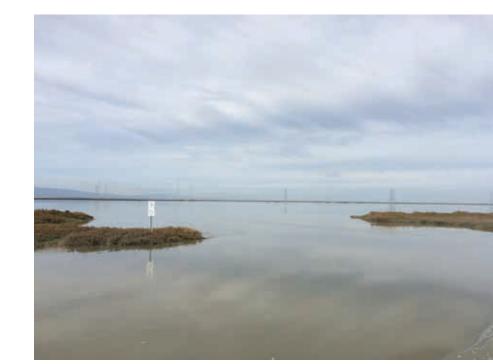
A6 breach at high tide

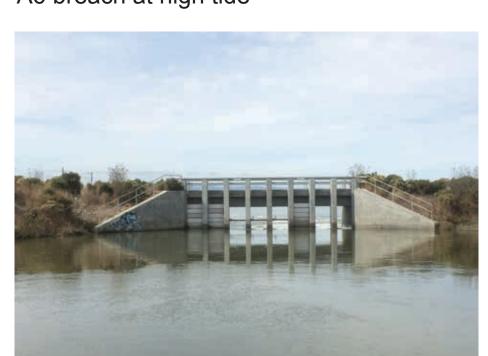
Flow-control structure at pond A8 (A8 notch)
