**ISLAND PONDS MITIGATION
MONITORING AND REPORTING
YEAR 7 – 2012**

January 2013

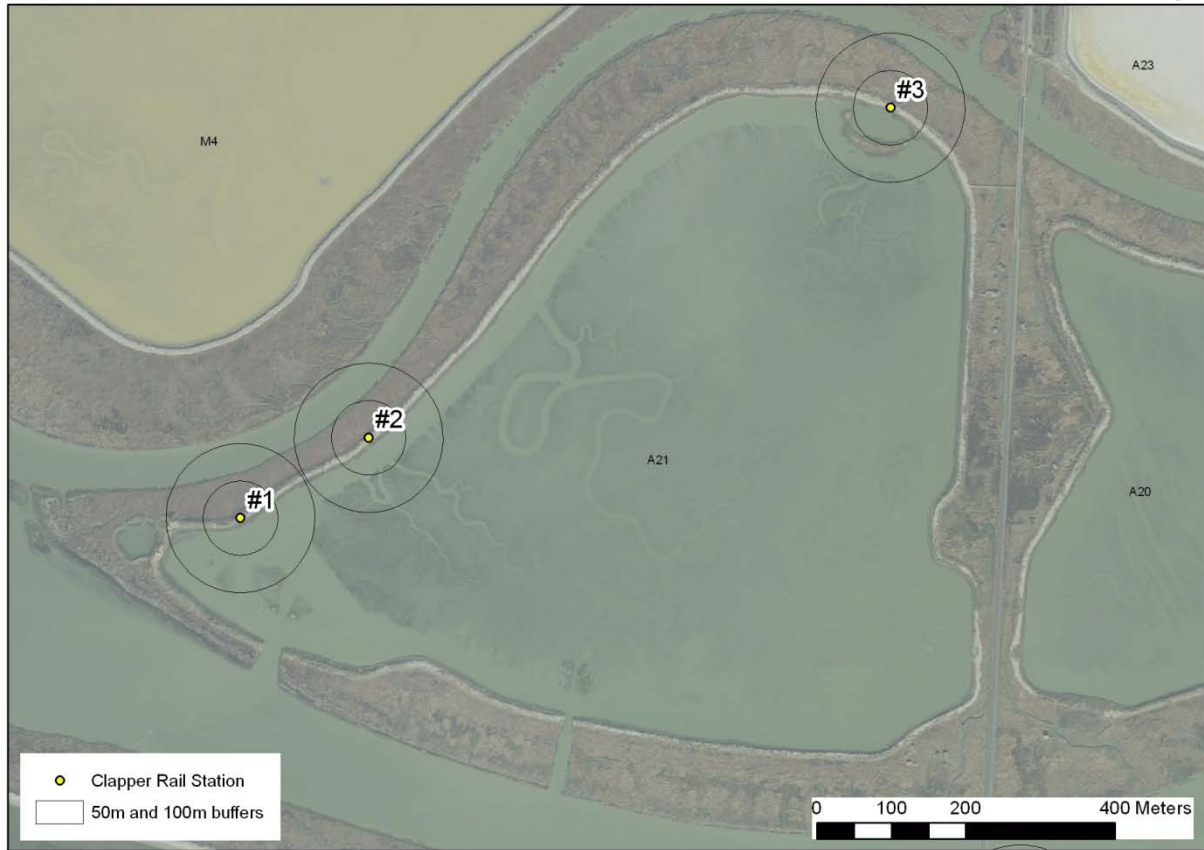
Figure 5. Location of clapper rail call count stations along the levee at Pond A21.

California clapper rail monitoring – The Refuge monitored for California clapper rail within Pond A21 in the spring of 2012 (Figure 5). Call-count surveys were performed using USFWS protocol from levees surrounding the pond on the following dates: 24 January, 24 February, and 4 April. No California clapper rails were heard within Pond A21 or in the surrounding outboard marshes.

Clapper Rail Call Count Stations
A21 #1-3

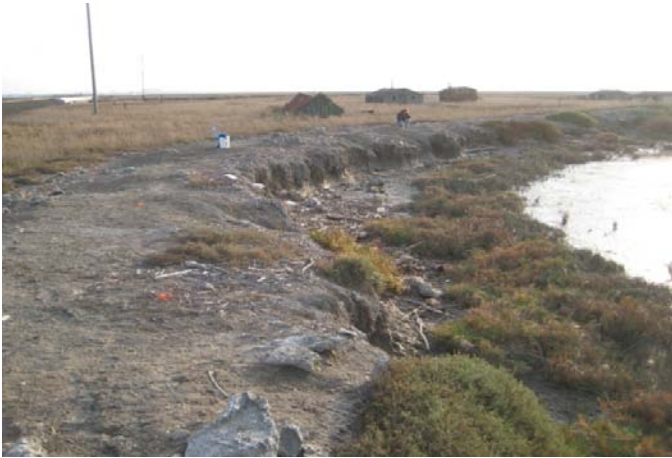
In 2008, field inspectors noted large amounts of debris and litter on top of a section of the Pond A21 levee in the southeast corner, mostly along the marsh vegetation and outboard slope interface. At that time, inspection staff interpreted the deposition of litter and debris as a sign that wave action and wind related run-up had caused floating trash to transfer from the pond area onto the levee surface. To establish an ability to accurately monitor the changes, in December 2008 a surveyed benchmark was installed to assist with collecting surveying measurements at this levee location.

2008 photo of Southeast corner of
Pond A21, looking westerly

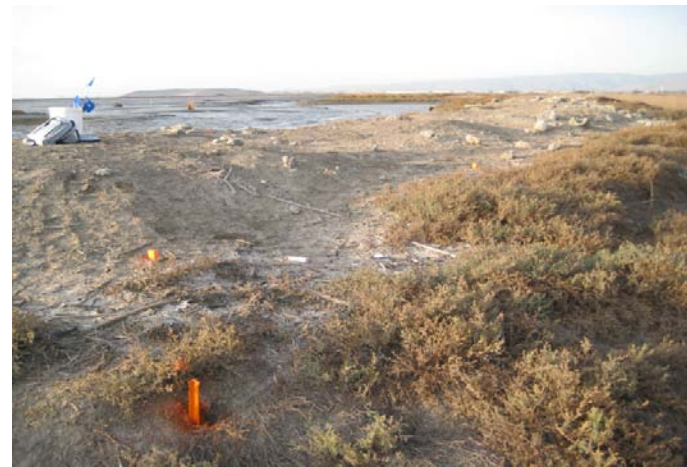
In 2008, a benchmark and location stakes were installed in the southeast corner of Pond A21 to enable more accurate tracking of erosion advancement along this levee which has been seemingly caused by wave action and levee overtopping. An elevation was assigned to the benchmark which references the northwest abutment of the Coyote Creek railroad bridge. (The top of the benchmark is 4.55 ft lower than the bridge abutment.) Location stakes were installed to form a series of eight cross sections along the top of the levee and baseline elevations were gathered immediately adjacent to each stake. Annual site visits obtain elevations at each stake and document any changes.

2008 photo of Benchmark "T-stake"
location lkg northerly

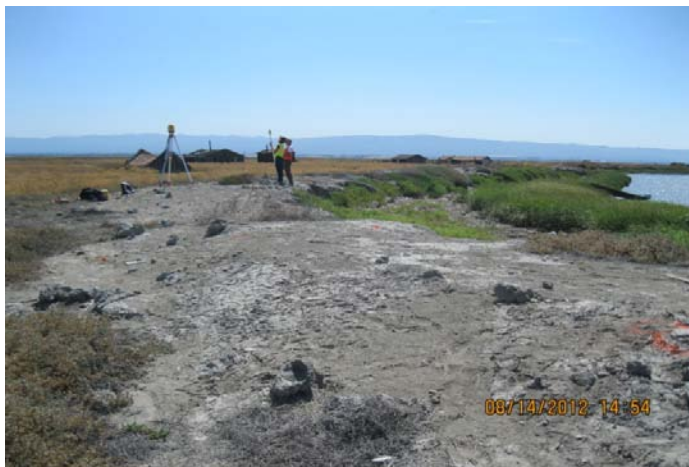
comparison of the data collected in August 2012, October 2011 and December 2008 shows minor, yet consistent degradation of the height of levee surface, averaging less than 2 inches of lost levee material. Lateral measurements taken at this location show continued loss of earthen material along the inboard slope of Pond A21. This inboard levee slope consists of a vertical edge, approximately 2 - 3 feet in height, with debris, slumped material, and newly growing pickleweed along the toe. The offset measurements taken in this location show an overall reduction in total levee width of a couple of inches to over a foot at one cross section during the last ten months. The total loss of levee width at the eight survey locations since 2008 ranges from one foot to almost 4 feet at one of the cross sections.

These measurements confirm the trend shown in previous surveys that the width of the pond levee is decreasing over time, with most locations experiencing more than two feet of lost girth since 2008. At this time, the levee doesn't appear to be at risk of failure, but future evaluations should continue until the data indicates the situation is stable.

2012 photo looking westerly
along levee towards stations 4, 3, 2, and 1

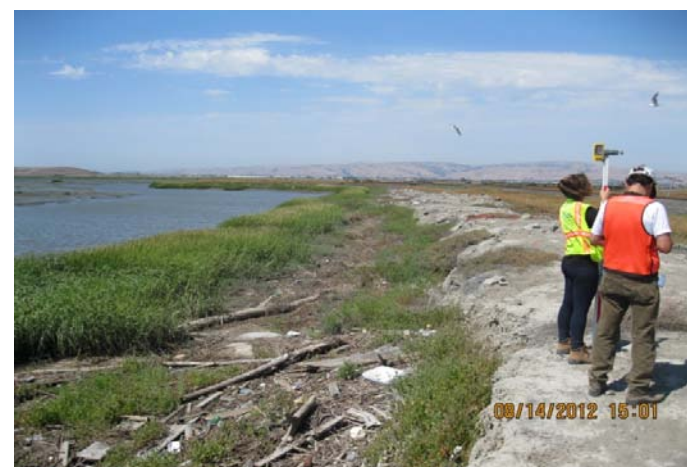
2012 photo looking northerly
notice extensive vegetation along inboard area
