Introduction

In 2010 the USGS mapped the bathymetry in the vicinity of the Alviso Pond complex including the main channel of South Bay, shallow intertidal mudflats, and Alviso and Guadalupe Sloughs to establish baseline bathymetry prior to the breaching of Pond A6 levees and opening of gates at Pond A8 (Foxgrover et al., 2011). Interferometric sidescan swath mapping was used to generate high resolution (1 m cell size) bathymetric grids of the far South Bay extending east of Calaveras Point to where Coyote Creek meets the railroad bridge, and down Alviso Slough to just past the A8 notch. Since 2010 we have conducted five additional surveys to monitor bathymetric change in this region as restoration progresses. Our next survey is scheduled for October 2013.

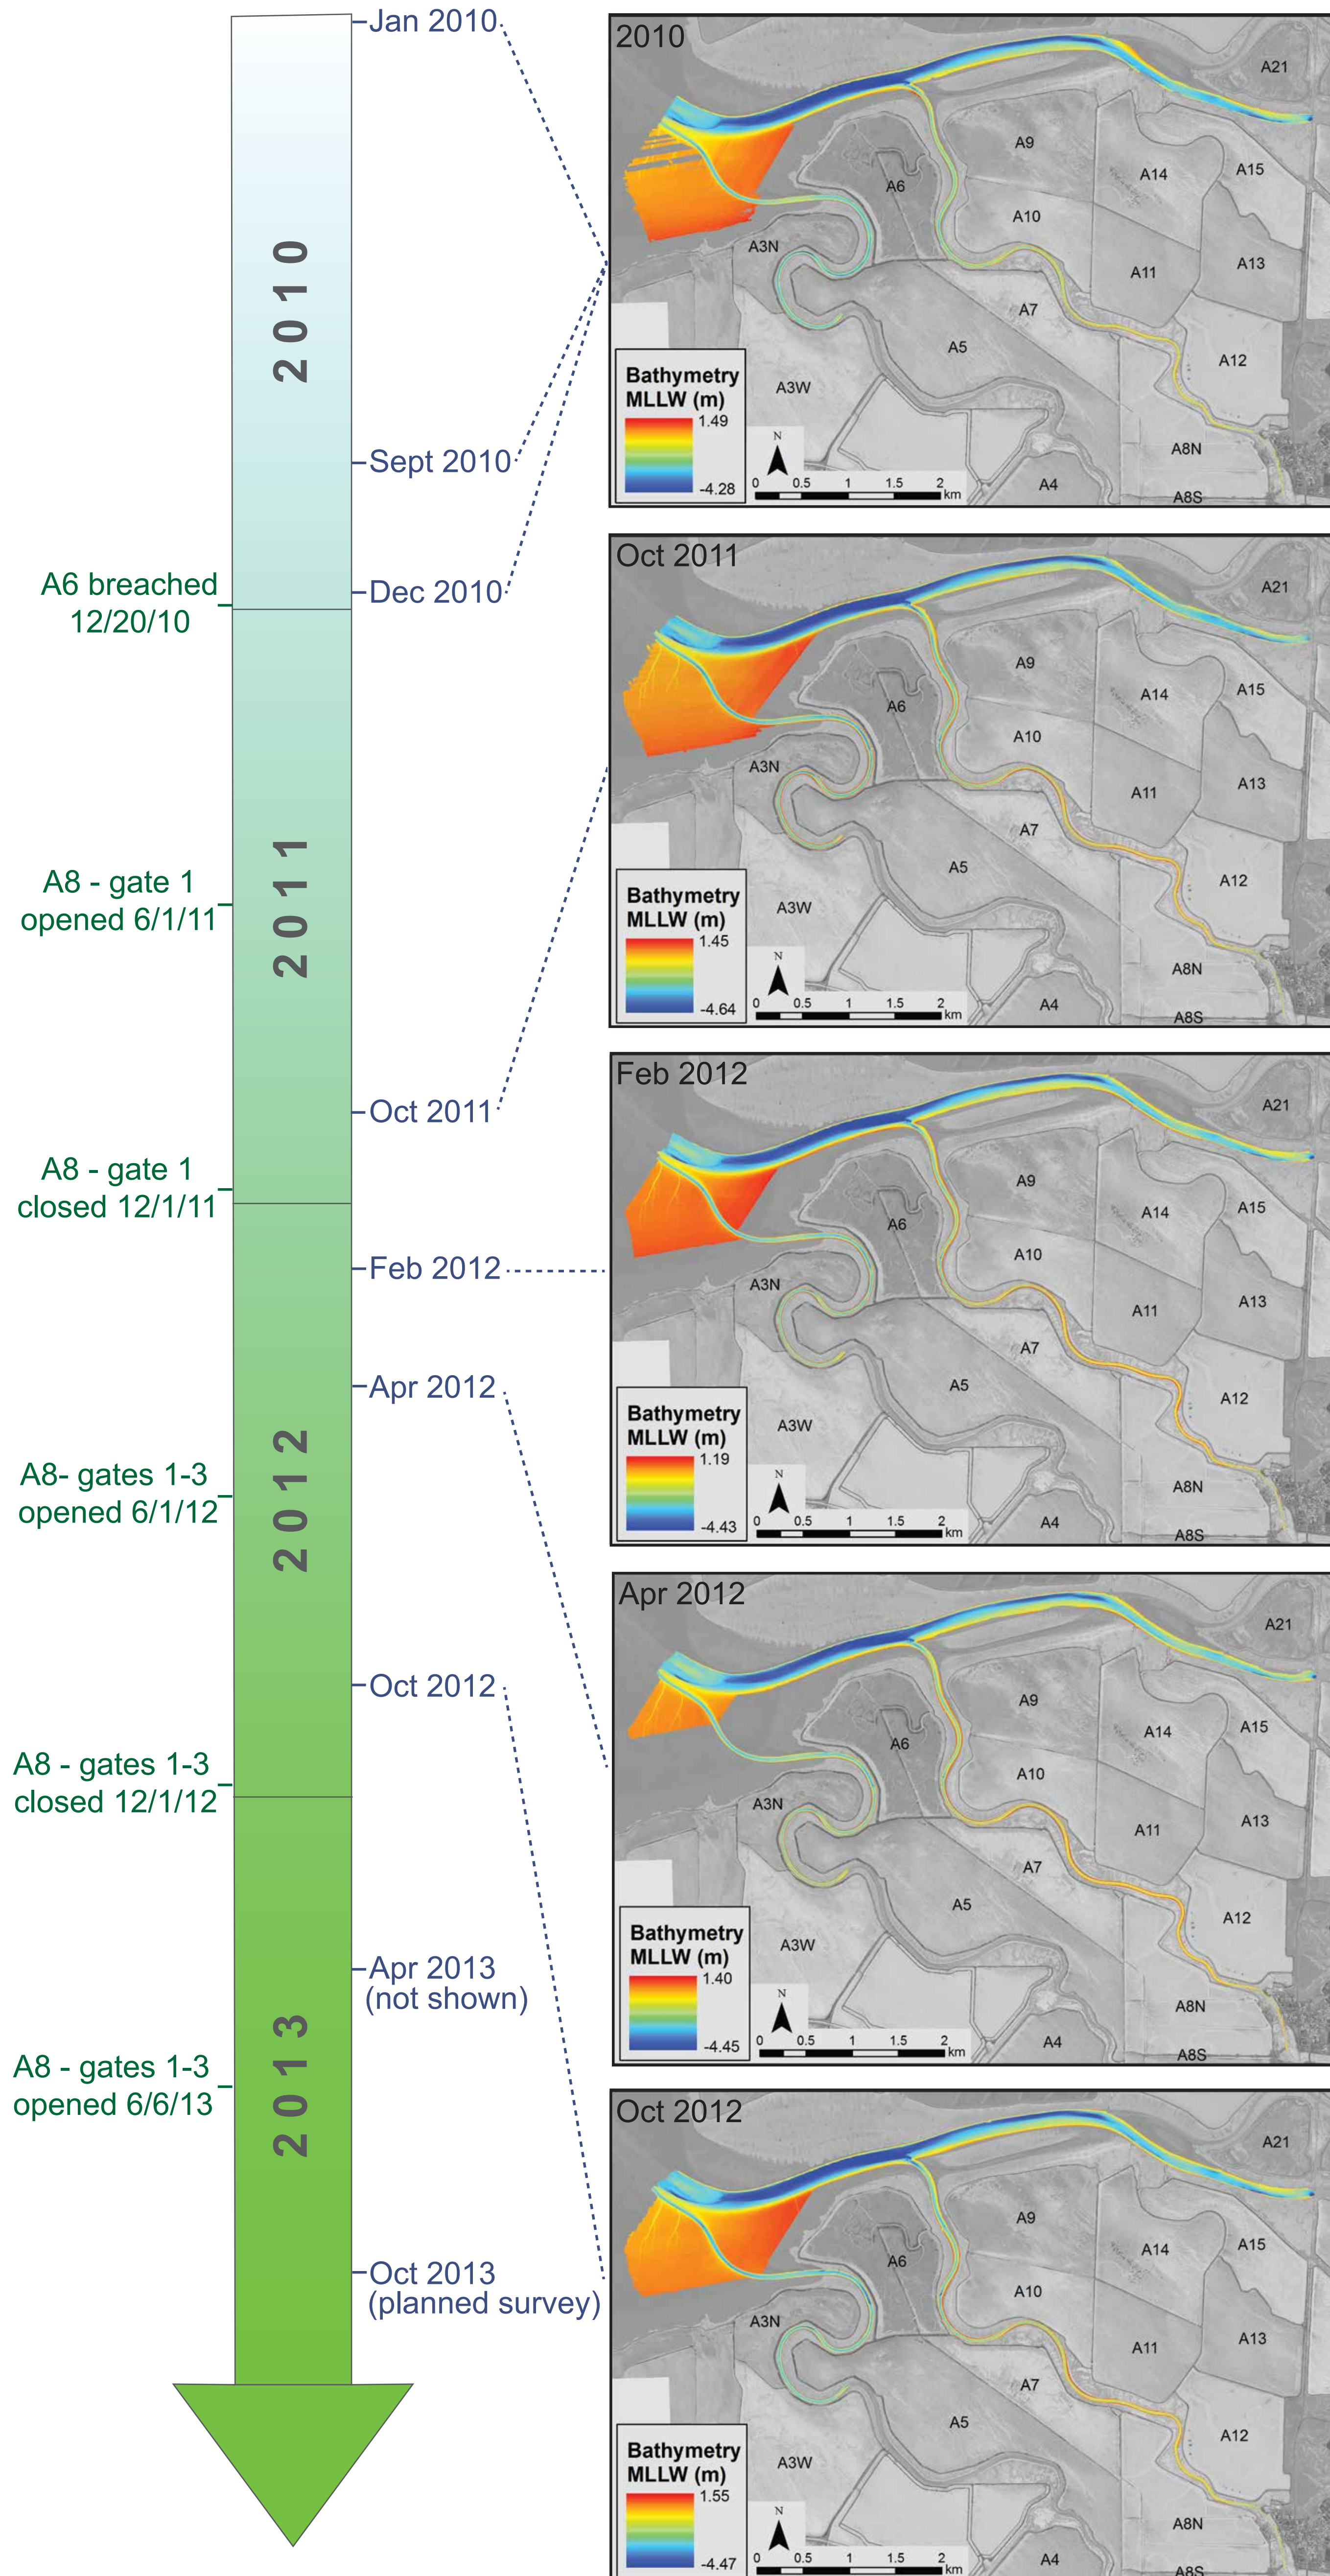
restoration activities

bathymetry surveys

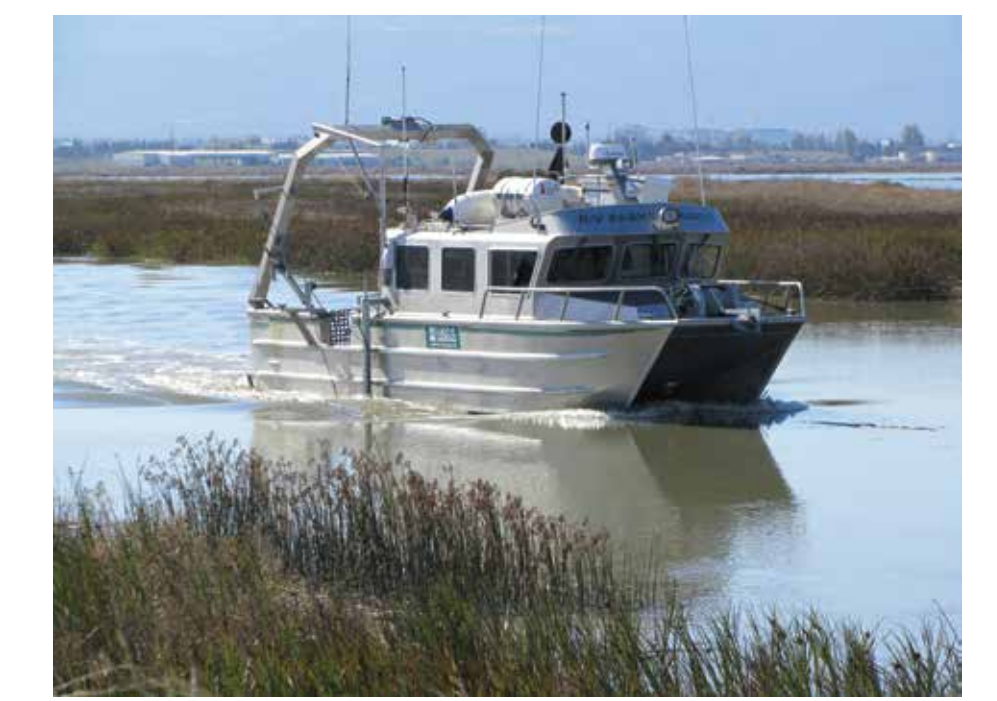
collecting swath bathymetry in Alviso Slough

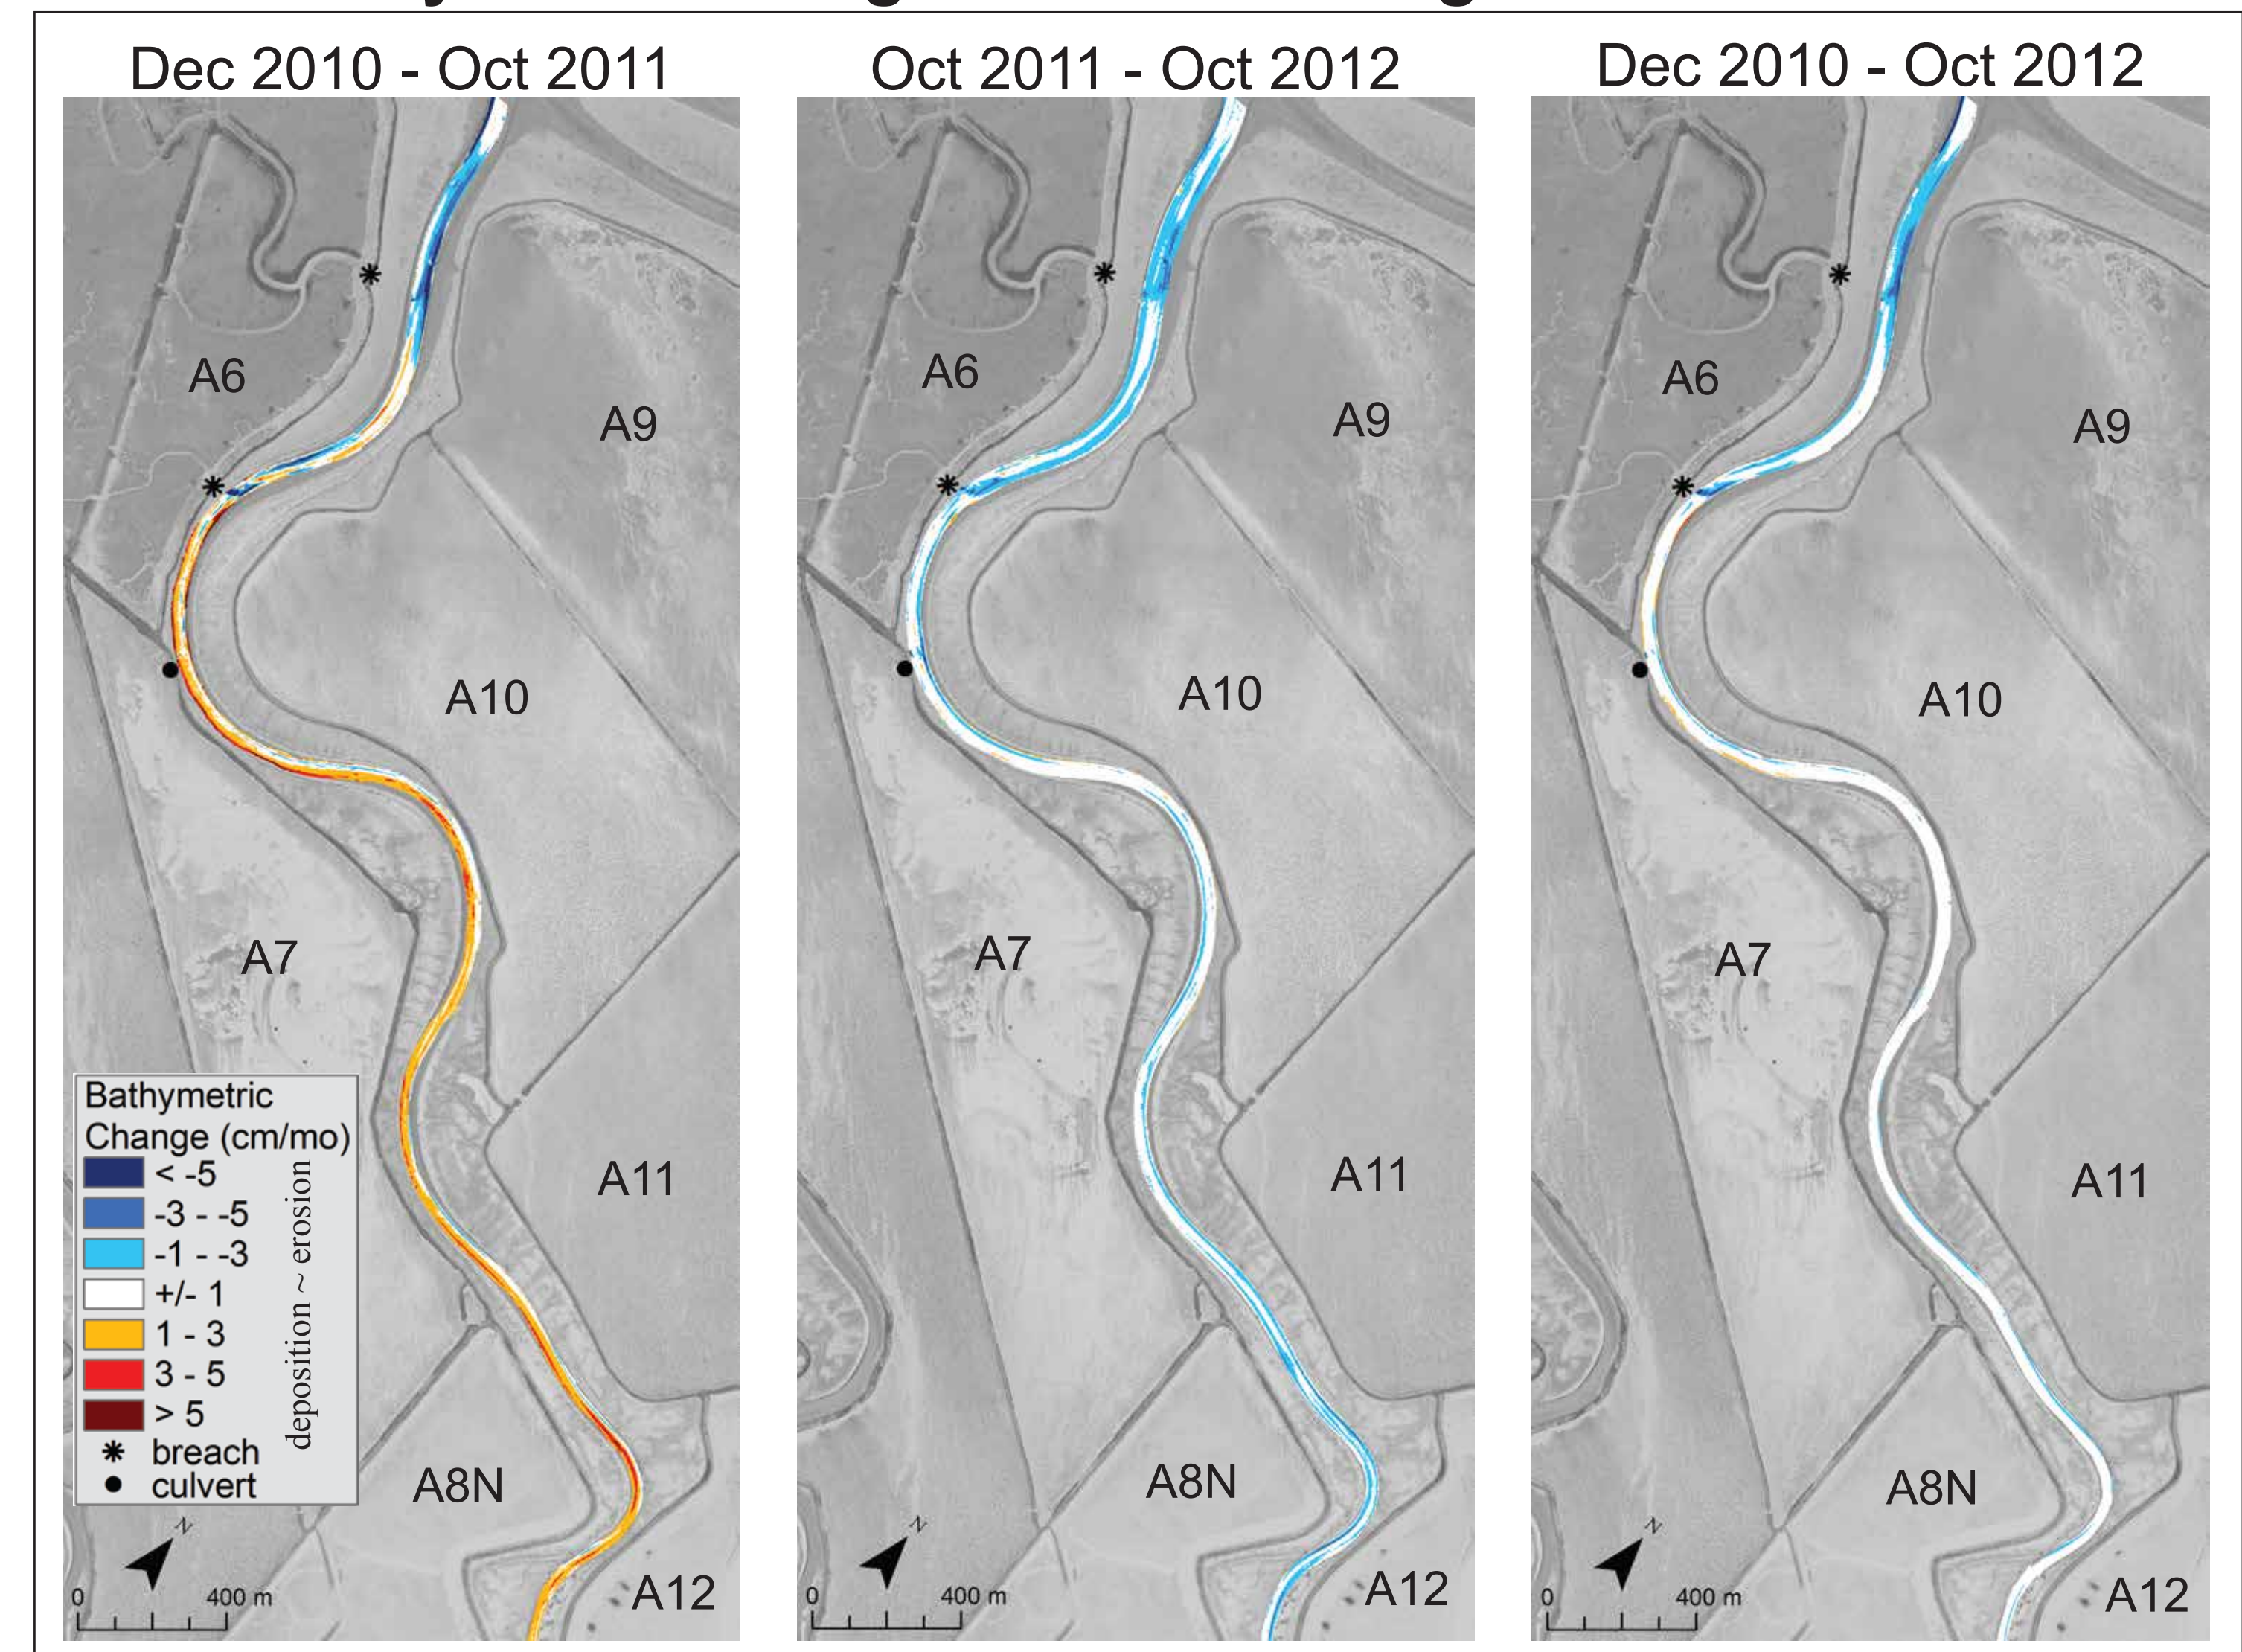
rate of bathymetric change in Alviso Slough

The greatest erosion has occurred within Alviso and Guadalupe sloughs bay-ward of the southern A6 breaches. Erosion on the order of 20+ cm dominates these reaches of the sloughs, and localized erosion directly adjacent to the breaches exceeds 75 cm. Changes within the sloughs south of the A6 breaches are more subtle and largely depositional. A major concern with restoration activities is whether or not the breaching of A6 levees would cause erosion of the adjacent intertidal flats, so far this has not been the case.

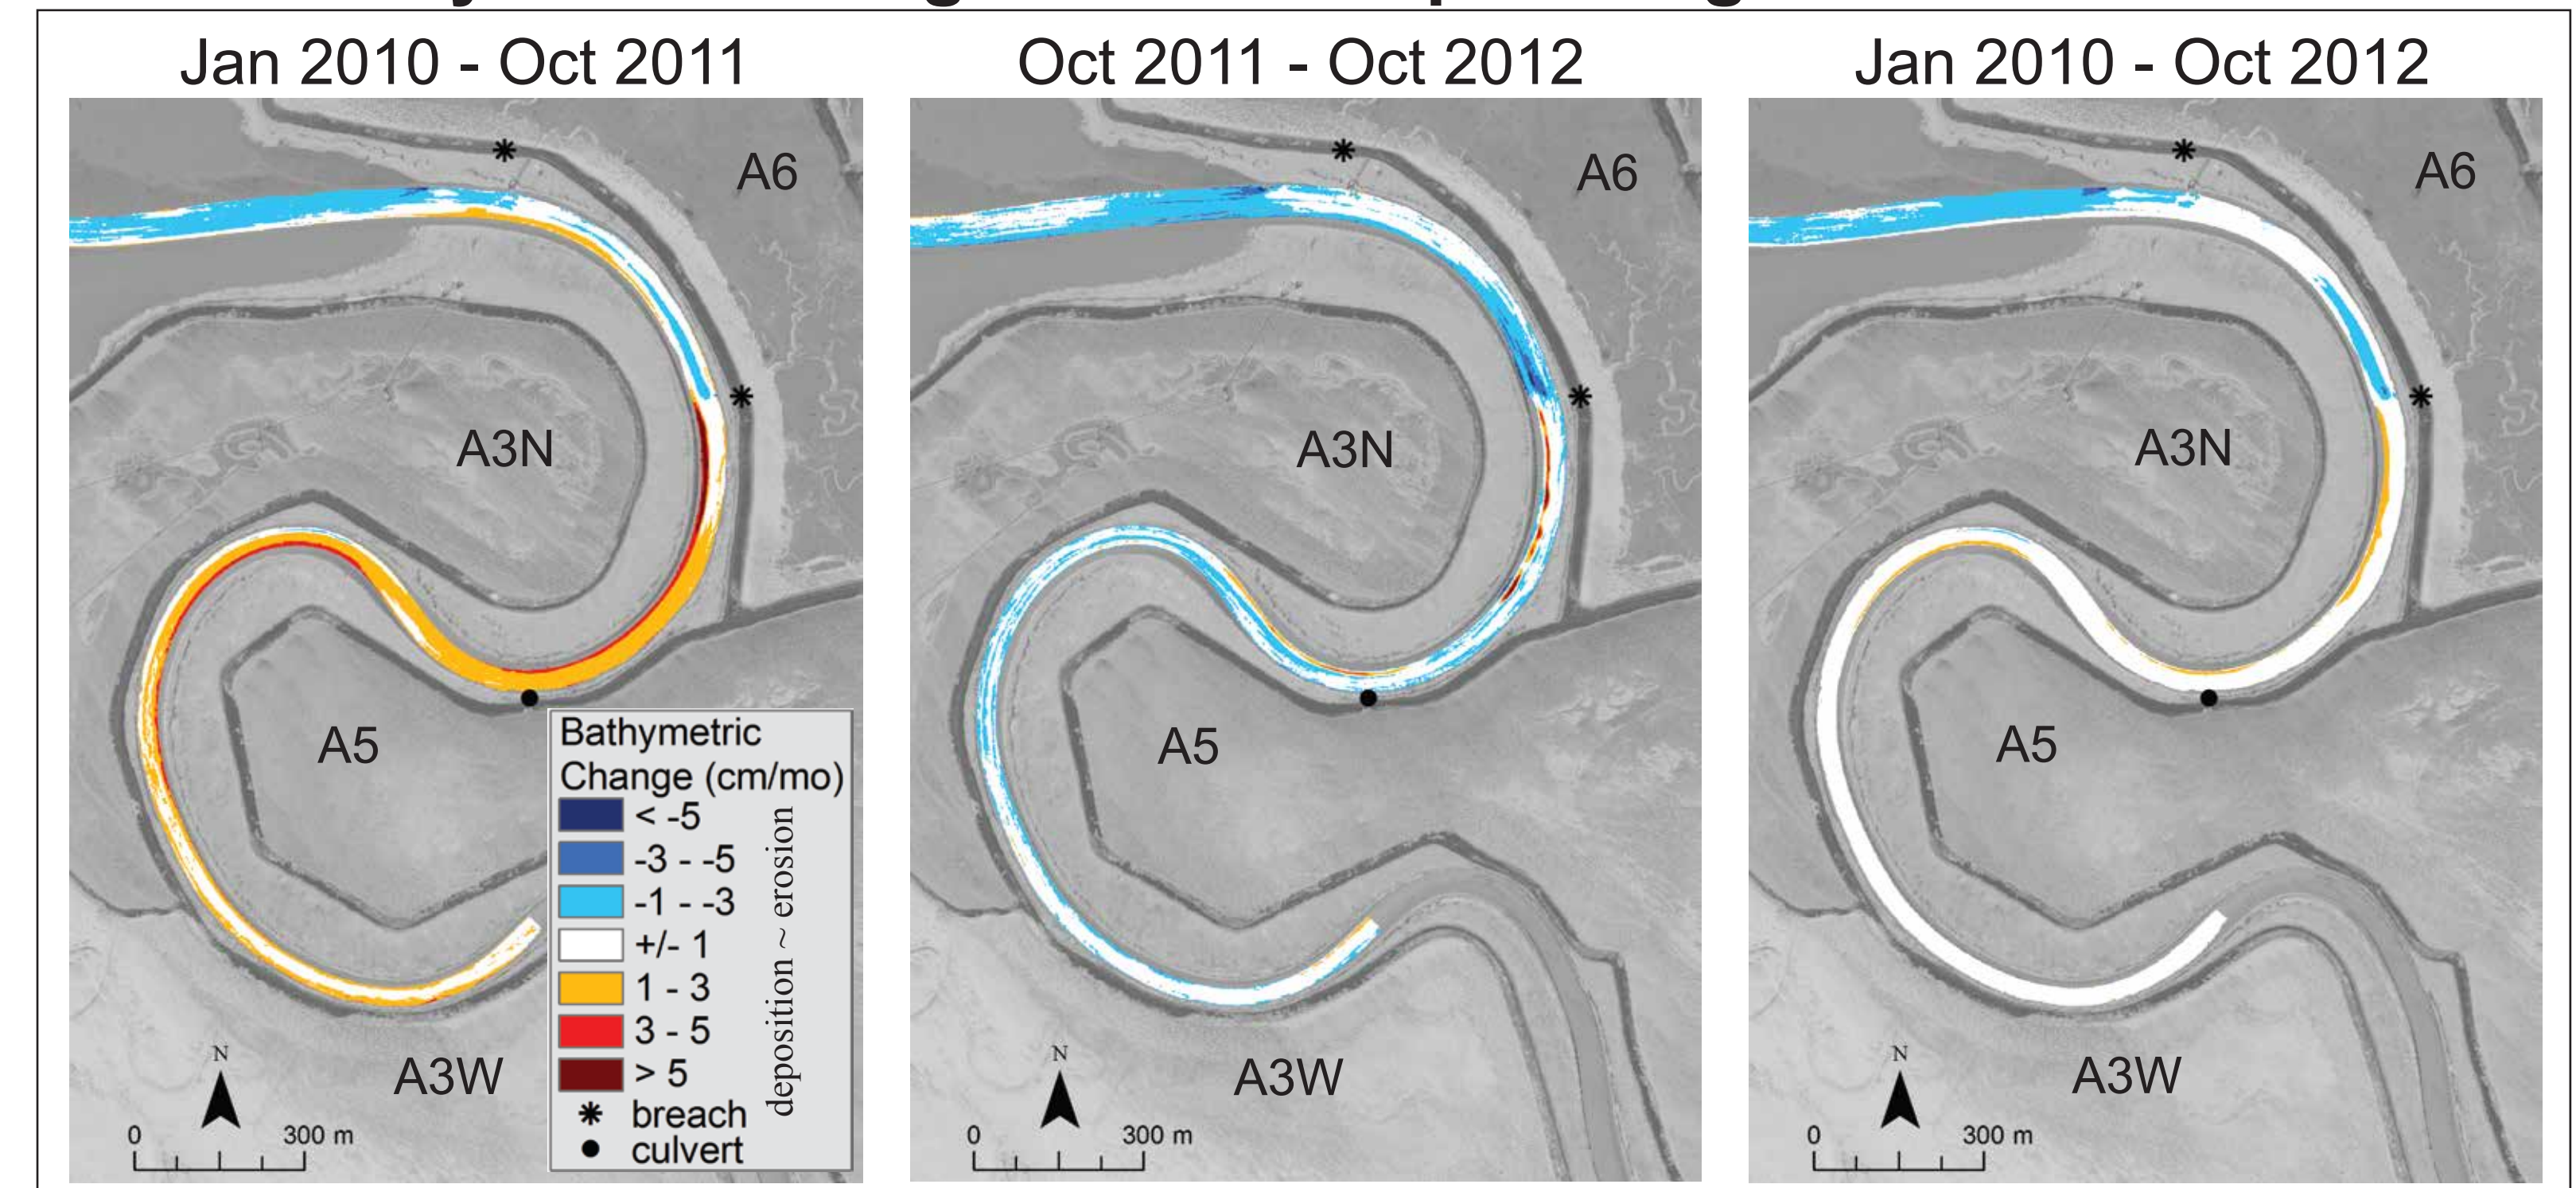
rate of bathymetric change in Guadalupe Slough
