# Ravenswood Pond Restoration Surface Elevation Tables-Marker Horizon Monitoring

Summary Report 2023-2025

January 13, 2026

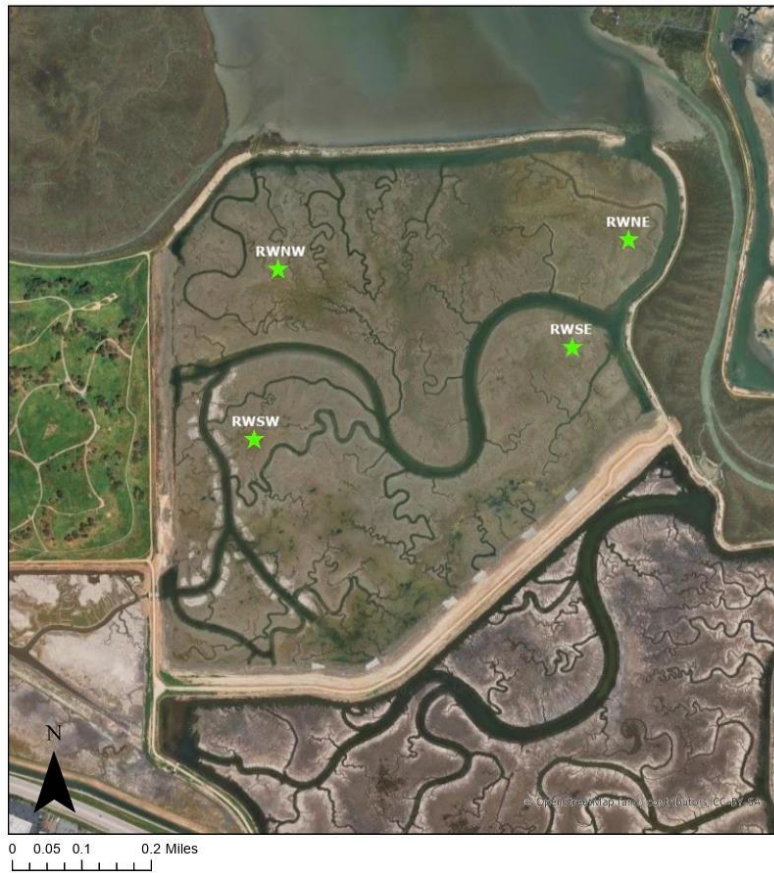
**Figure 2.** SET-MH plot locations in Ravenswood Pond R4 restoration. The site was breached to bay tidal waters in the northeast corner.

In early December 2023, we installed deep SET-MH plots (n=4) to quantify the relative contributions of surface and subsurface processes to vertical accretion and elevation change at four distinct locations within Ravenwood (Figure 2), prior to the pond being breached to bay waters on 12/13/2023. The plot locations were selected to achieve spatial coverage of the site. Prior to breach, the soil surface was covered by a thick salt crust and was unvegetated (Figure 3). Plots were surveyed for initial elevation using a Leica Viva Real Time Kinematic (RTK) Global Positioning System (GPS) rover with real-time corrections (SmartNet North America, accuracy  $\pm 1$  cm x, y;  $\pm 2$  cm z; Leica Geosystems Inc., Norcross, GA, Table 1). Plots will continue to be surveyed for elevation annually. A Solinst Levellogger 5 LTC was installed in the channel between RWNE and RWSE to collect time series data on water level, temperature and salinity for one year. Vegetation development is monitored at each SET-MH measurement. During readings, percent cover and average height of vegetation is recorded at the plot level and in three additional 1 m<sup>2</sup> quadrats.

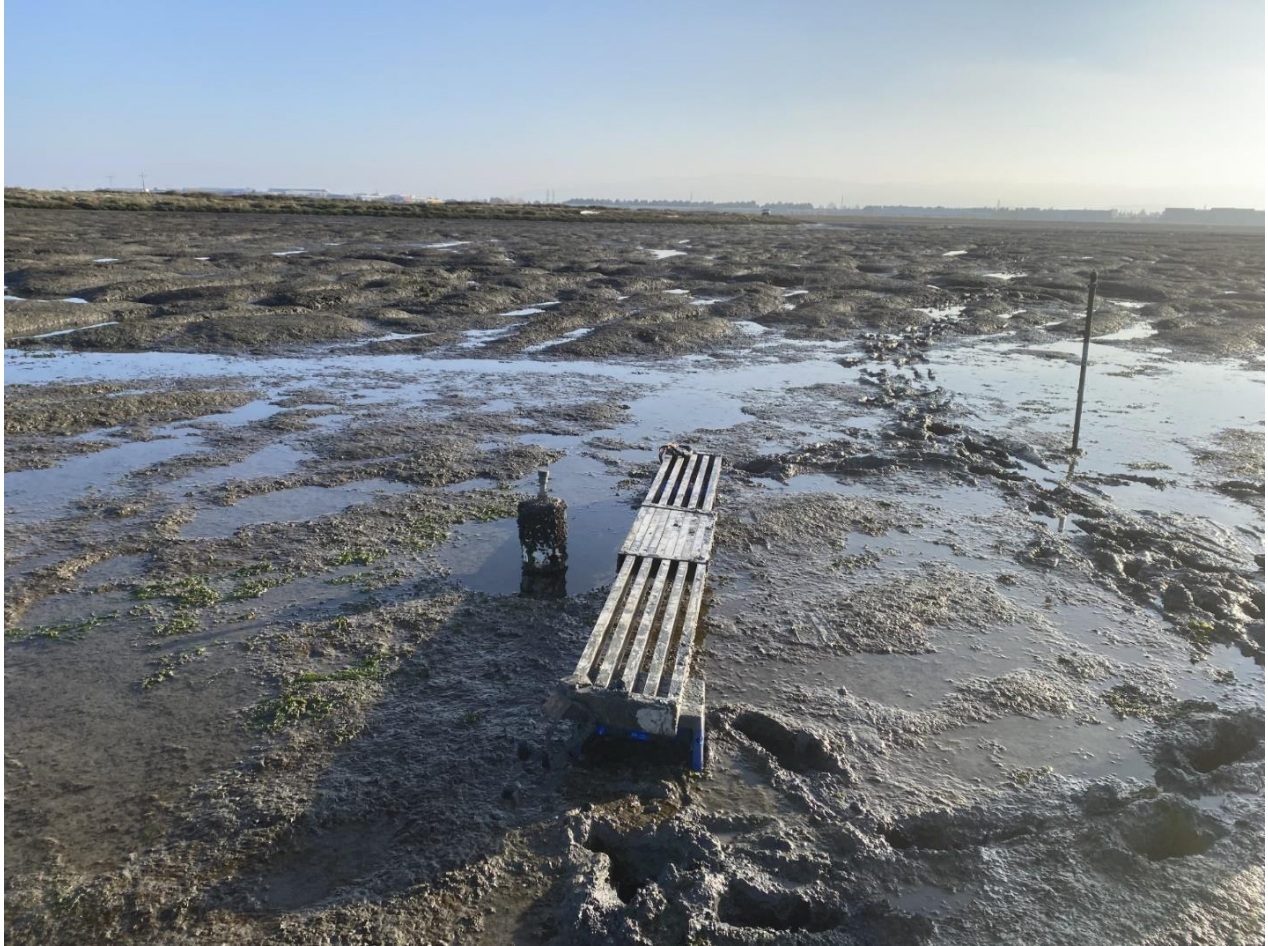
Feldspar plots at all SET-MHs have not been located since breach, possibly eroded from high water velocities. Two years post-breach, the topsoil layer is no longer a salt crust, and the site is now covered in a thin mud layer (Figure 6).

**Figure 6.** Photo of a SET-MH plot in Pond R4 approximately one-year post-breach. Feldspar plots have not been located at any SET-MH location. All SET-MH plots remain unvegetated, but algal mats have been observed

- Visible and measurable change has occurred at Ravenswood Pond R4 since the site was breached to tidal waters. Elevation change across the site shows positive elevation gains in the western area of the site, and elevation loss near the breach, potentially caused by water velocities during breach or thereafter.
- The restoration has a seasonal patterns of water salinity and tidal cycles.
- Wetland vegetation is not present at SET-MH plots, but cyanobacteria have begun to colonize and is an indicator of succession and is an early colonizer for vegetation establishment.
- USGS plans to re-install marker horizons and employ alternative methods if necessary in fall 2026.
