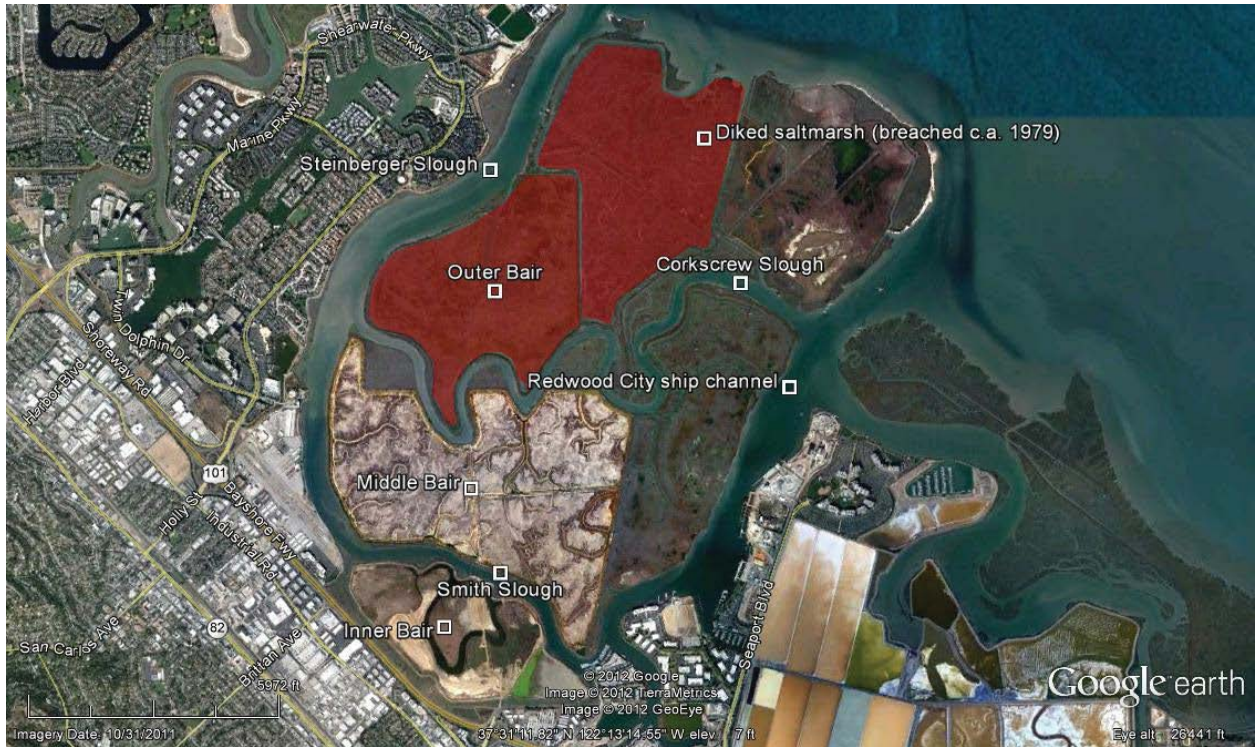
Figure 3a. Bair Island Marsh Complex and adjacent sloughs. Breached ponds are shaded red.
