South Bay Salt Pond Restoration Project

URBAN LEVEE FLOOD MANAGEMENT REQUIREMENTS

DRAFT
(March 2004)

MOFFATT & NICHOL ENGINEERS

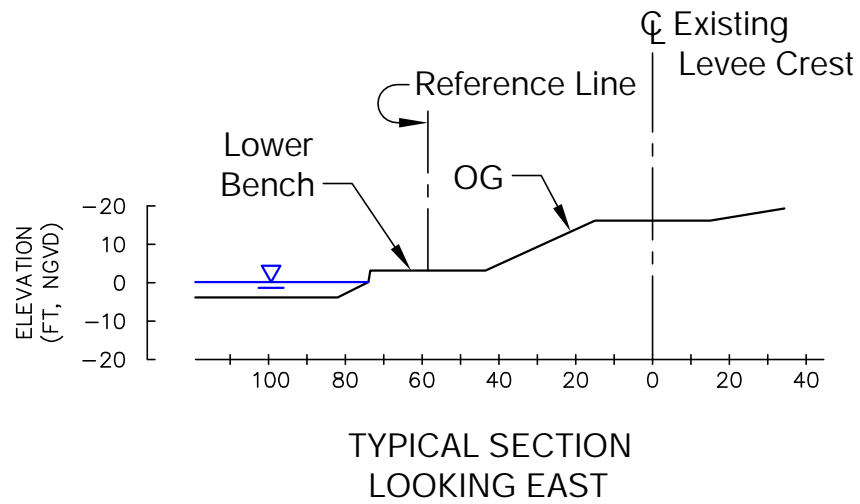
STATION 20+00±
LOOKING EAST

POND A2W

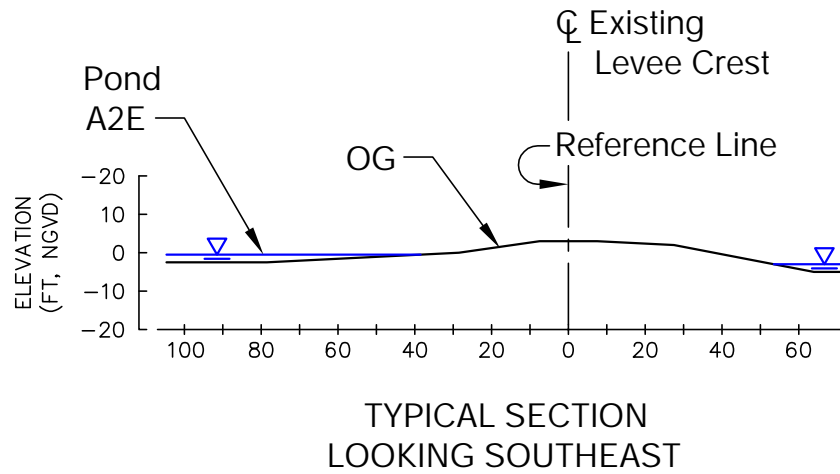
STATION 45+00±
LOOKING SOUTHEAST

POND A2E

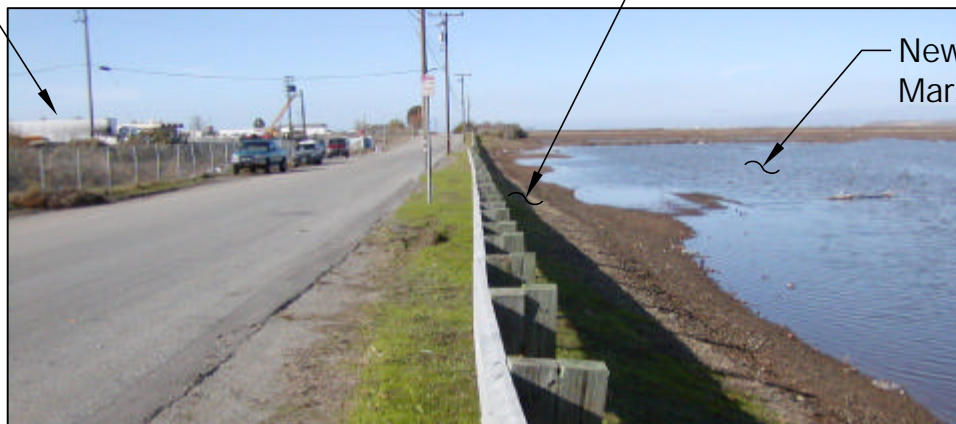
STATION 56+00±
LOOKING NORTH

Note: Reference Line location does
not appear in photo.

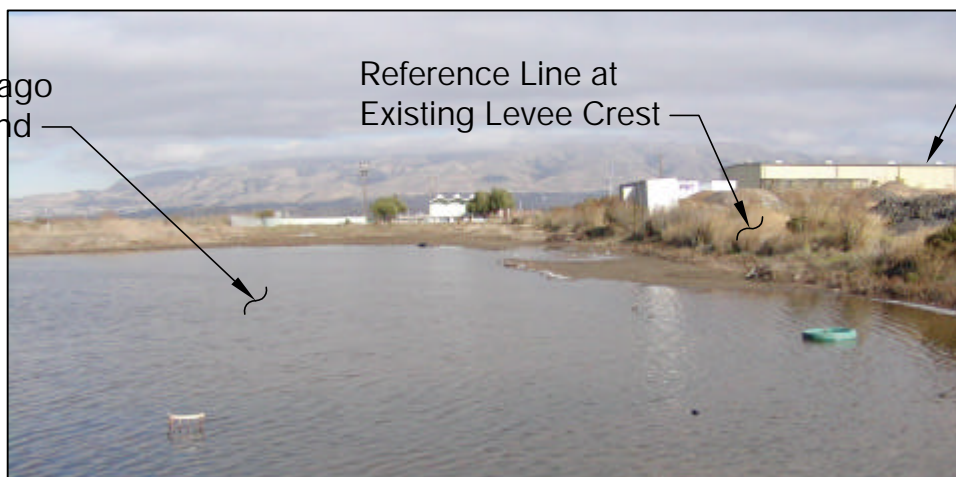
STATION 47+00±
LOOKING EAST

NEW CHICAGO MARSH

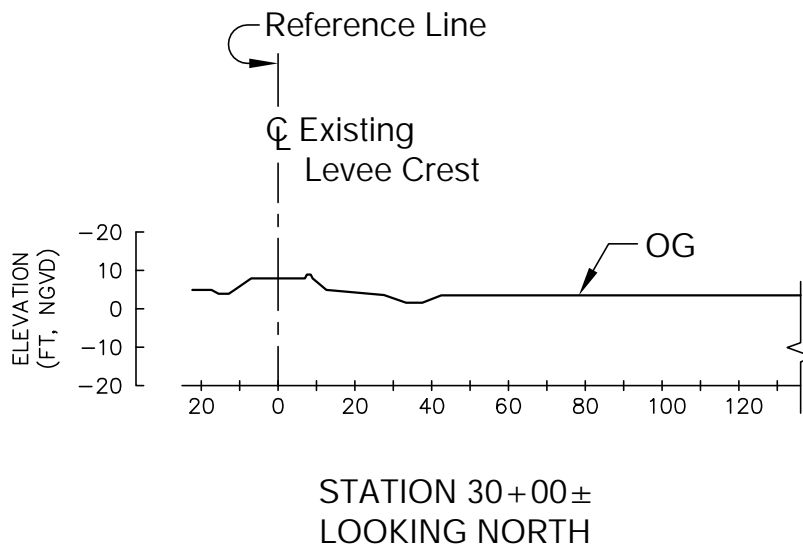
STATION 30+00±
LOOKING NORTH

POND A22

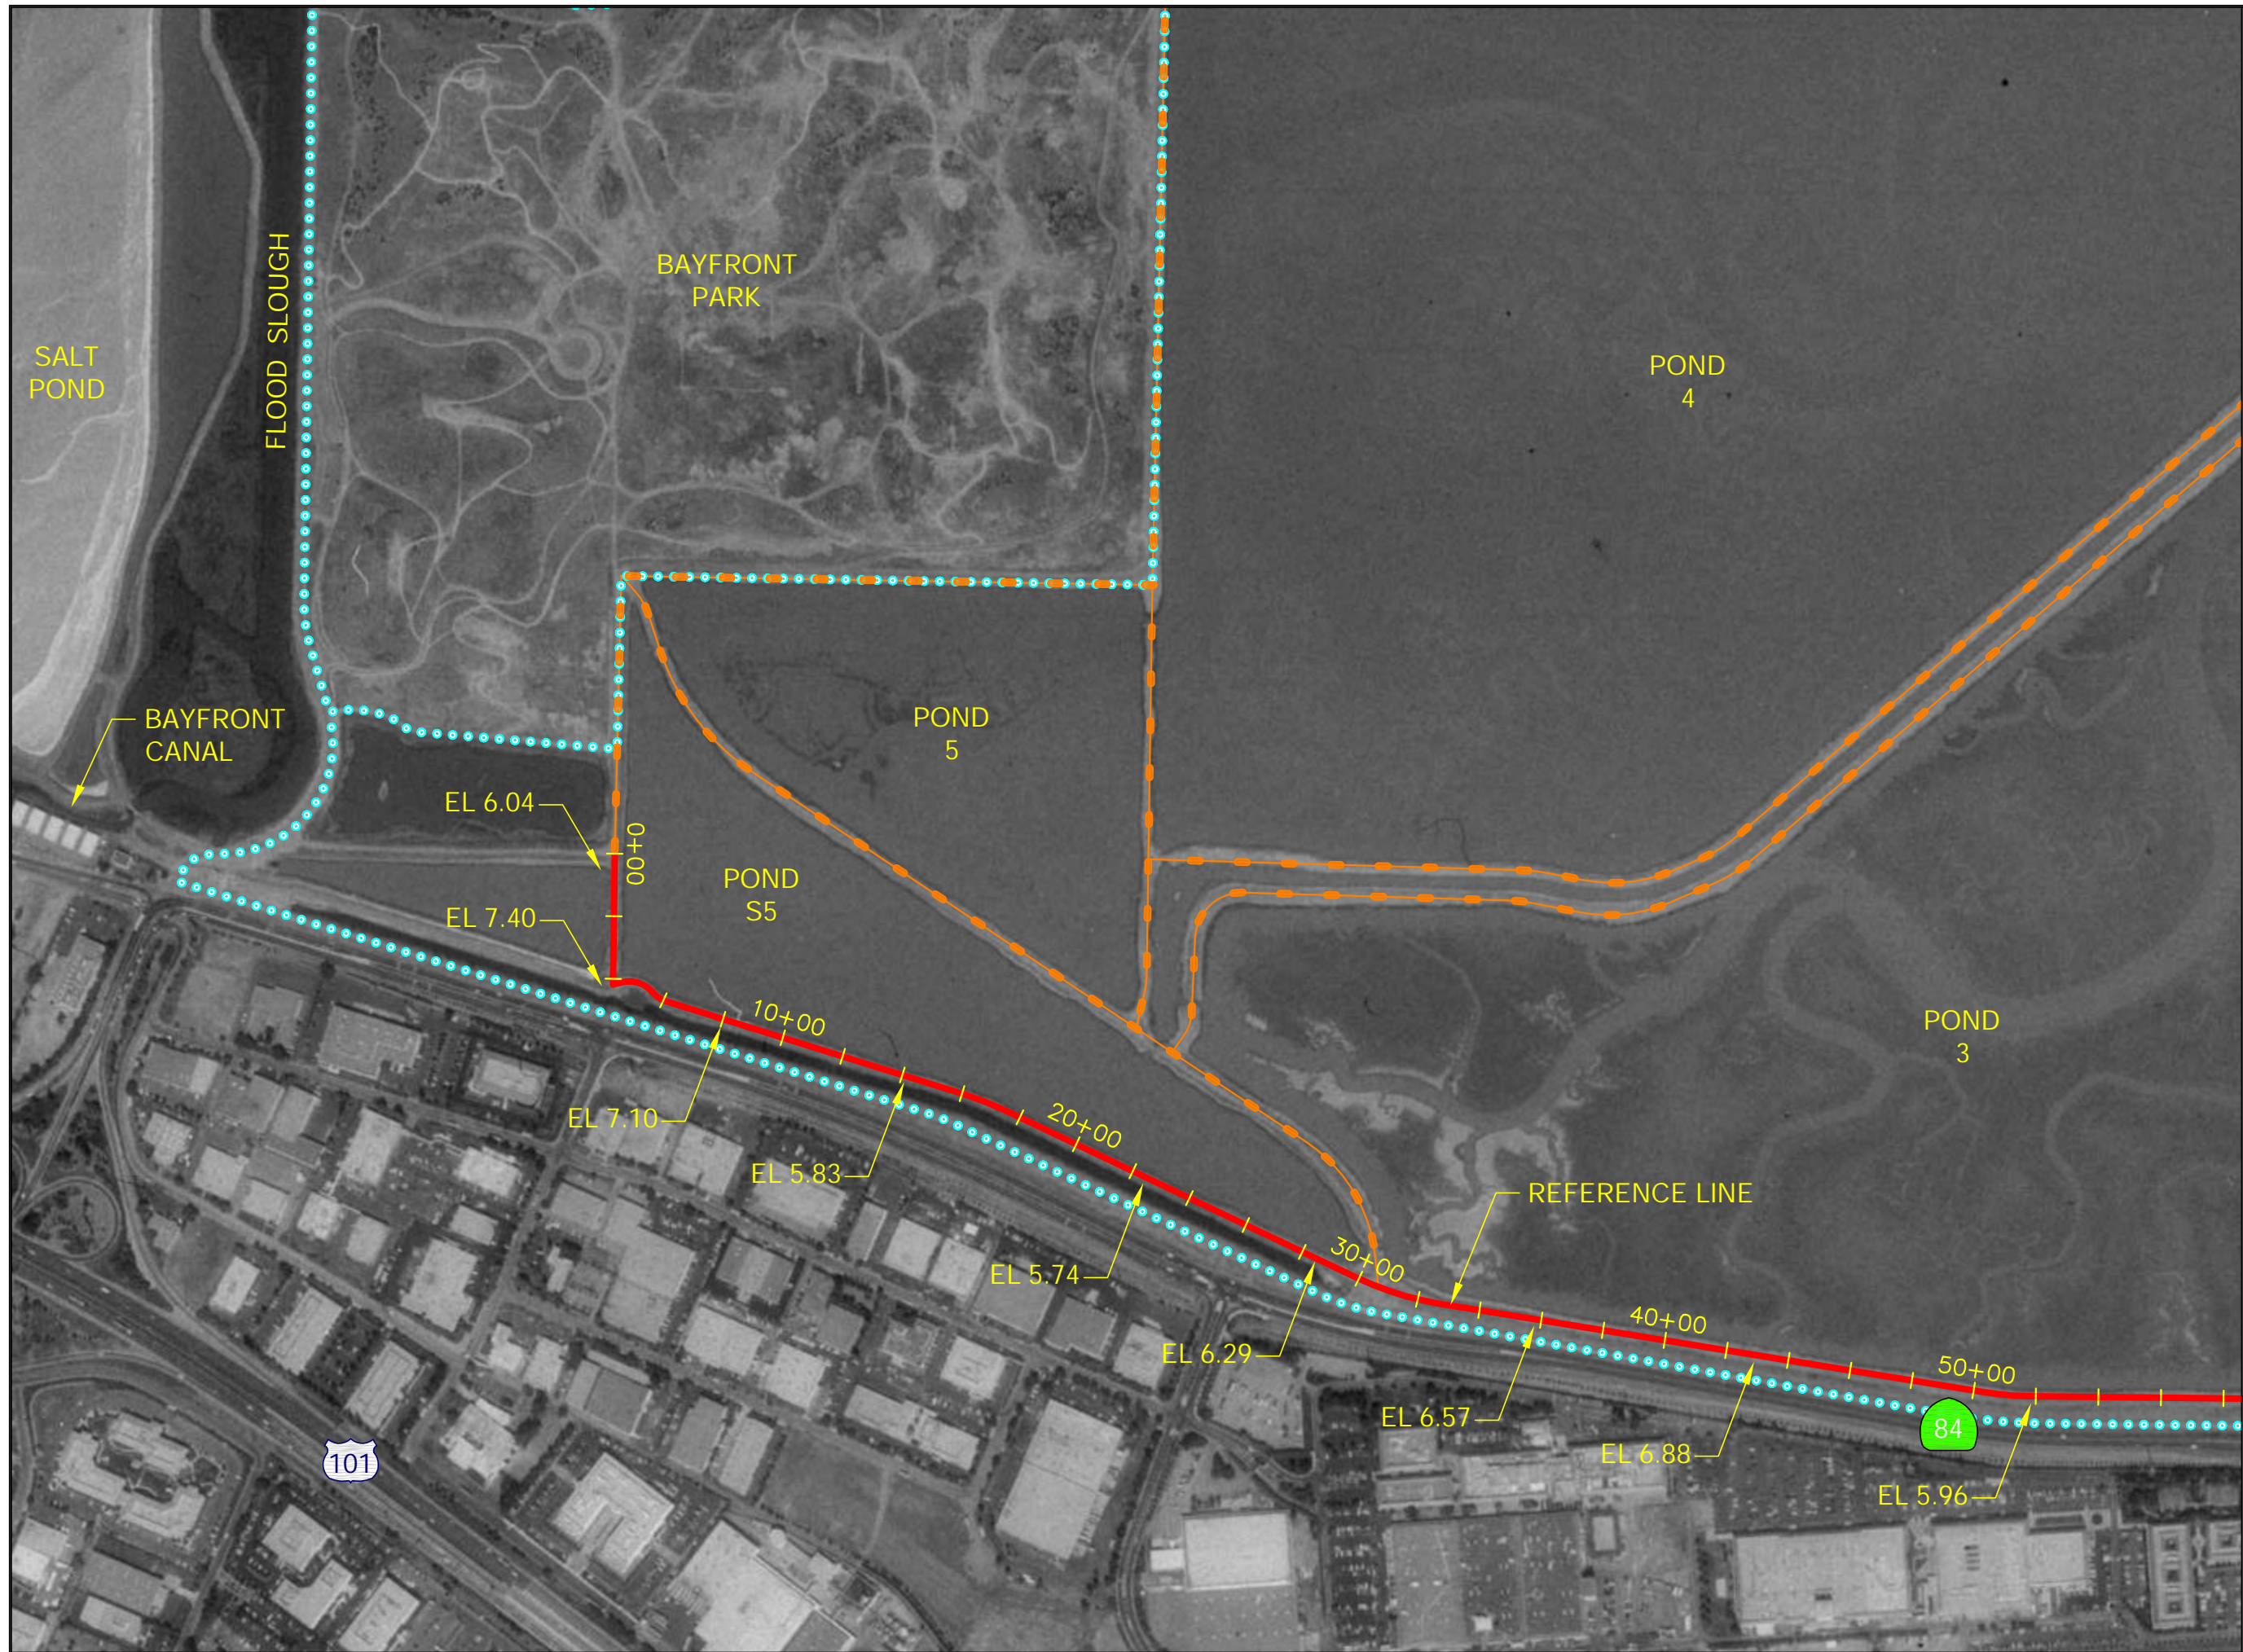
Figure 3.4.2a shows the pond, the surrounding area, and the reference line. The pond is bounded by a drainage ditch (Bayfront Canal) and Highway 84 to the south, other ponds to the north and east, and County property to the west where a pump structure exists. Figure 3.4.2b shows a cross-section through this portion of the levee. The pond was dry during the site visit and crystallized salt was observed on the surface.

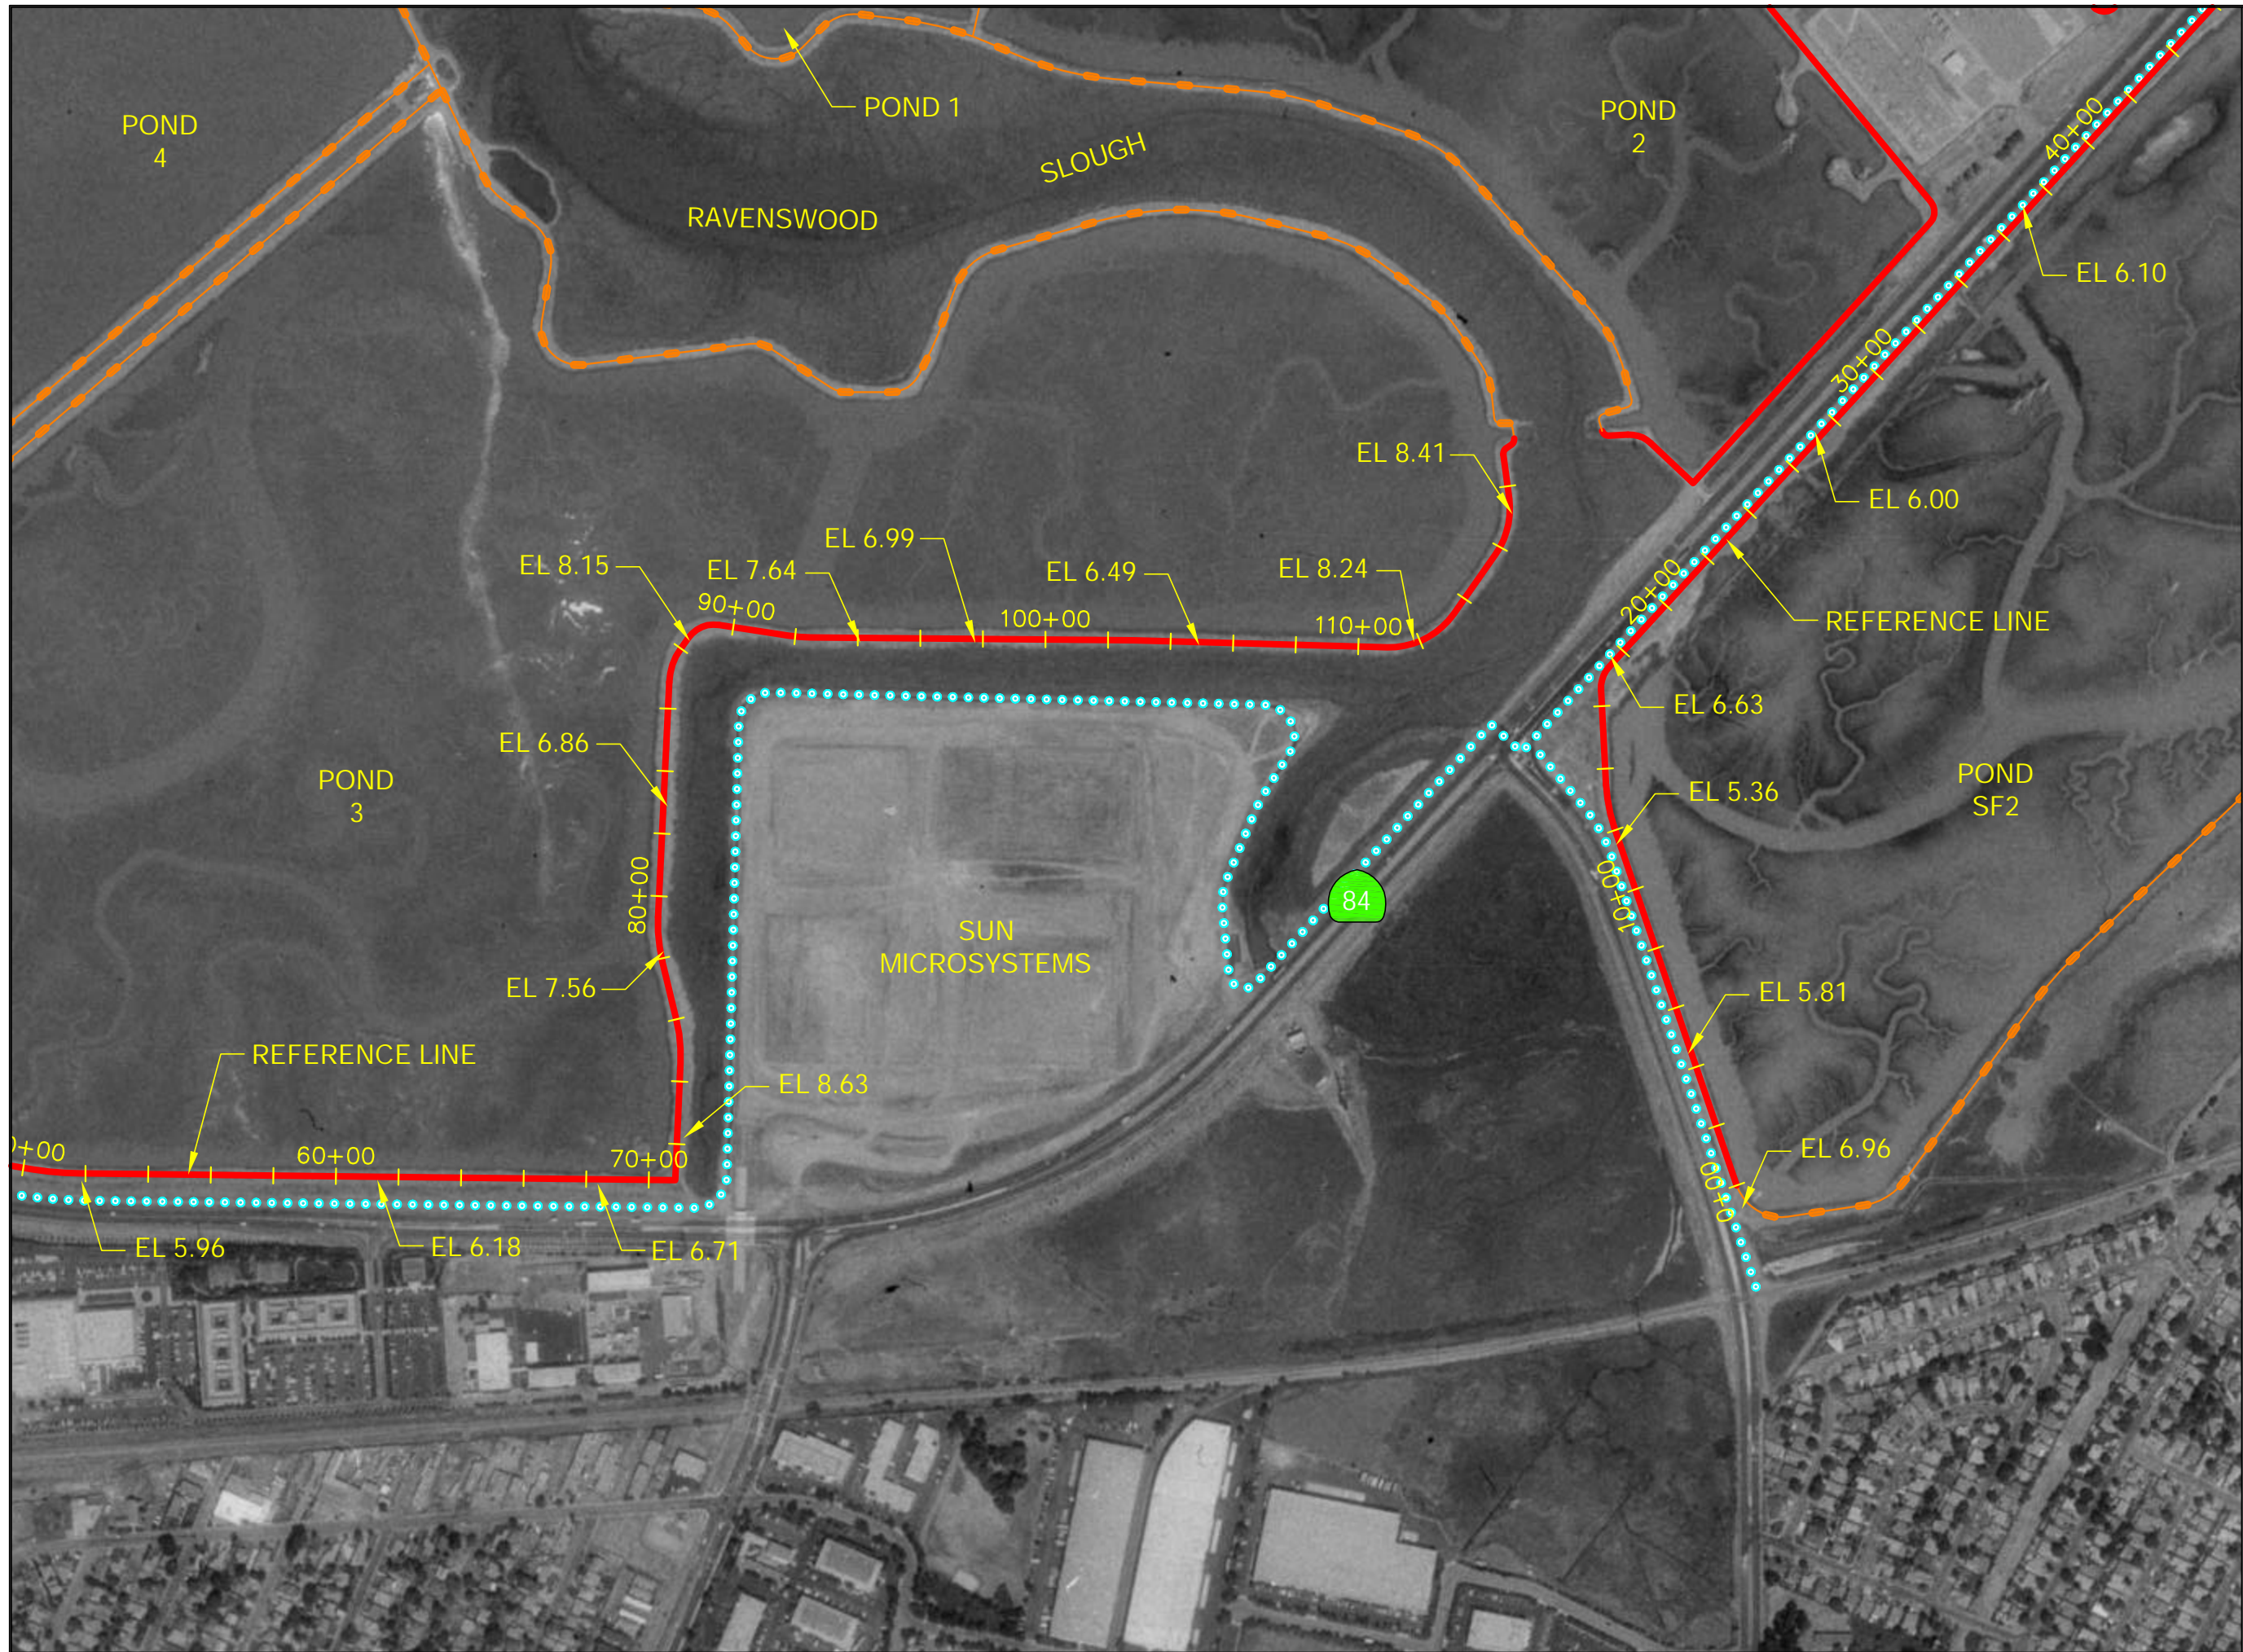
Figure 3.4.2c shows the pond, the surrounding area, and the reference line. The pond is bounded by Highway 84 to the south, Ravenswood Slough to the northeast, other ponds (ponds 4 and S5) to the northwest and west. Figure 3.4.2d shows a cross-section through the portion of levee fronting Highway 84. The pond was dry in many areas during the site visit, and a significant amount of crystallization of salt was observed on the surface.

STATION 14+00±
LOOKING EAST

WEST BAY POND S5

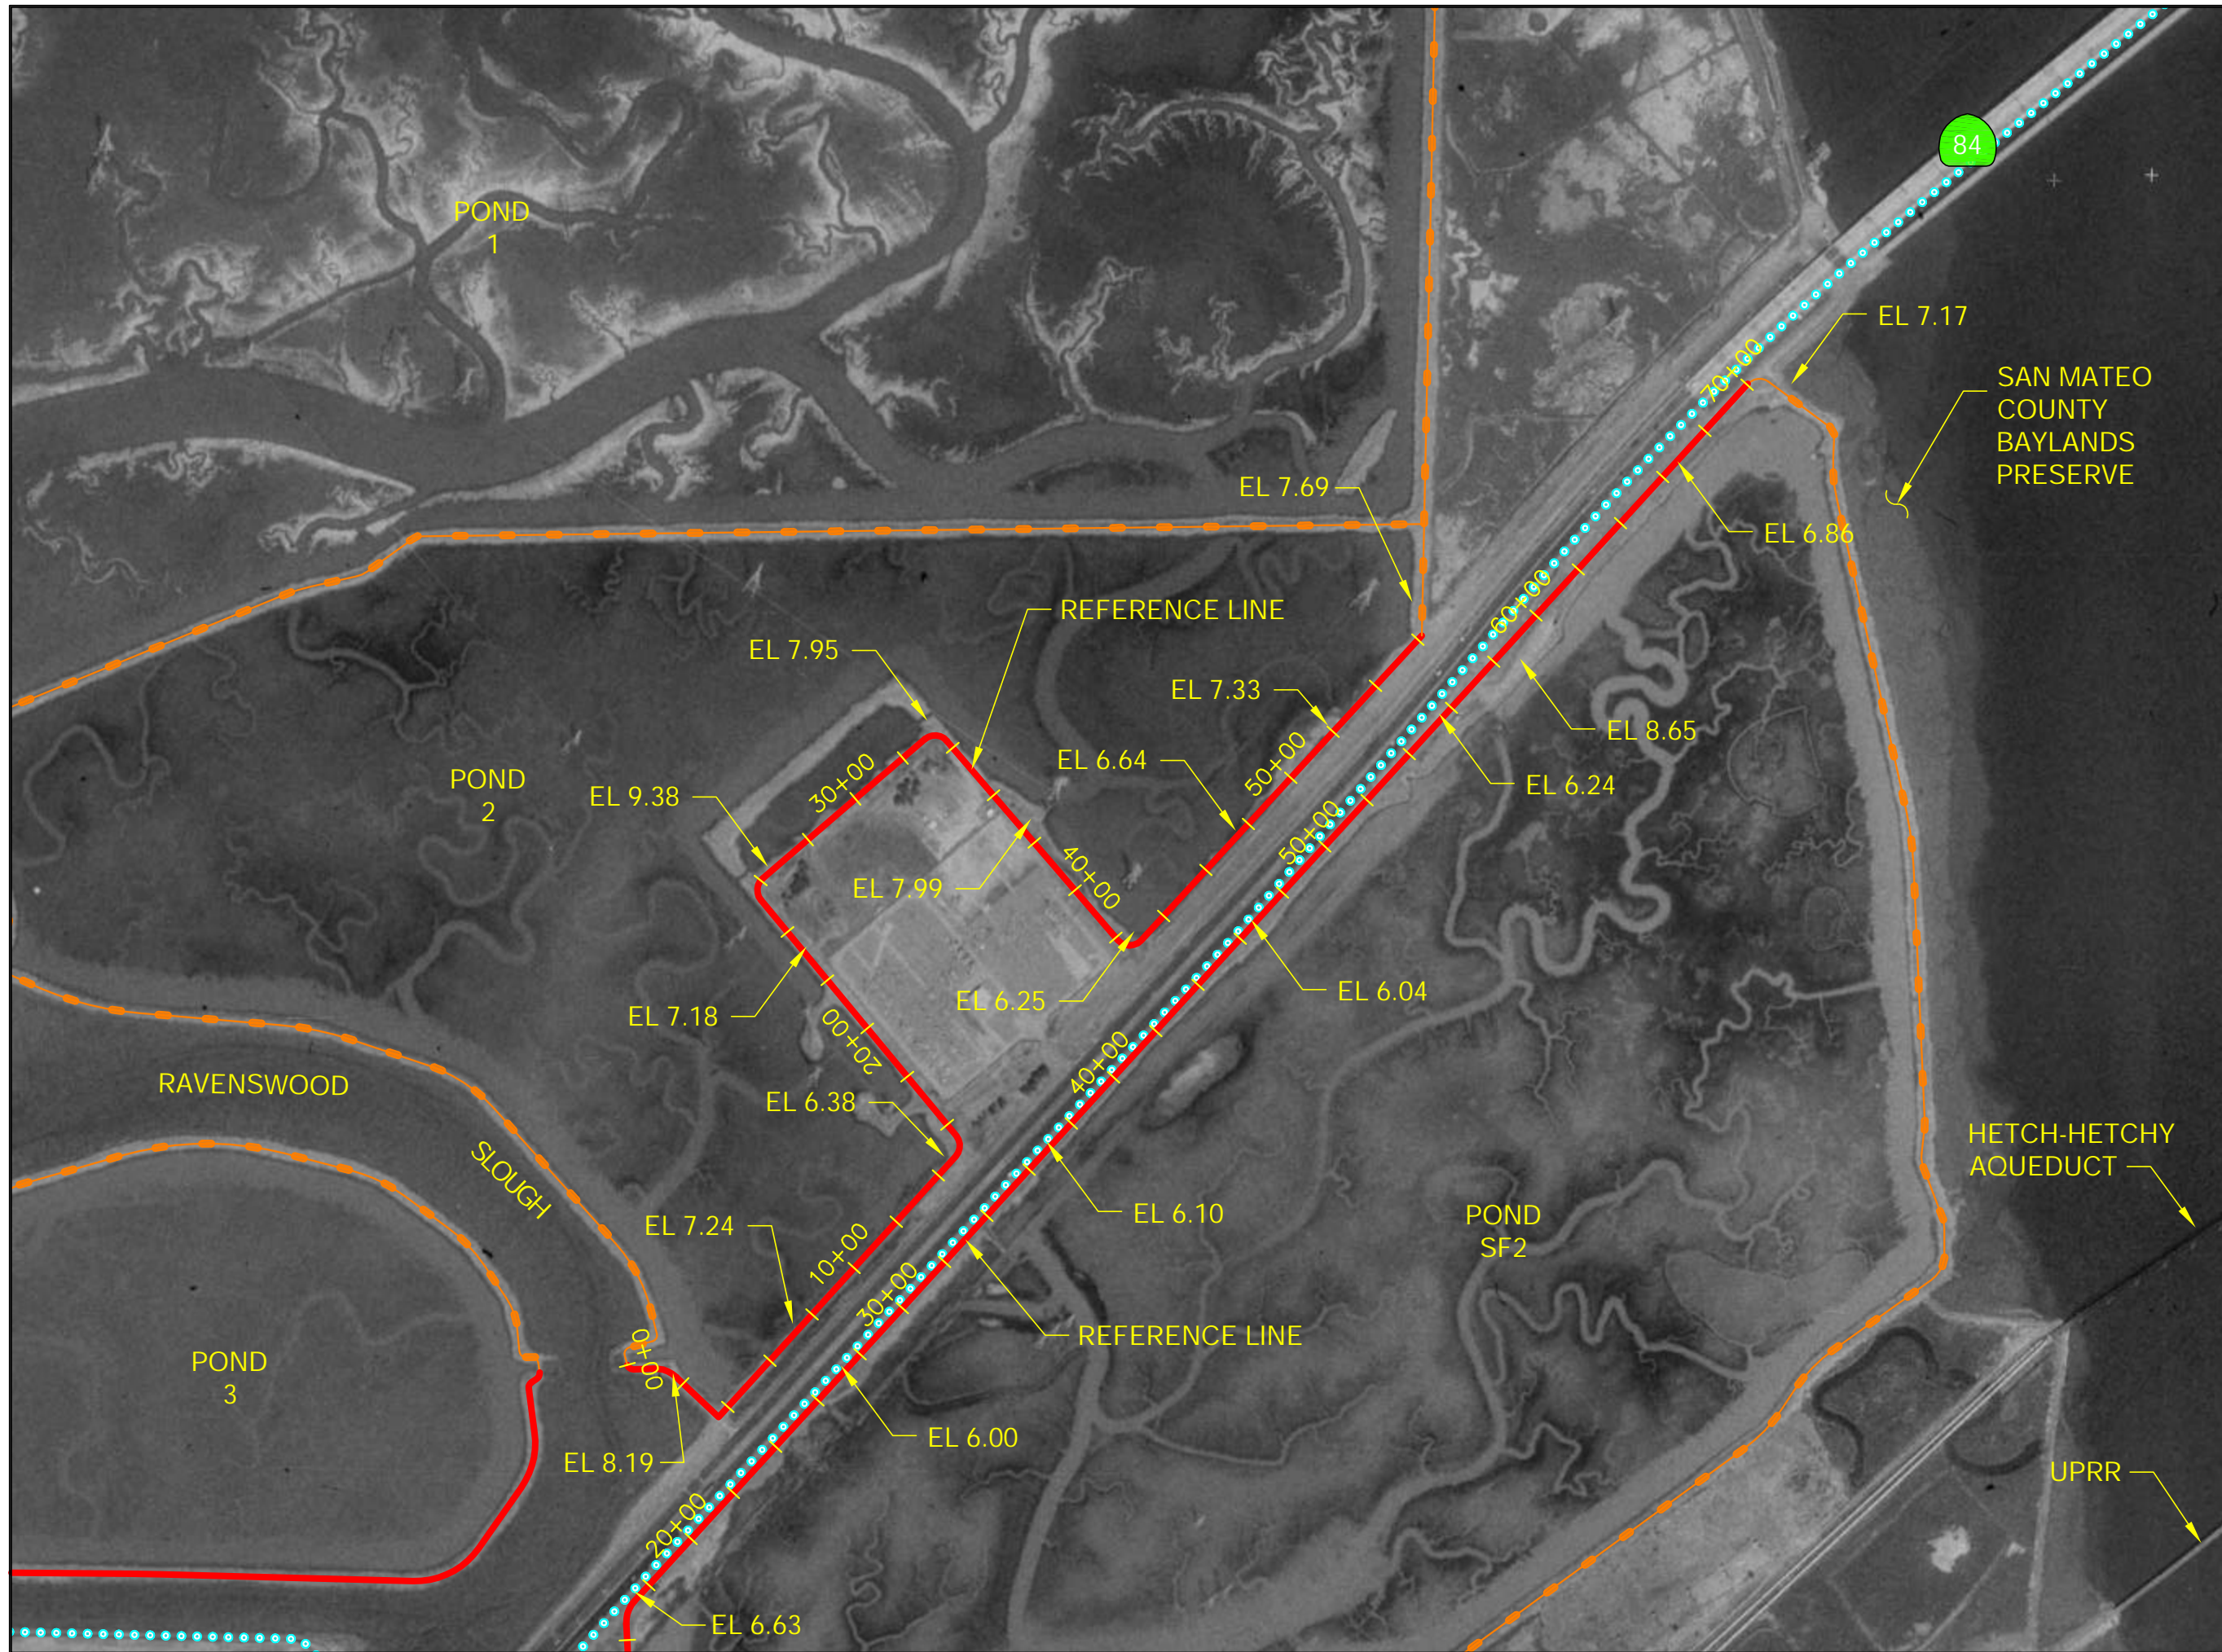
Figure 3.4.2e shows the pond, the surrounding area, and the reference line. Urban development adjacent to the pond include Highway 84 to the north and west and the SPRR railroad to the south.

STATION 48+00±
LOOKING WEST

WEST BAY POND 3

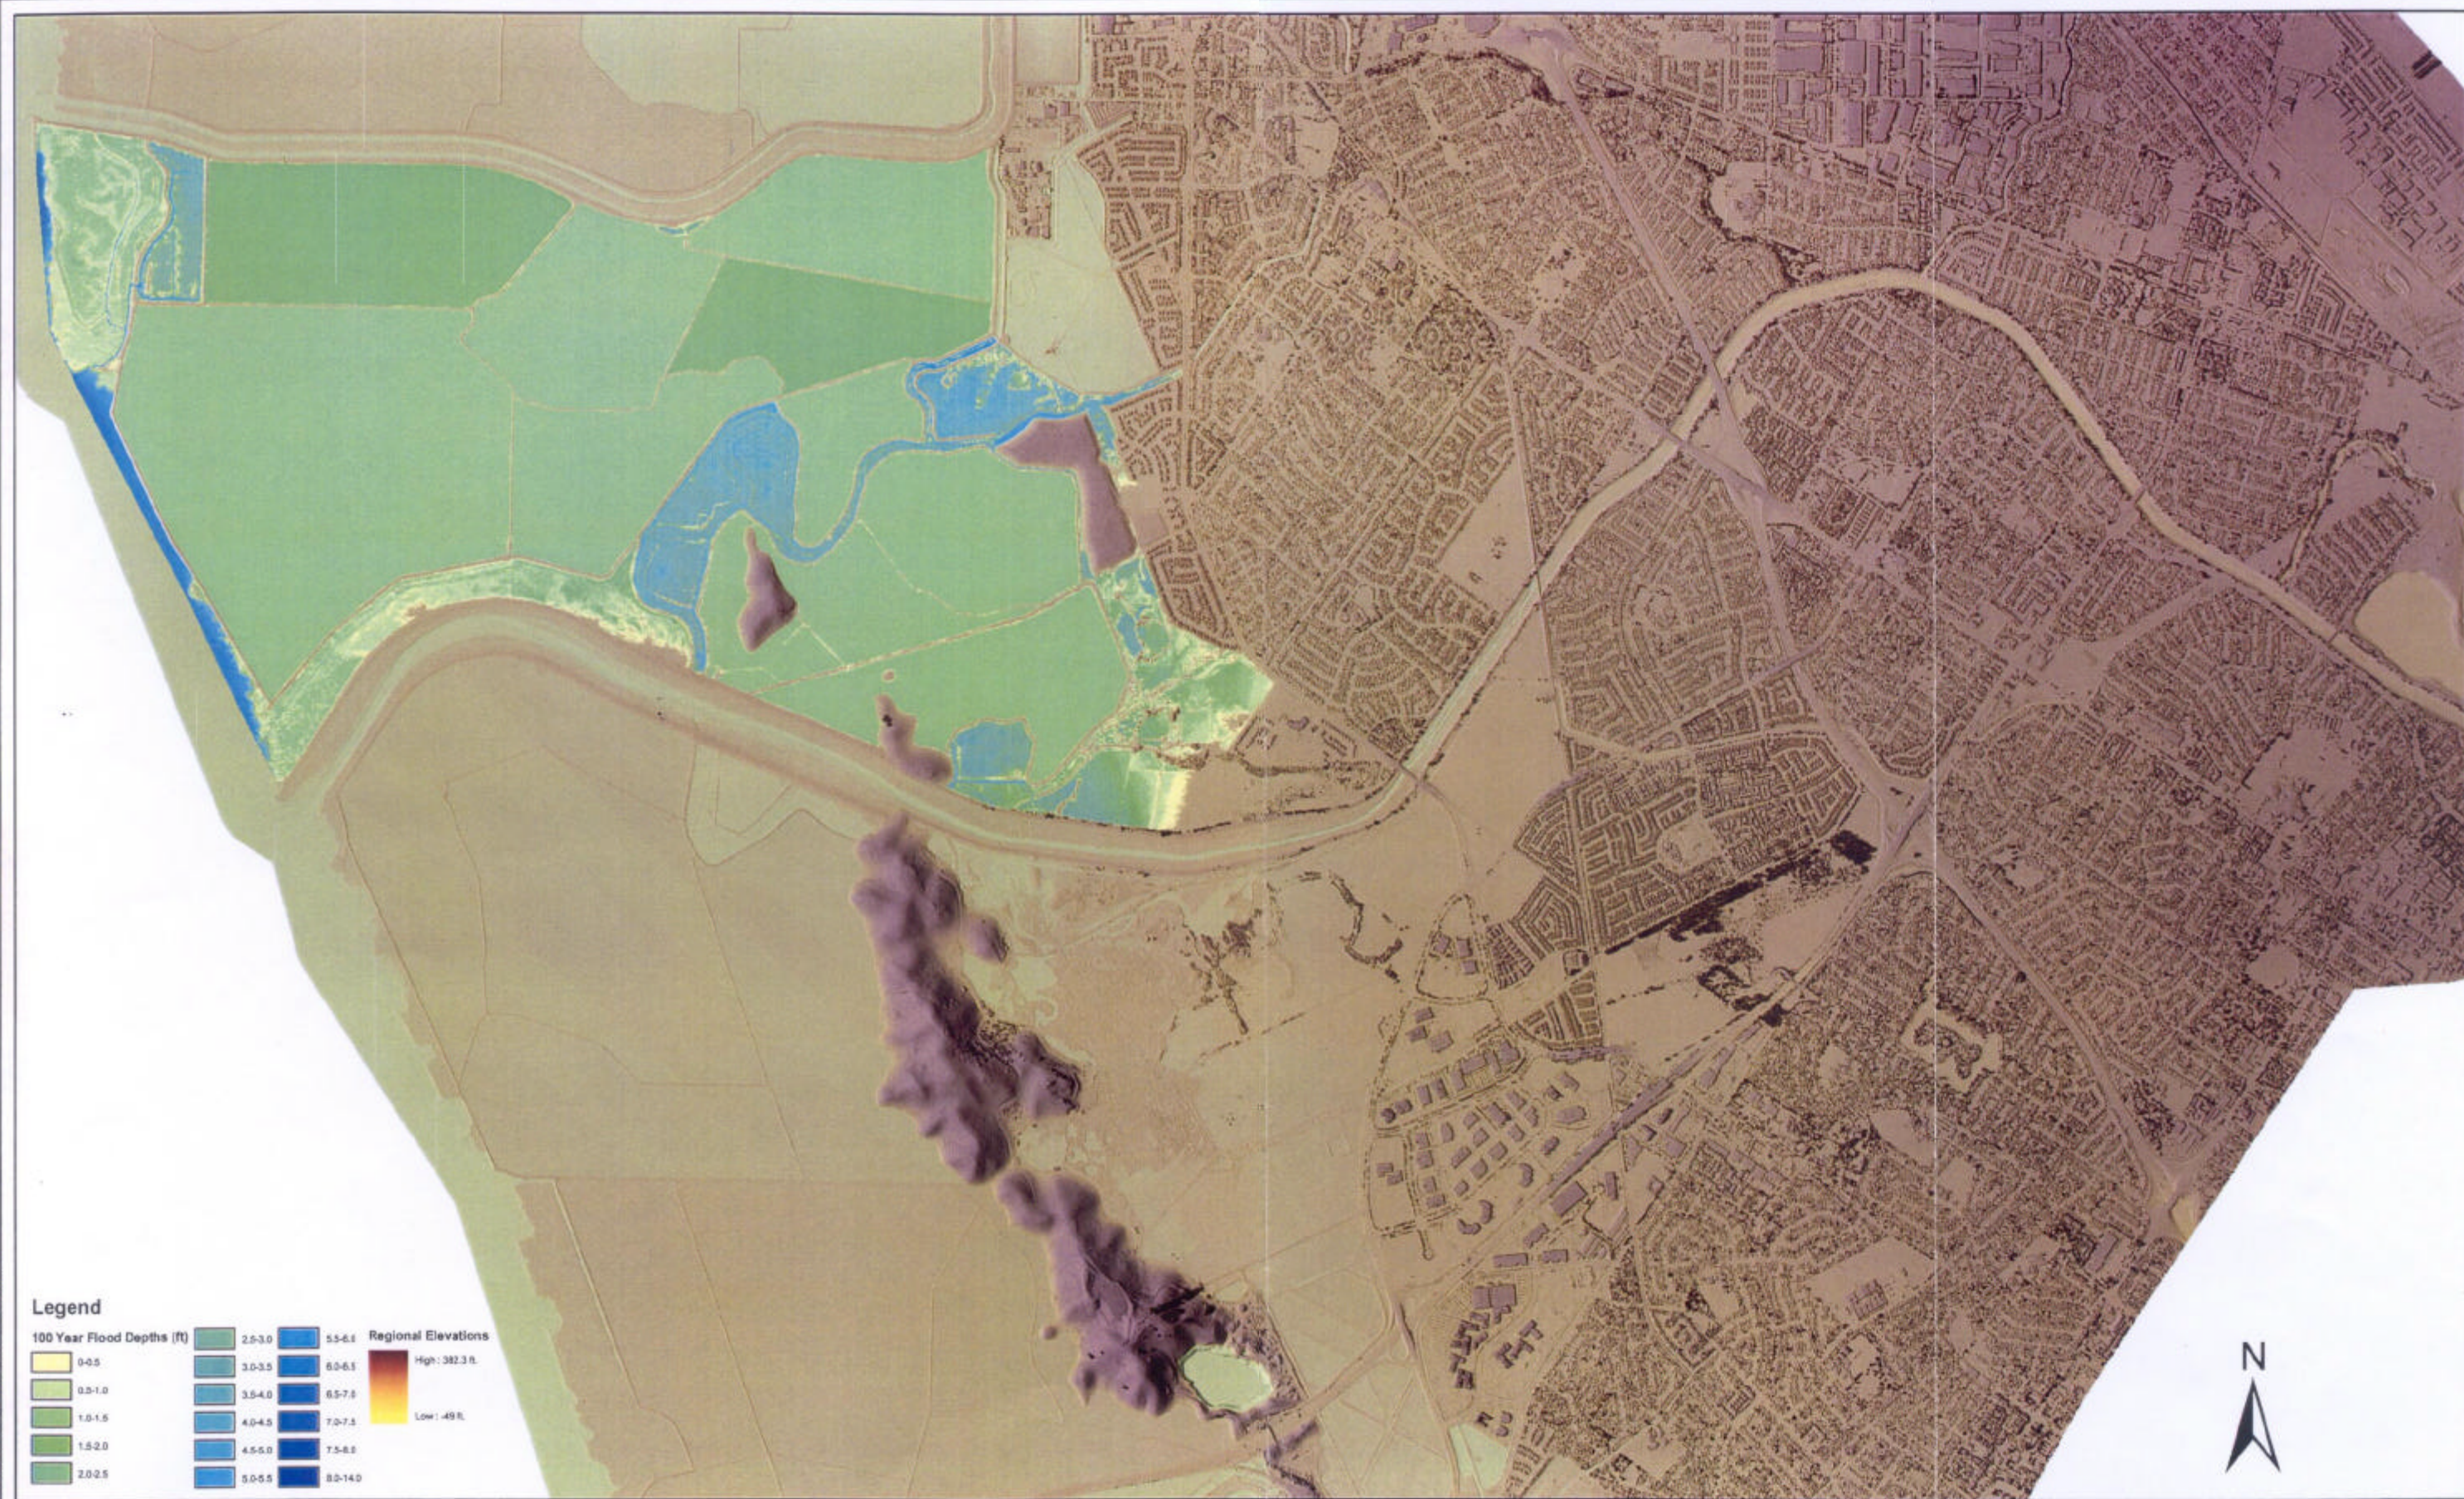
Figure 3.5.1: 100 – Year Floodplain
(Source: Alameda Creek Floodplain Study,
URS, 2003, Prepared for ACFCWCD)

Previous reports (URS 2002) state that the Alameda Creek Flood Control channel was designed to protect surrounding lands from the standard project flood, which is the flood with a return period of approximately 500 years. Due to siltation, the channel's capacity has lessened, but still provides significant protection from the 100-year event. During this event, the southern levees are above the water surface but the northern levees are overtopped in the downstream reaches (below Ardenwood Blvd.), resulting in moderate flooding of undeveloped areas. Figure 3.5.1 shows the 100-year floodplain, as simulated using hydraulic analysis described in the report.

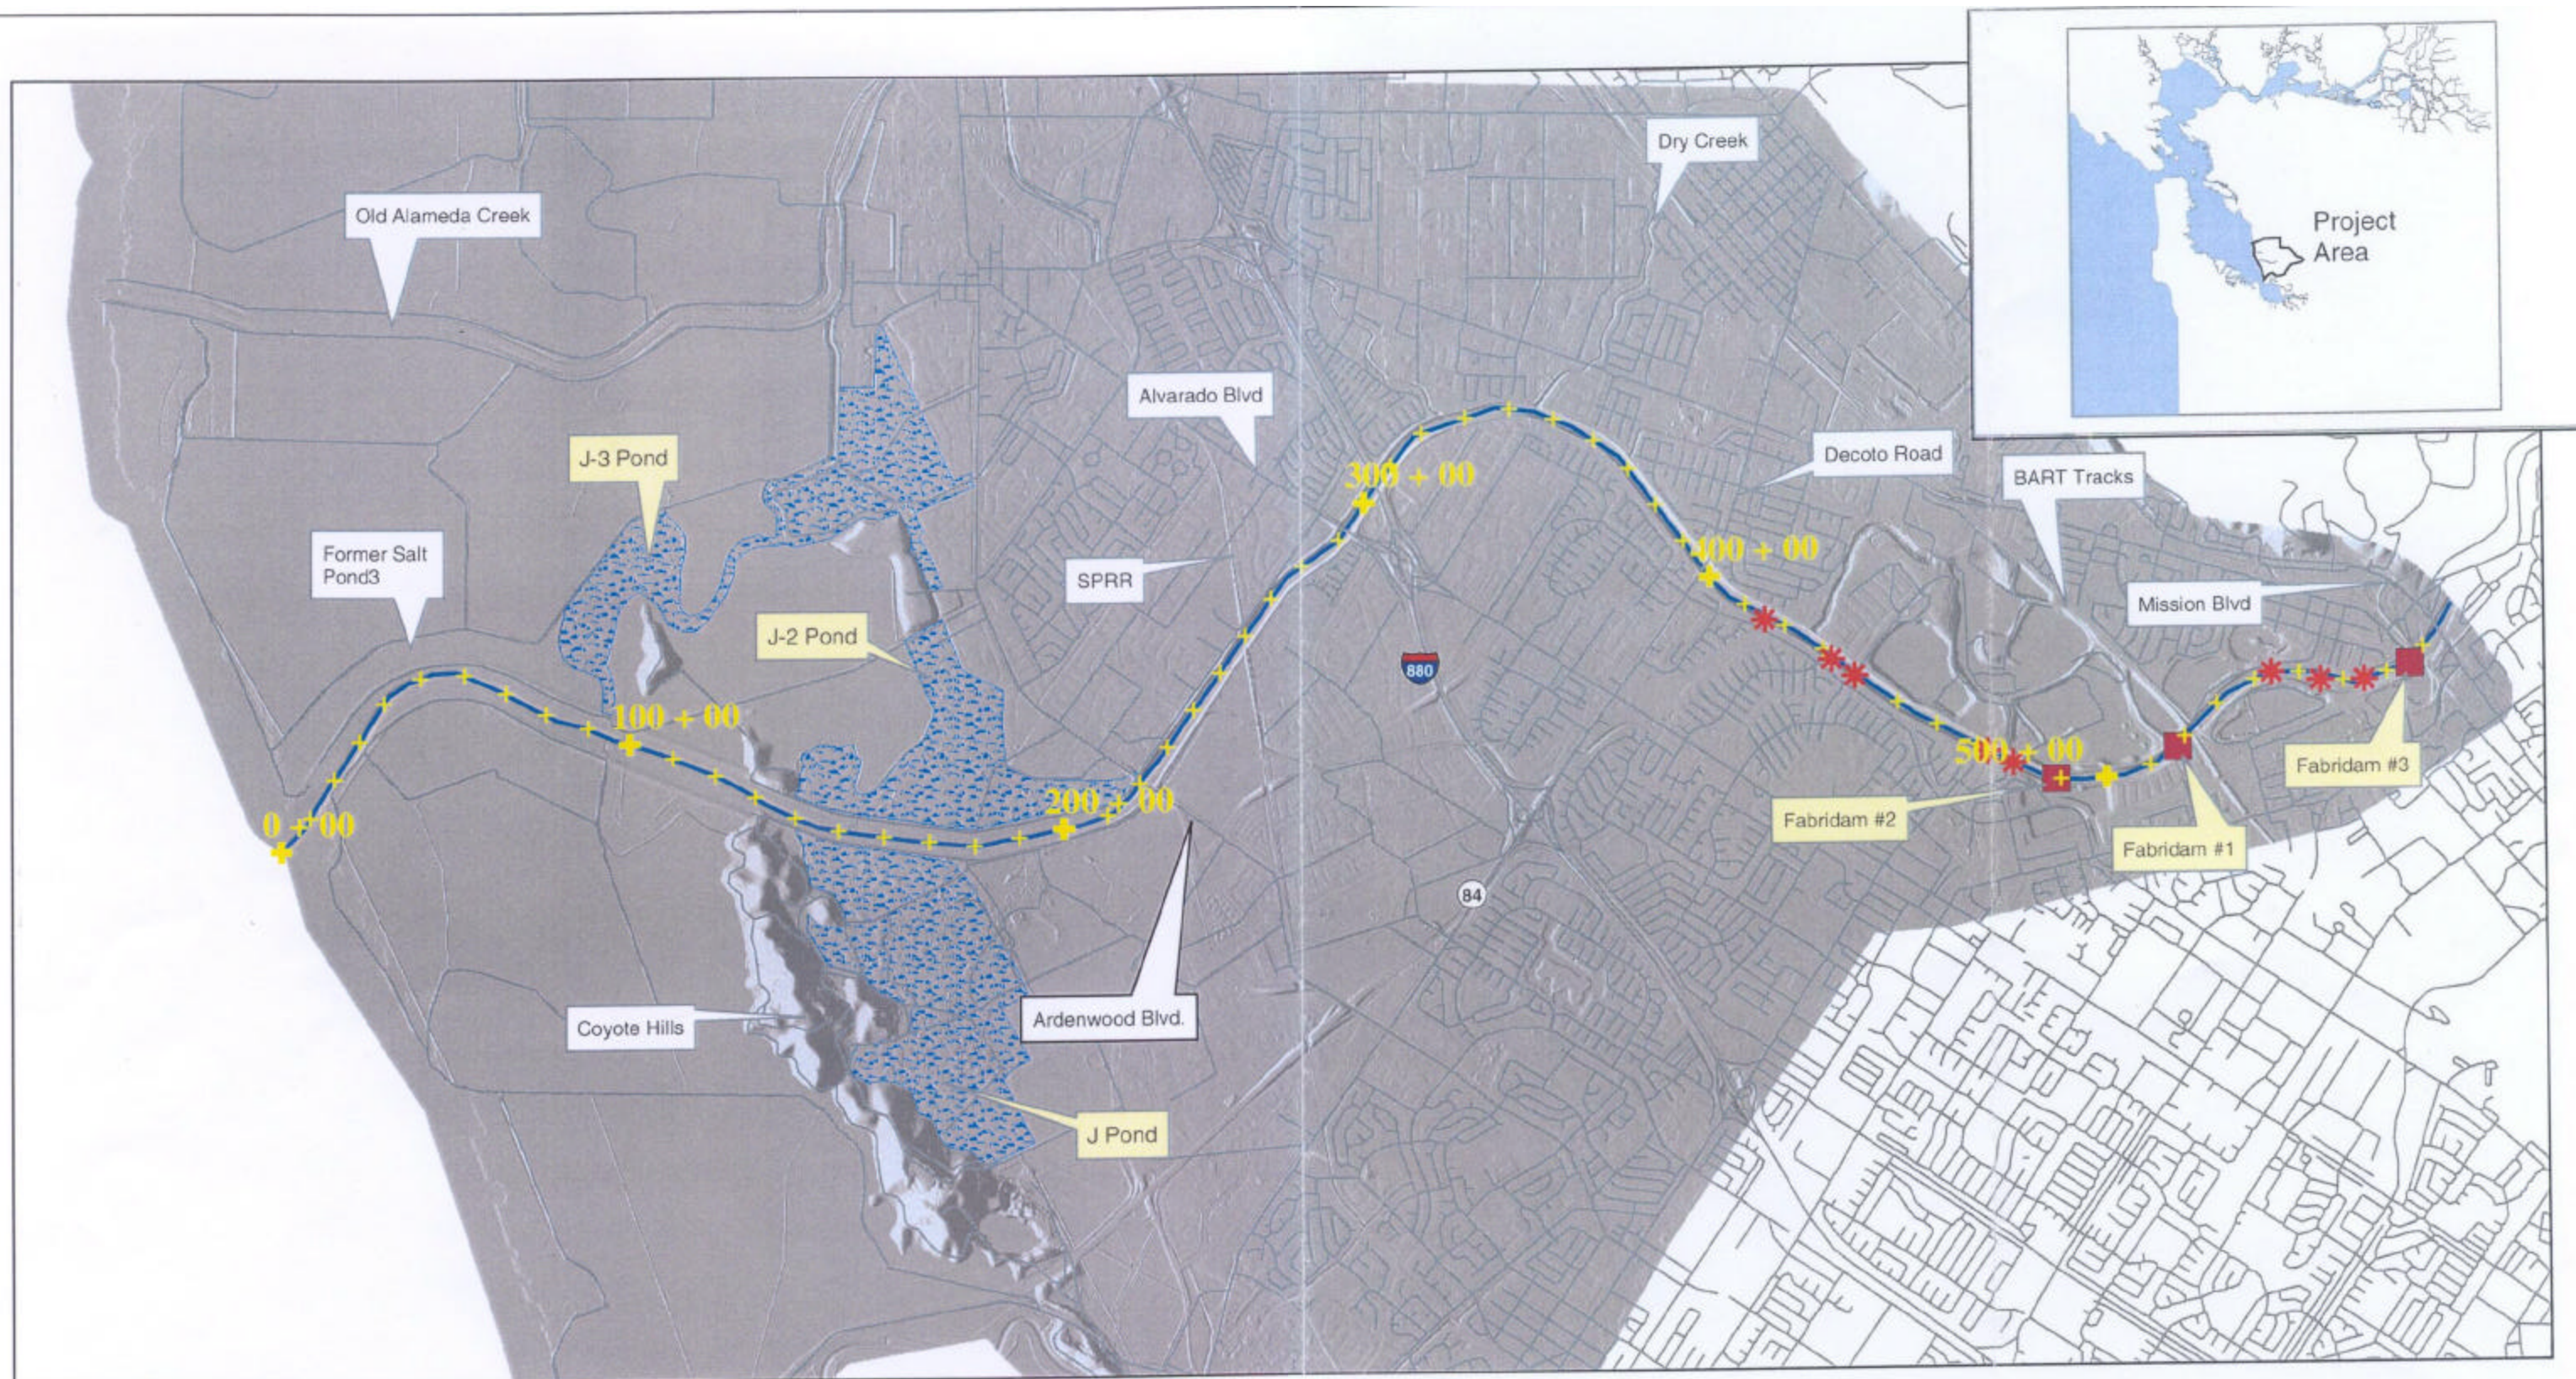
Figure 3.5.2a: Site Features
(Source: Alameda Creek Floodplain Study, URS, 2003, Prepared for ACFCWCD)

The existing topography in the area of the proposed urban levee is relatively flat, with three significant waterways passing through – the Alameda Creek Flood Control Channel (Coyote Hills Slough), the old Alameda Creek, and Mount Eden Creek. Figure 3.5.2a shows a layout of the study area investigated by URS for the ACFCWCD, including a station line which can be used to determine cross section locations. Figure 3.5.2b shows cross sections through the Flood Control Channel levees. The proposed urban levee essentially follows the reference line previously determined by the Alameda Creek Levee Reconfiguration Project (ACLRP) with minor alterations.
