# South Bay Salt Pond Restoration Project

## URBAN LEVEE FLOOD MANAGEMENT REQUIREMENTS

**URBAN LEVEE FLOOD MANAGEMENT REQUIREMENTS  
SOUTH BAY SALT POND RESTORATION PROJECT**

July 2005

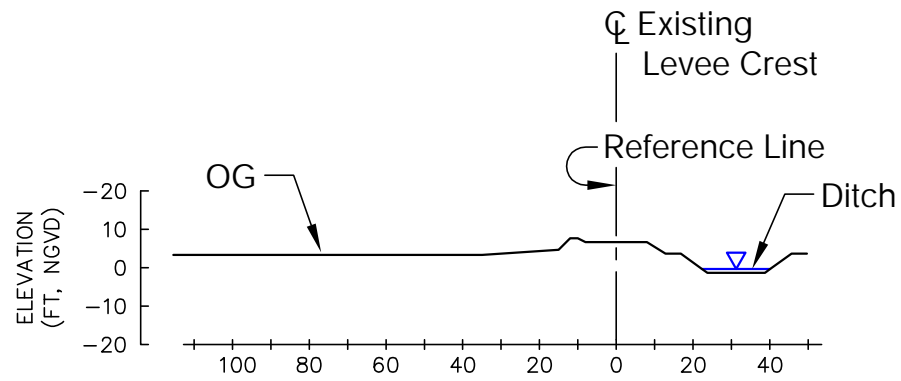
Note: The portion of pond shown in the section was dry at the time of investigation.

TYPICAL SECTION  
LOOKING EAST

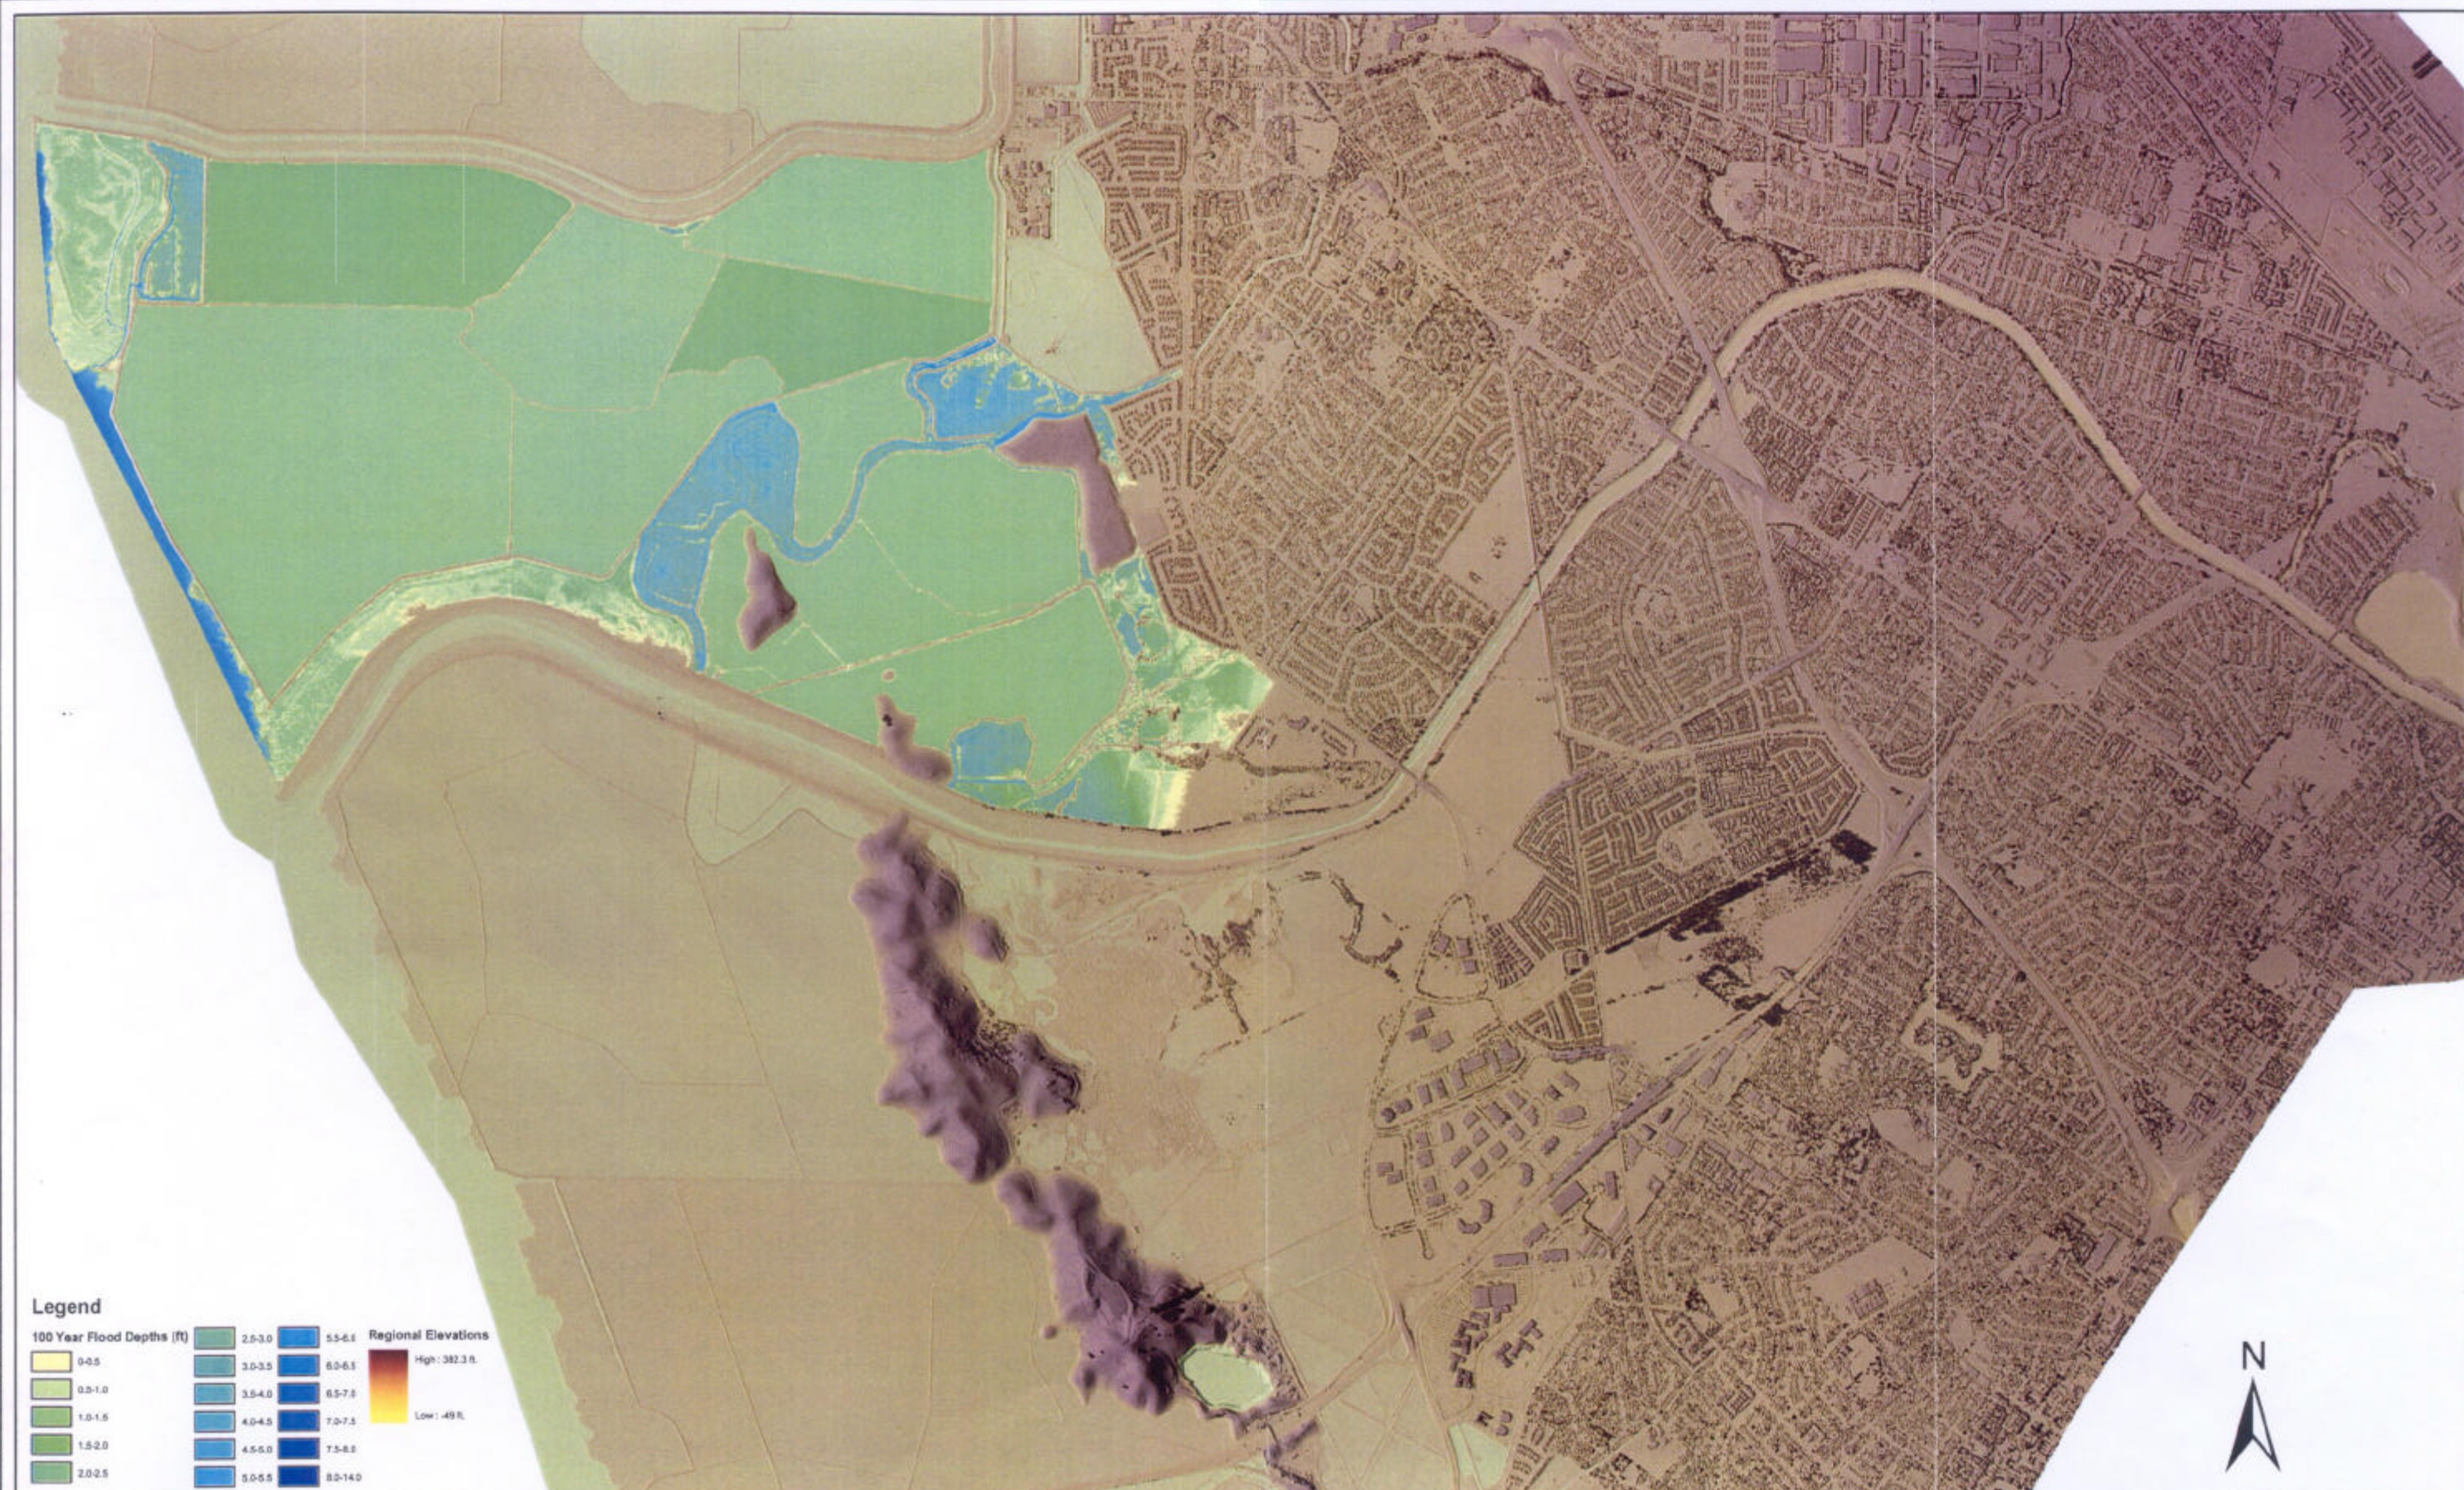
Figure 3.5.1: 100 – Year Floodplain  
(Source: Alameda Creek Floodplain Study,  
URS, 2003, Prepared for ACFCWCD)

Previous reports (URS 2002) state that the Alameda Creek Flood Control channel was designed to protect surrounding lands from the standard project flood, which is the flood with a return period of approximately 500 years. Due to siltation, the channel's capacity has lessened, but still provides significant protection from the 100-year event. During this event, the southern levees are above the water surface but the northern levees are overtopped in the downstream reaches (below Ardenwood Blvd.), resulting in moderate flooding of undeveloped areas. Figure 3.5.1 shows the 100-year floodplain, as simulated using hydraulic analysis described in the report.
