**ISLAND PONDS MITIGATION MONITORING  
AND REPORTING  
YEAR 1- 2006**

Philip Williams & Associates, Ltd.  
H.T. Harvey & Associates  
University of San Francisco  
Santa Clara Valley Water District  
U.S. Fish and Wildlife Service - Don Edwards National Wildlife Refuge

January 2007

PWA REF. # 1864

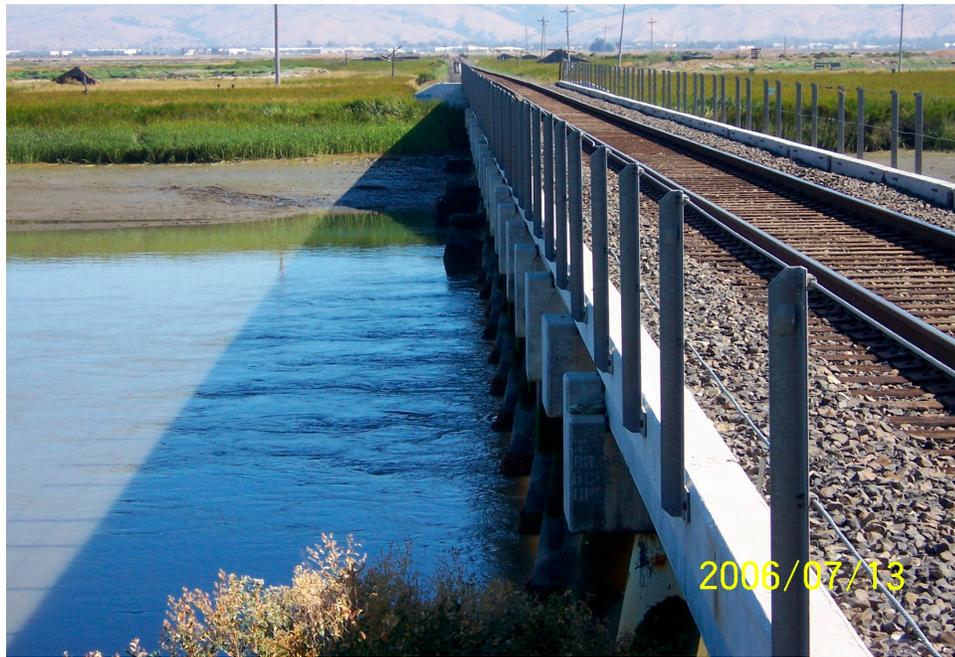
West Side of Bridge Looking North – July 13<sup>th</sup>, 2006

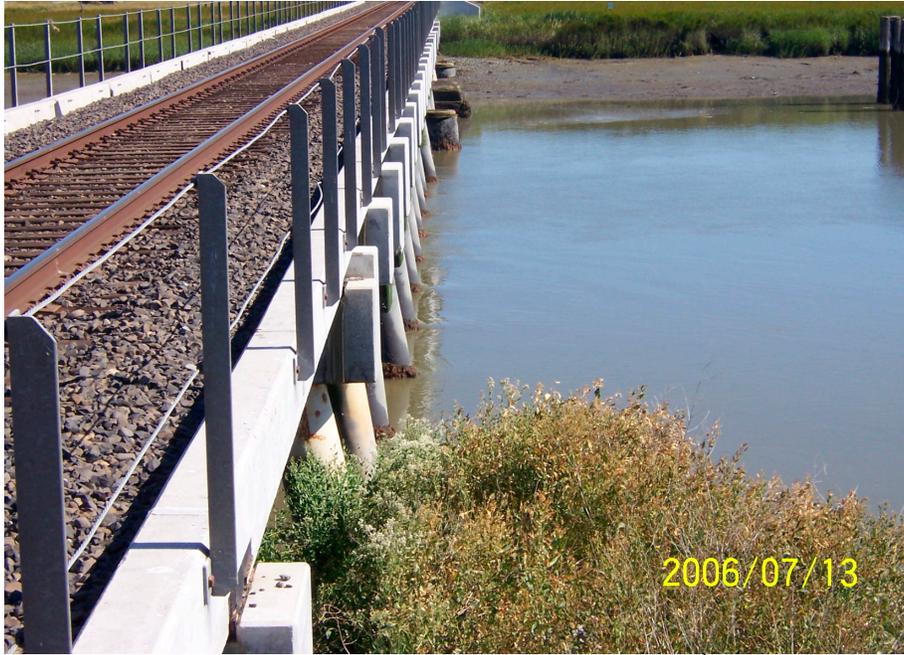
East Side of Bridge Looking North – July 13<sup>th</sup>, 2006

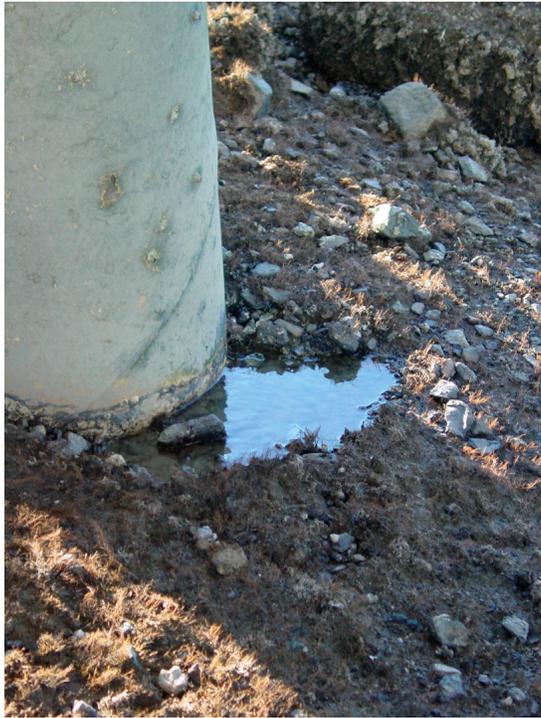
Close-up of West Side Pier on South Bank Looking West

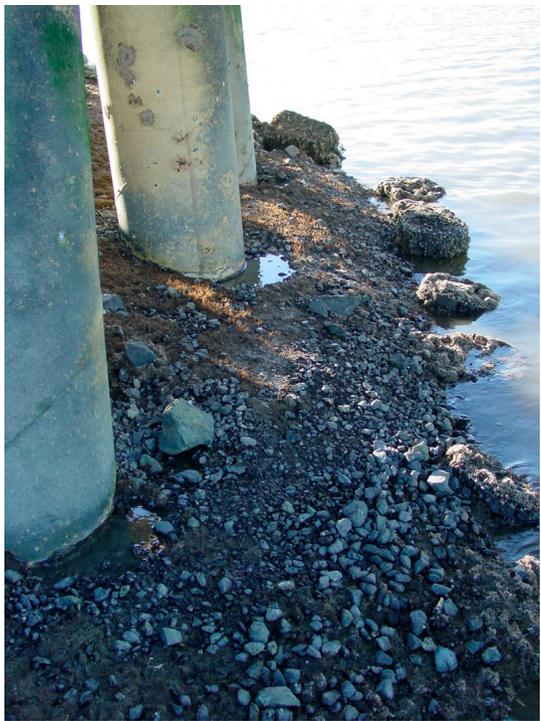
Close-up of all Piers on South Bank Looking West

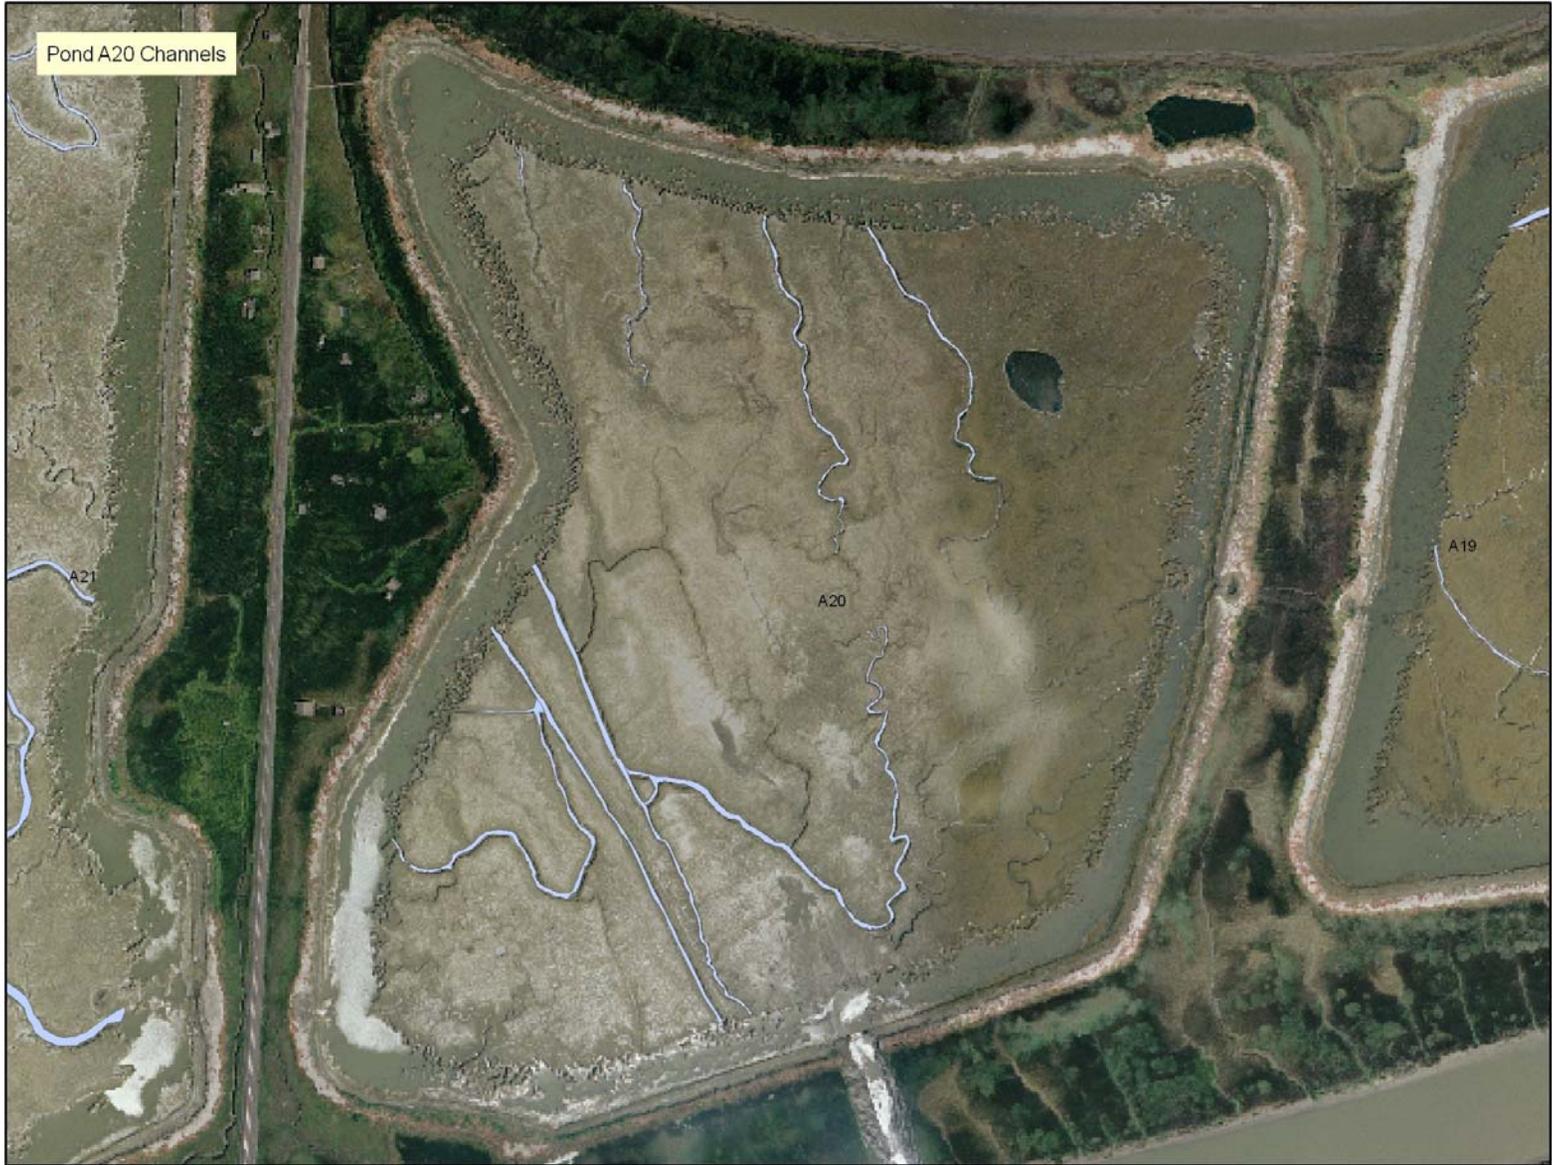
Figure 2: Channel Networking in Pond A20 during 2006

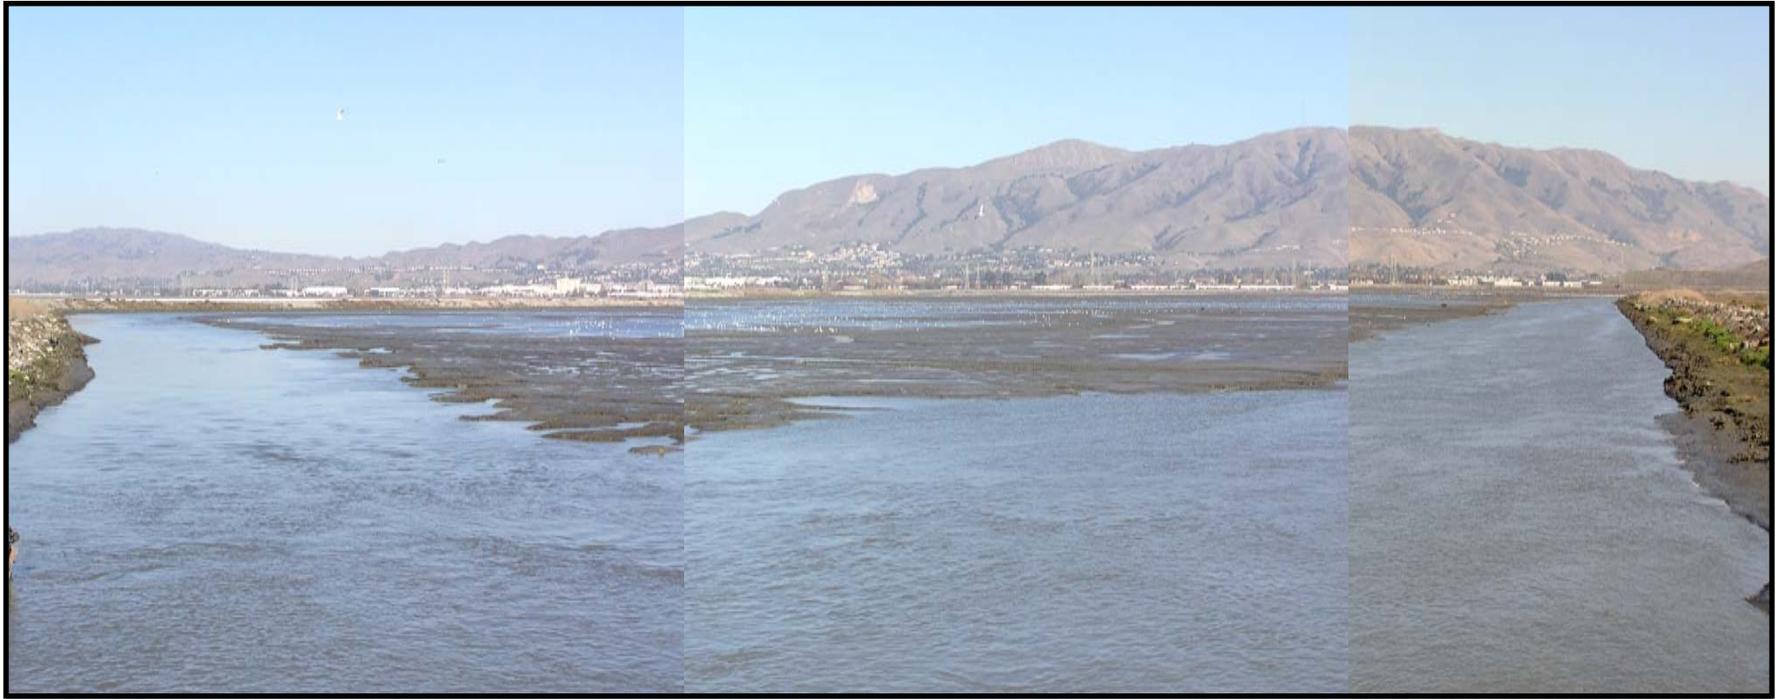
**Figure 4: Photo Point taken of Pond A19 during ebb tide – December 1, 2006**

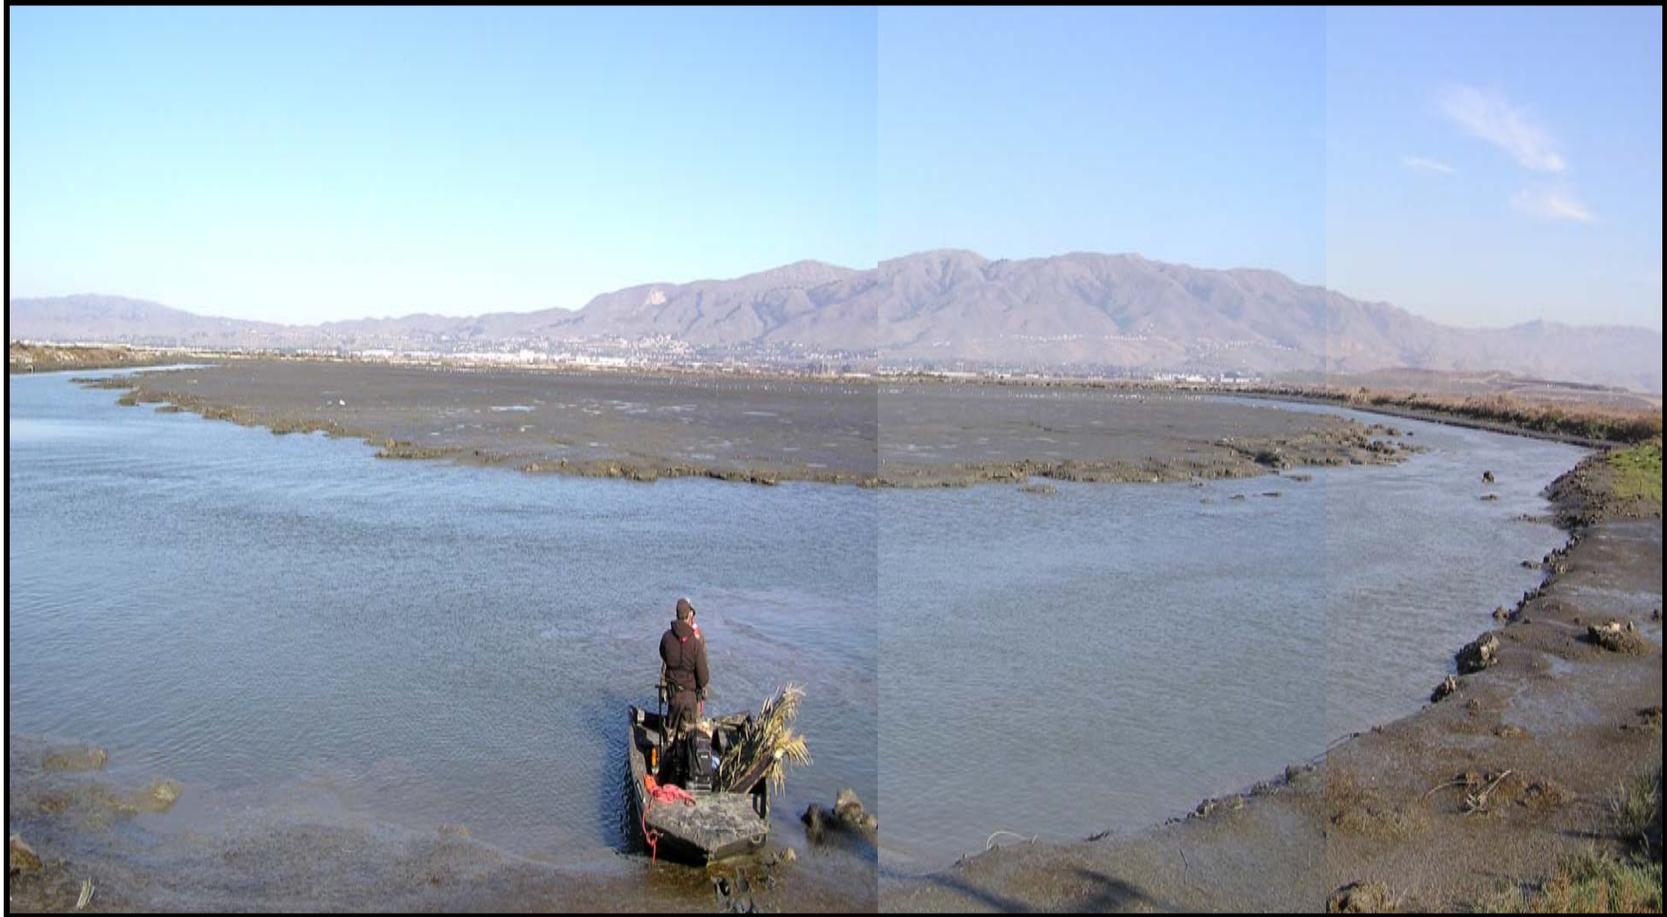
Figure 5: Photo Point taken of Pond A20 during ebb tide – December 1, 2006

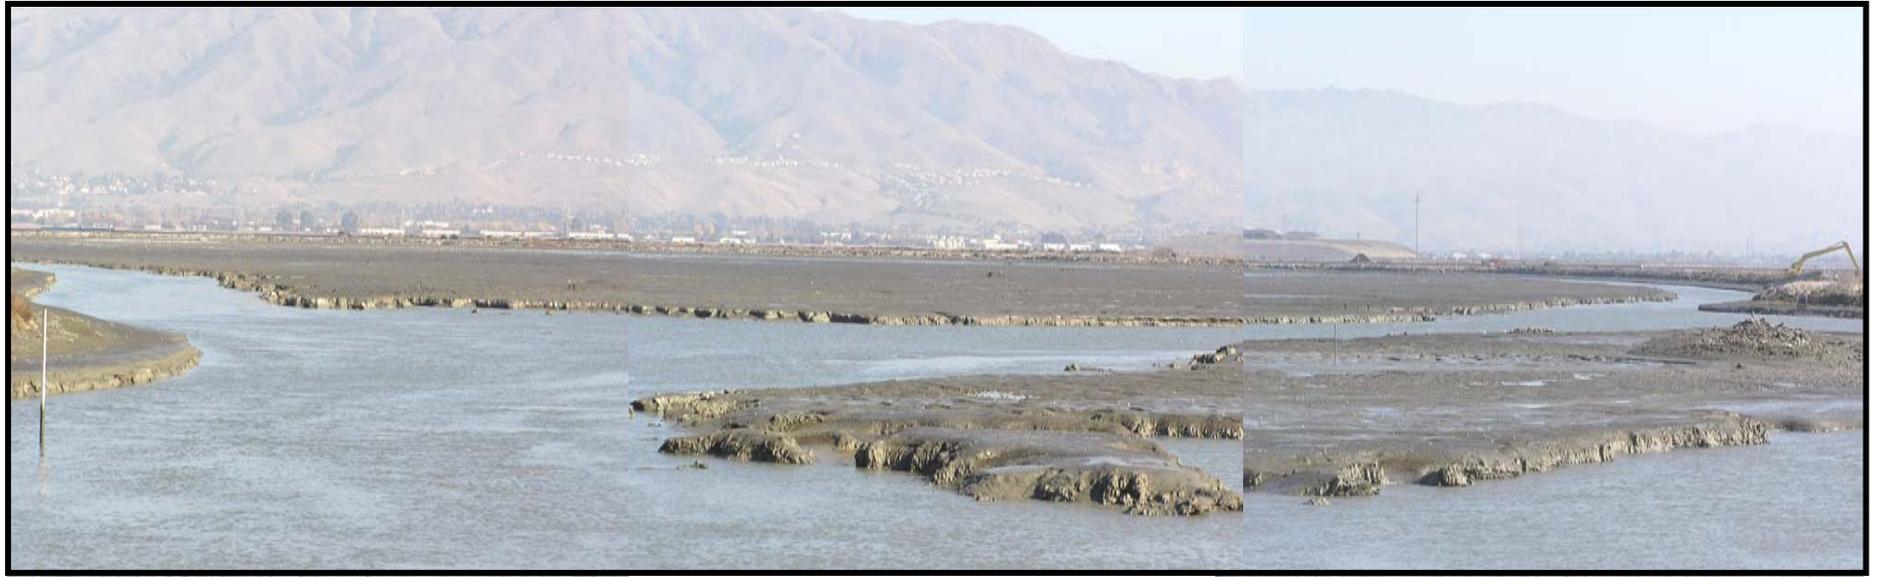
**Figure 6: Photo Point taken of Pond A21 during ebb tide – December 1, 2006**

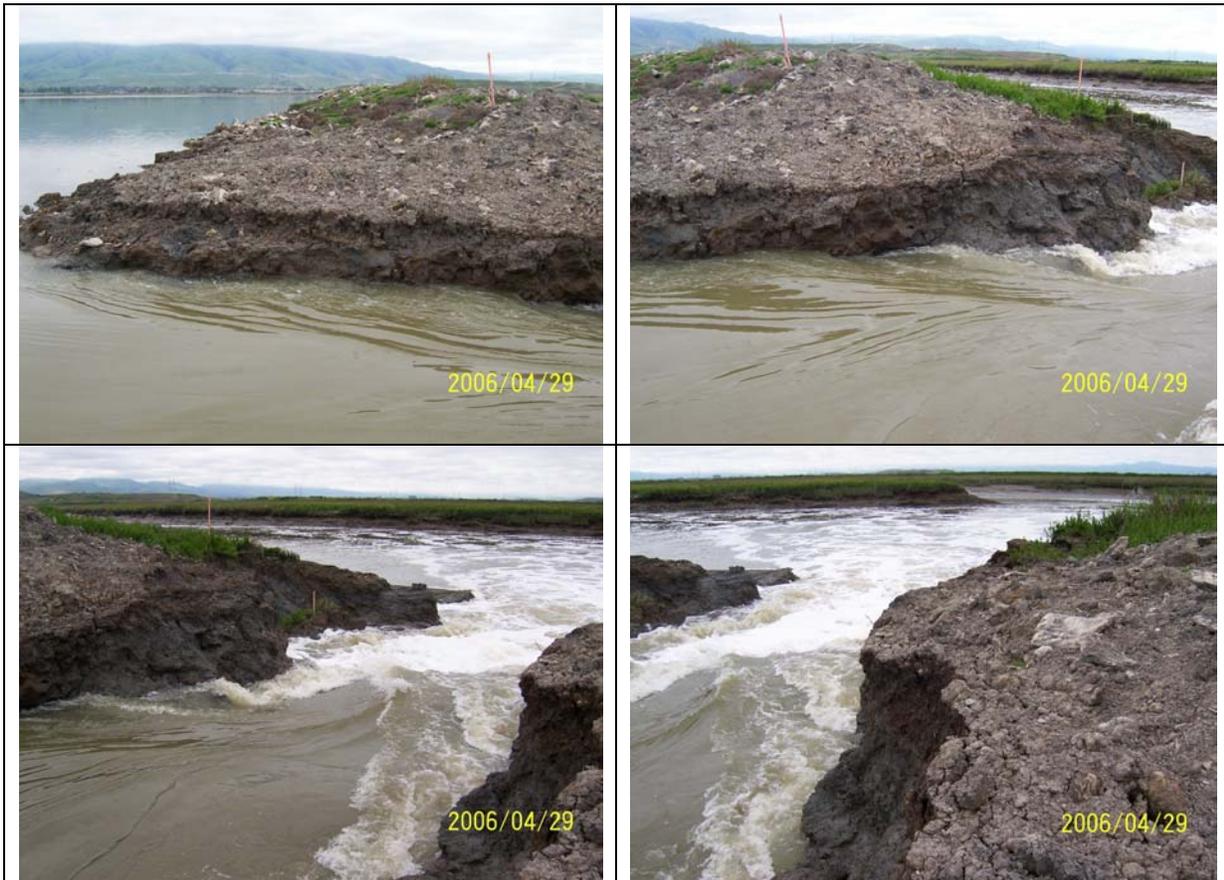
Pond A19W breach on April 29, 2006, looking from pond towards old levee and Coyote Creek

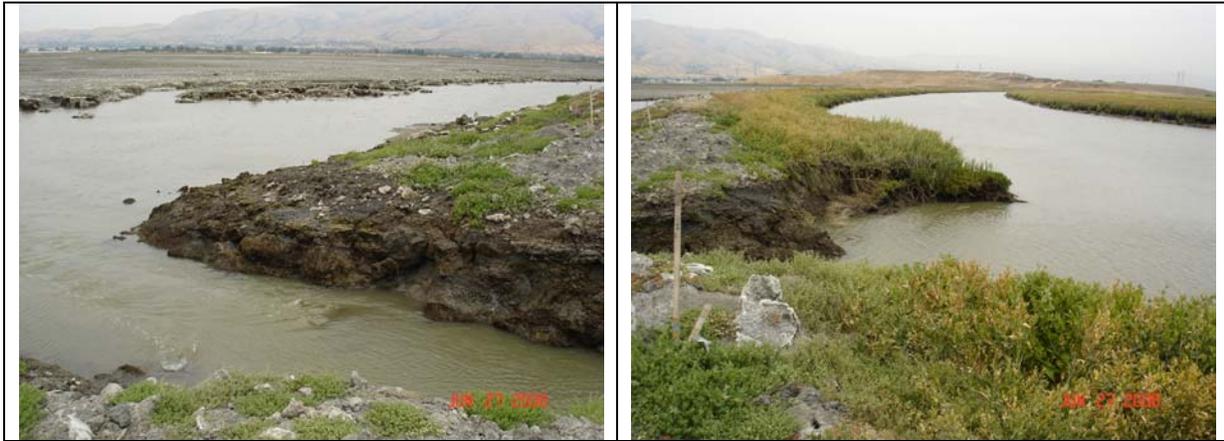
Pond A19W breach on June 27, 2006, looking east towards old levee and Coyote Creek

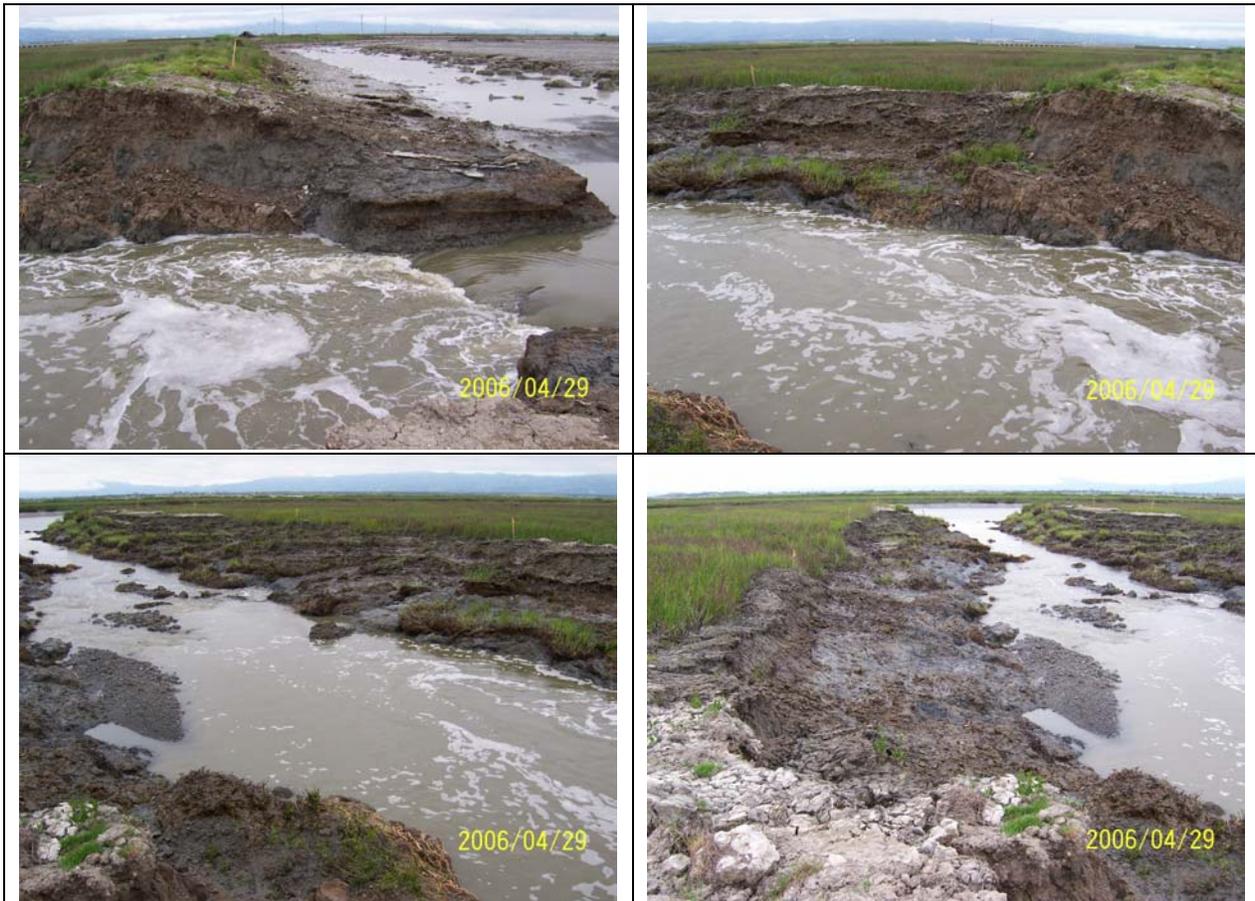
Pond A20 panoramic photos taken from the old levee on April 29, 2006. Remnants of the sidecast material noticeable in lower photos.

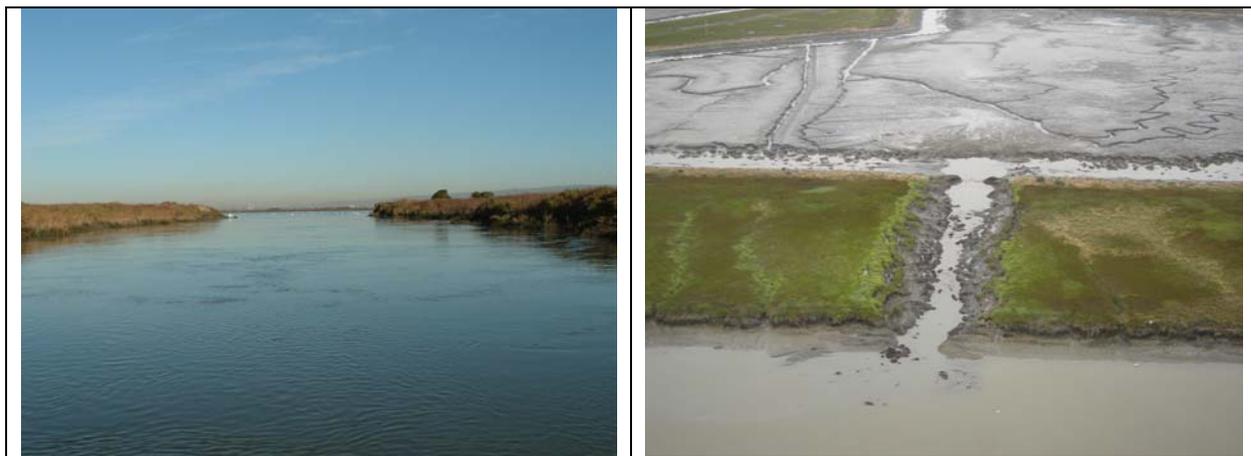
Left: Pond A20 on November 28, 2006, looking from Coyote Creek towards pond  
Right: Pond A20 on August 8, 2006, taken from helicopter looking from Coyote Creek to pond.

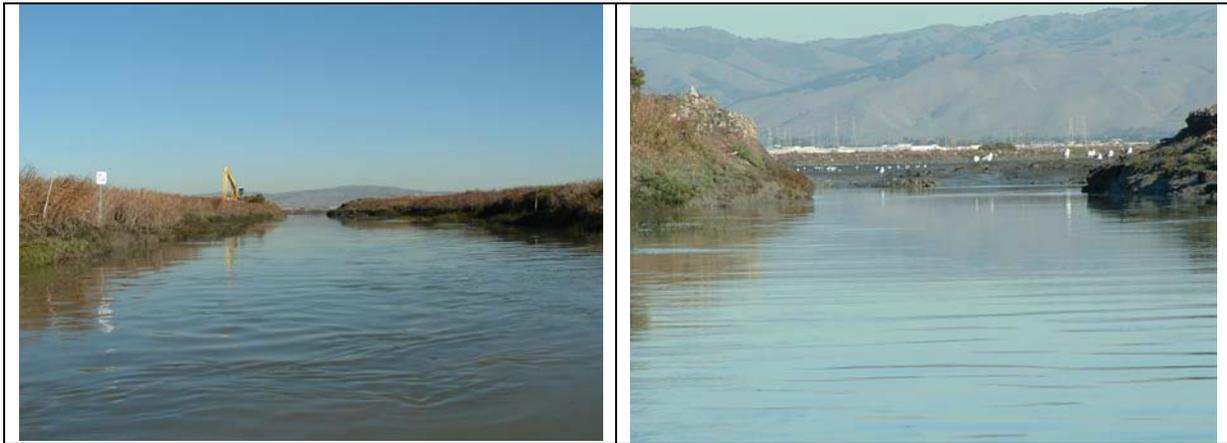
Left: Pond A21E breach on November 28, 2006, looking from Coyote Creek towards pond  
Right: Pond A21E breach on November 28, 2006, looking from breach channel to pond

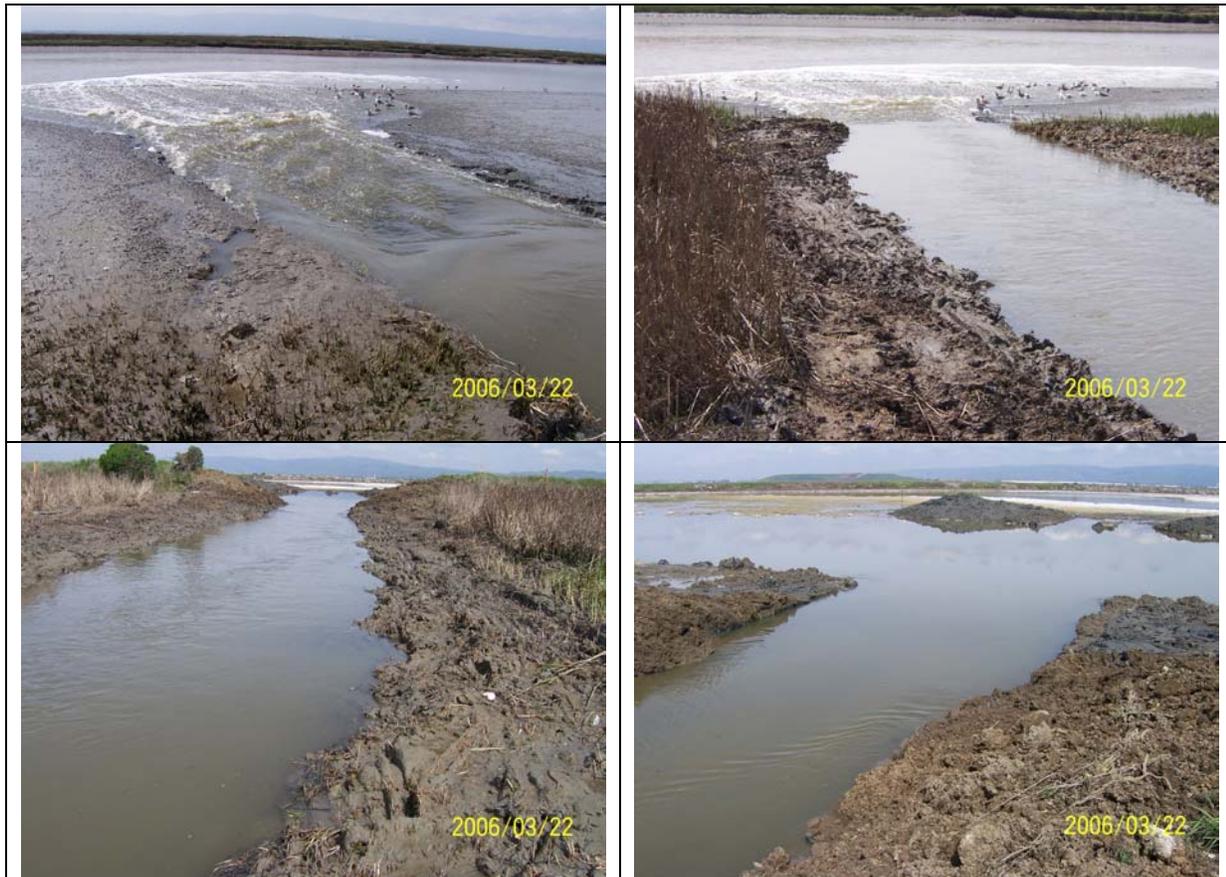
Pond 21W breach on March 22, 2006, initial days after being breached before major erosion

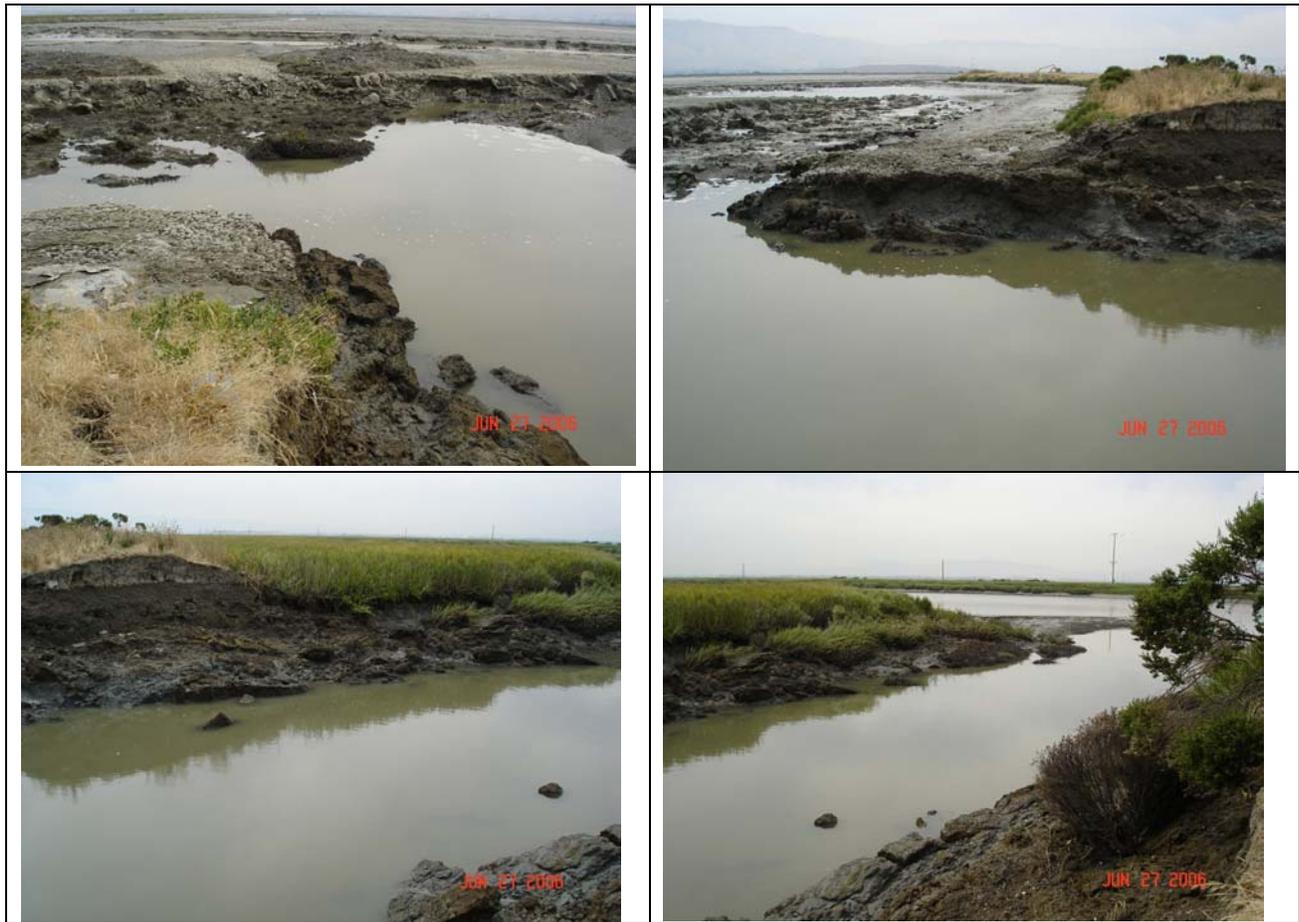
Pond A21W panoramic photos taken of breach from the old levee on June 27, 2006
